**Event Type:** Initial Attack Entrapment and Escape

**Date:** July 4, 2026

**Location:** Chelan Hills Fire, Washington

## The Story and Lessons from this Initial Attack Entrapment and Escape Incident

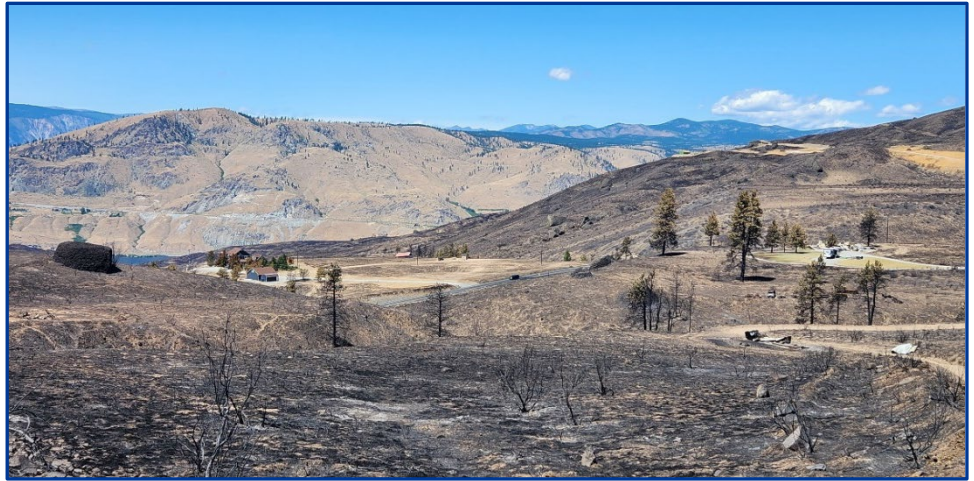
*Figure 1.—The Safety Zone as seen from above by Crew 1 as they left Sunflower Lane.*

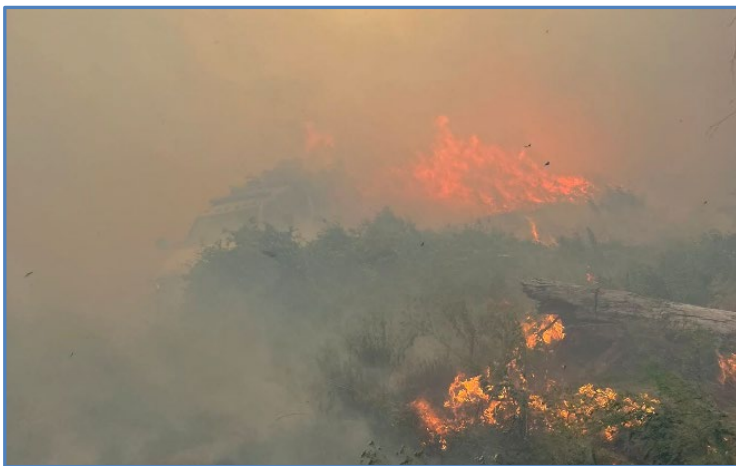
***Figure 4.—Photo taken by Engine 2 crew members looking back toward their engine as they egressed to take refuge beside a nearby building.***

Meanwhile, at 1537, Engine 2 with the Engine Boss and one crew member mistook a pullout for the road due to the same lack of visibility. The engine left the roadway, travelling downhill approximately 250–300 feet down the slope, knocking over several small trees as it travelled. (“Eng 2 Left Road” on Figure 5.) Just short of merging back onto Mountain Spring Road, the engine became disabled. (“Eng 2 Final” on Figure 5.)

Two minutes later, threatened by fire, the crew immediately evacuated the engine and took refuge behind a nearby building. (“Eng 2 Area of Refuge” on Figure 5.)

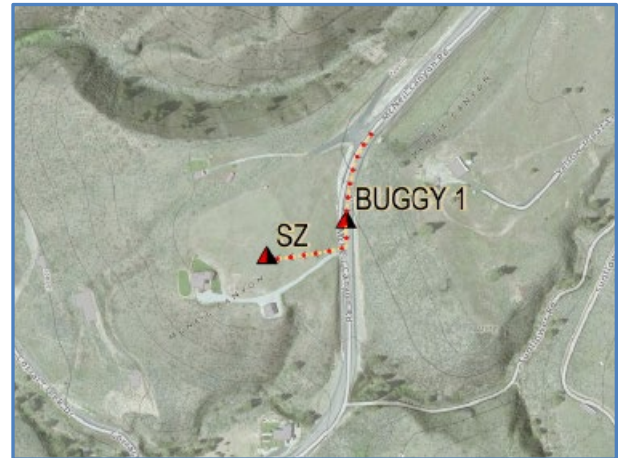
One minute later, Crew 1 observed smoke and then flames coming from the engine compartment of the second 5-Person Crew Carrier (4<sup>th</sup> of 5 in the convoy) and its engine died.

The Crew Carrier occupants evacuated immediately. They, along with other Crew 1 crew members, attempted to suppress this engine compartment fire with fire extinguishers. However, the metal was too hot to fully open the

hood and two extinguishers were defective. As two additional extinguishers were used, it became evident that there was no way that they could put this fire out.

***Figure 2.—The location of the burned Crew Carrier ("Buggy 1") and Safety Zone ("SZ").***

1. Two fire extinguishers malfunctioned.
2. Pre-filter screens on air intake for vehicles may be warranted, much like the emission screens required on chainsaws and logging equipment.
3. Responders reported embers inside the cabs of vehicles due to permanently open vents and damaged door seals.

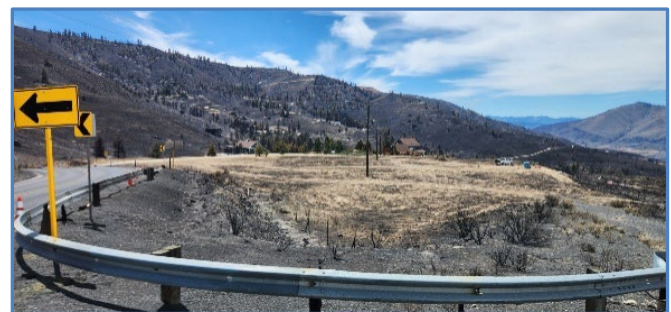
***Figure 3.—Looking down at the Safety Zone from the burned Crew Carrier's location.***

It should be noted that although the Safety Zone was a safe and secure location, the area’s short, mowed grass still carried fire through portions of the Safety Zone. Multiple units had to utilize pump and roll tactics to protect apparatus and personnel.

Flame lengths were 15–24 inches. Approximately 75 percent of the Safety Zone area received some fire activity. While parked in the Safety Zone, several apparatuses lost airlines or received other minor damage from flames burning underneath the vehicles. No other injuries or serious damage was reported.

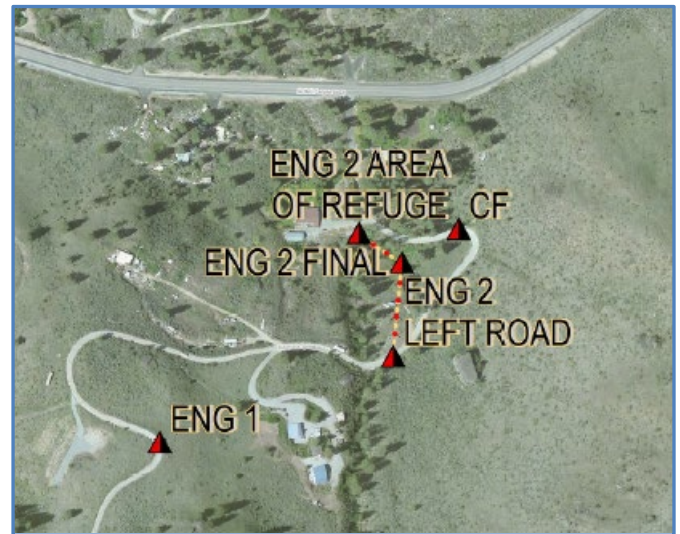
Additionally, after this initial attack entrapment event, a member of the public was found deceased in his car near where Engine 2 left the roadway. This vehicle was on a corner approximately 100 feet from where the engine left the roadway—but, in the smoke and chaos, was not visible to the Engine 2 crew.

**Figure 5.—Engine locations. “CF” is the location of the civilian fatality.**

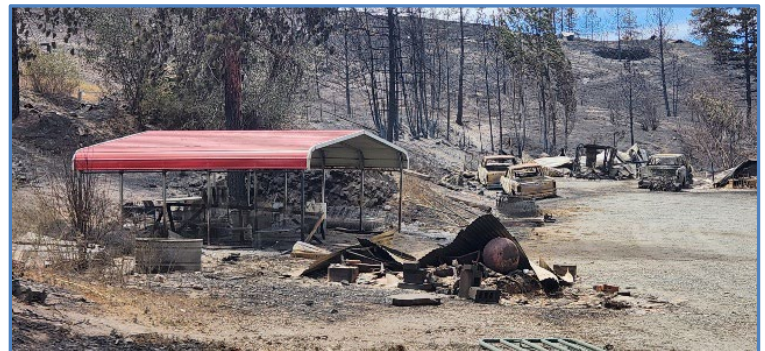
At approximately 1610, as they evaluated the need to deploy their shelters (getting their shelters out and in hand), the Task Force Leader arrived onsite, got the crew members into his vehicle, and evacuated them the 0.26 miles to the Safety Zone.

**Figure 6.—The Engine 2 crew members evacuated the engine and took temporary refuge behind this building—now burned—in the foreground. The Task Force Leader arrived and the crew members evacuated in his vehicle.**
