# LYONS FERRY FIRE

## BURNOVER

### Consolidated Incident Report and Lessons Learned

*Incident Date: July 16, 2026*

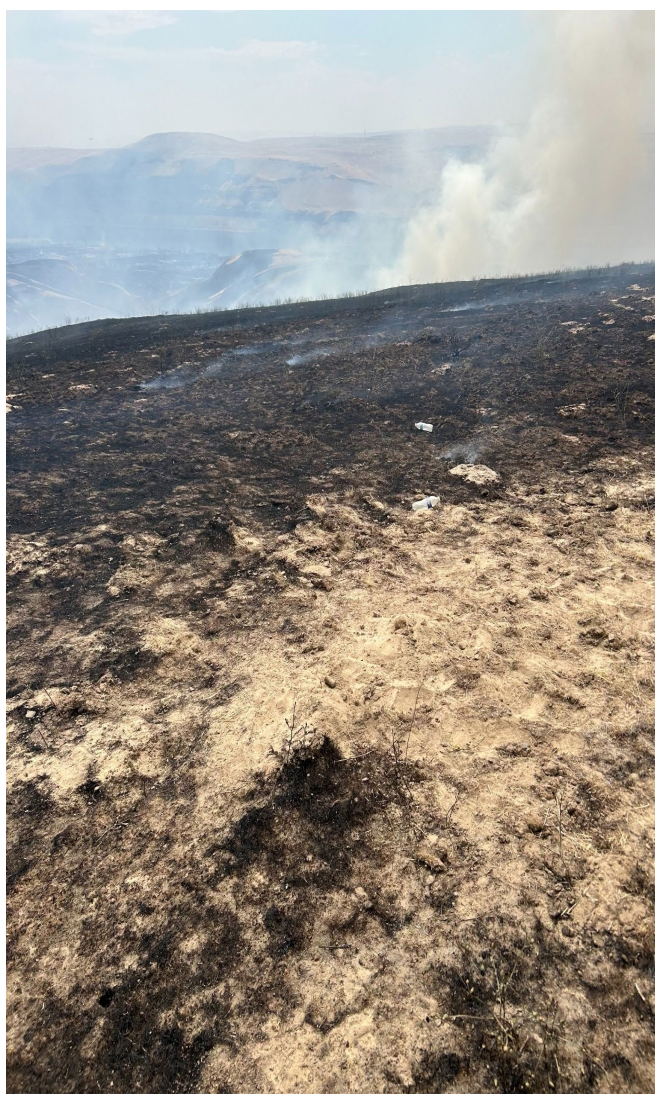
***Actual location where the burnover occurred, photographed after fire passage.***

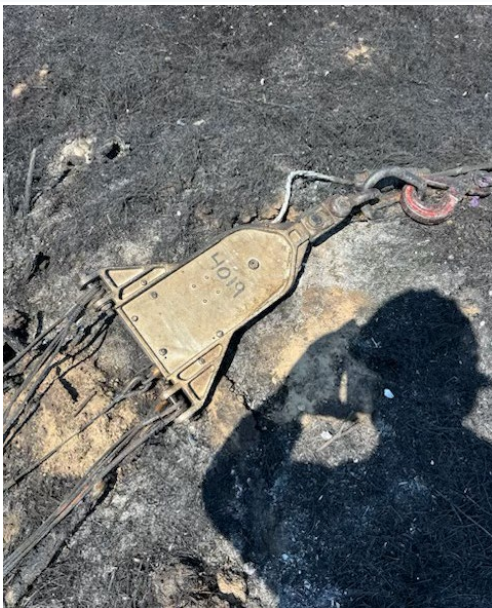
- One helicopter bucket, estimated replacement value of more than \$20,000
- One 75-foot longline, estimated value of approximately \$3,200

***Damaged helicopter bucket.***

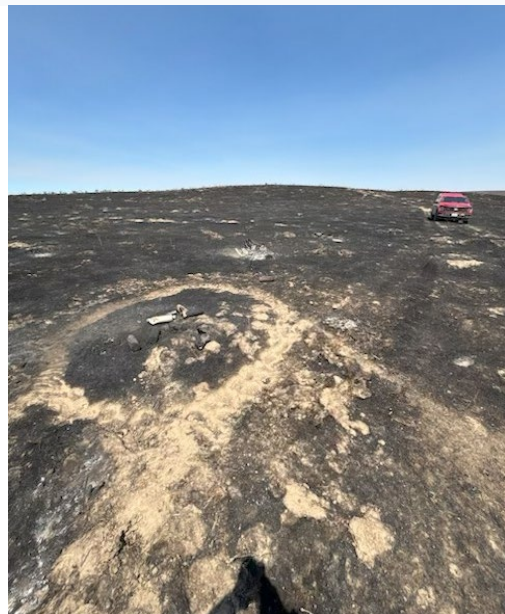
***Area where fuel cans and flammable equipment had been staged.***

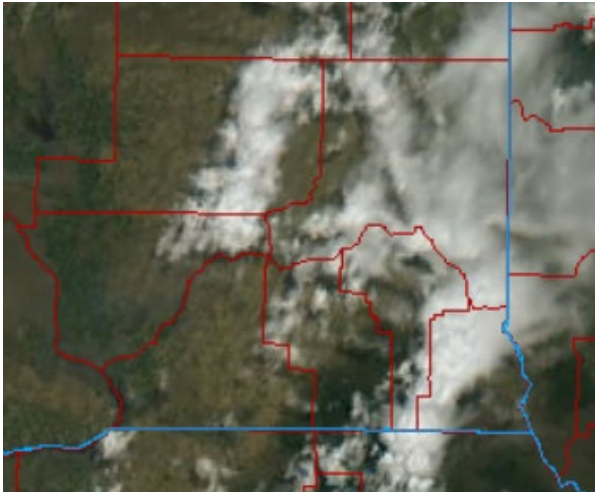
A weak thunderstorm located to the west of the incident likely contributed to the gusty and erratic winds responsible for the burnover occurrence.

*Satellite imagery within approximately five minutes of the burnover.*

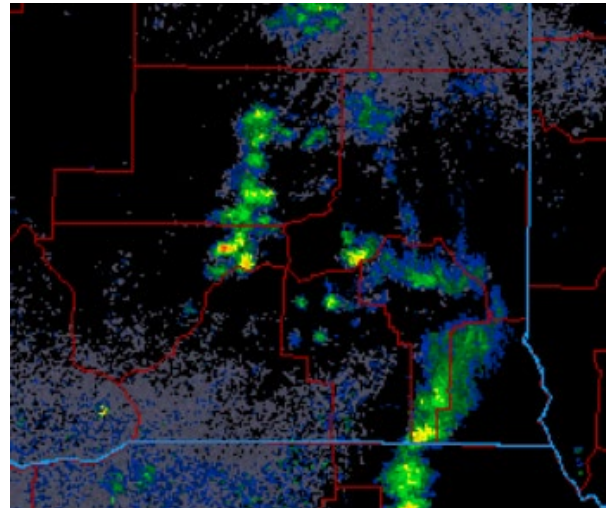
*Radar imagery within approximately five minutes of the burnover.*
