# Aviation Investigation Final Report

| <b>Location:</b> | Cabazon, California | <b>Accident Number:</b> | WPR23FA302 |
| <b>Aircraft:</b> | Bell 407 (A1); Sikorsky S-64E (A2) | <b>Aircraft Damage:</b> | Substantial (A1);<br>Minor (A2) |
| <b>Defining Event:</b> | Midair collision | <b>Injuries:</b> | 3 Fatal (A1); 2 None<br>(A2) |

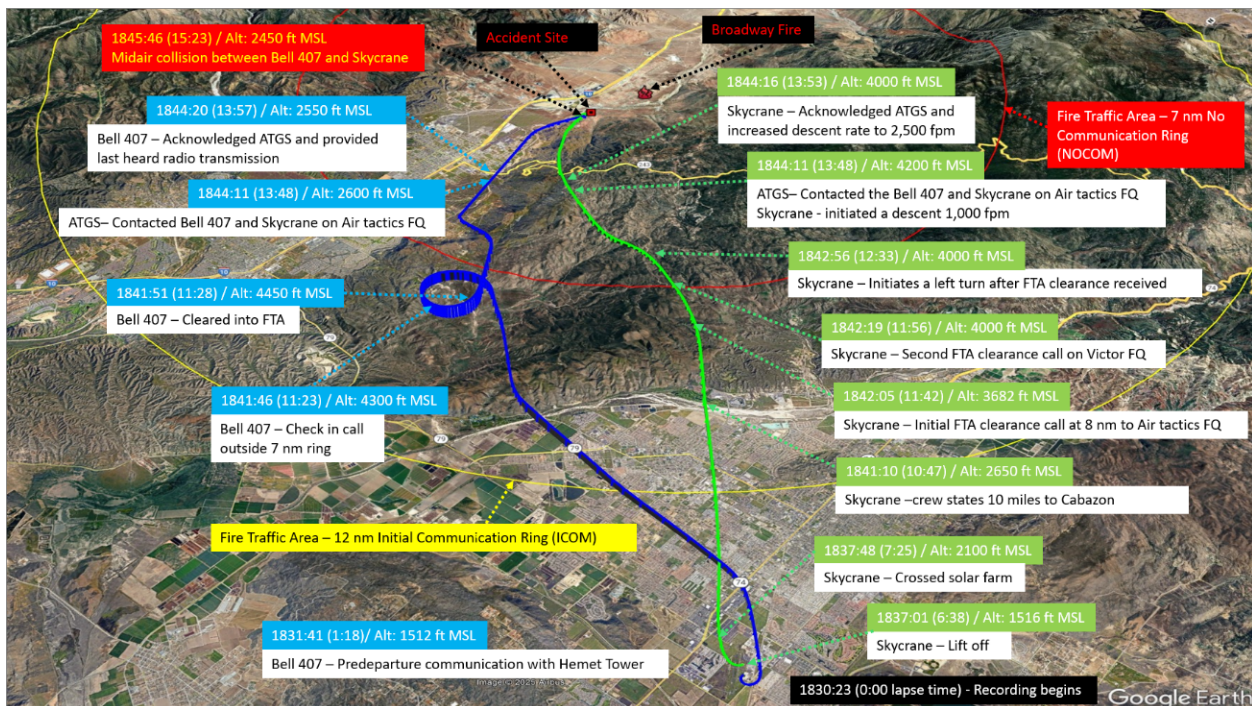
Review of the communication recording from within the Skycrane shows that the recording started at 0:00 lapse time (refer to figure 1).

Figure 1. Recorded ADS-B data with select communications annotated.
