# Rapid Lesson Sharing

**Event Type:** Water Tender Tip-Over

**Date:** July 25, 2026

**Location:** Scorp Fire; Murphy, Idaho

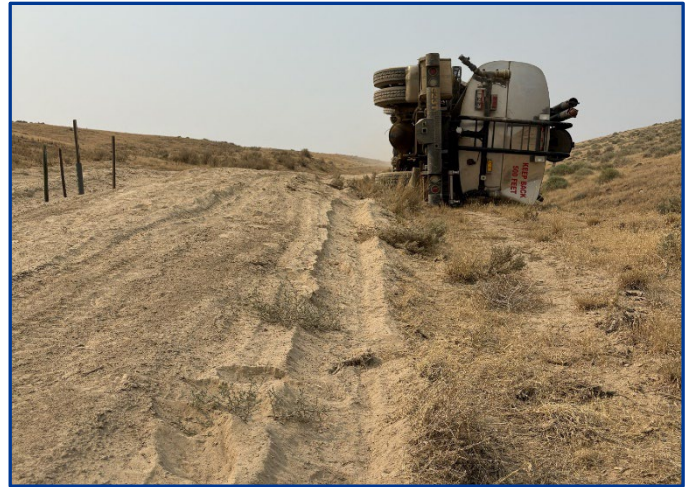
At approximately 1633 hours, a water tender en route to the Scorp Fire via an unimproved dirt road—the primary access route—slowly tipped-over onto its passenger side. While the operator wasn't wearing his seatbelt, due to the slow nature of this tip-over incident, he only received minor injuries.

*After losing the tire—without the operator's knowledge—he continued another 0.3 miles, where the tip-over occurred.*

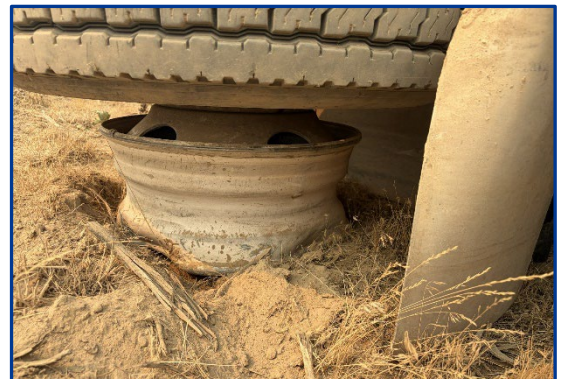
The tender had unknowingly punctured an outside passenger-side dual tire due to sharp rocks. The tire separated from the wheel about 2.3 miles from the maintained gravel road. After continuing another 0.3 miles, the operator attempted to avoid T-posts in the middle of the roadway (strong metal stakes shaped like the letter "T" that are driven into the ground—see photo on right) by moving onto a soft moon-dust shoulder—and the vehicle slowly tipped over.

*The T-posts (on left) that the water tender operator tried to avoid by driving over onto the soft moon-dust shoulder—and the vehicle slowly tipped over.*

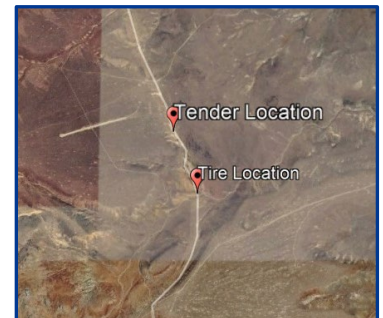
- The operator was unaware a tire had blown and separated.
- Five responding vehicles experienced flat tires travelling on this same unimproved road during the incident's first operational period.
- The failed tire was manufactured in 2014. While it appeared serviceable during visual inspection, tire age may have contributed to this failure.
- T-posts placed in the center of the road forced the tender onto the soft shoulder.

*The outside passenger-side dual tire was punctured by sharp rocks and separated from the wheel.*

- Conduct thorough vehicle inspections before travel. Ensure that tires meet manufacturer and agency requirements.
- Understand the limitations of your vehicle and equipment. Evaluate whether your vehicle is suitable for the assigned routes and terrain.
- Select travel routes that match your vehicle's capabilities. Note that soft shoulders have a proven tendency to collapse under the weight of a vehicle, especially a heavier vehicle, and lead to rollover accidents.
- Wear your seatbelt. The water tender operator in this incident was not wearing his seatbelt. He was fortunate that due to the slow nature of the tip-over, he only sustained minor injuries.
- The combination of a missing tire, uneven terrain, and unstable road surface led to a slow tip-over.
