# Aviation Investigation Final Report

| <b>Location:</b> | Springerville, Arizona | <b>Accident Number:</b> | WPR23LA306 |
| <b>Date &amp; Time:</b> | August 5, 2023, 15:20 Local | <b>Registration:</b> | N461WY |
| <b>Aircraft:</b> | Boeing CH-46E | <b>Aircraft Damage:</b> | Destroyed |

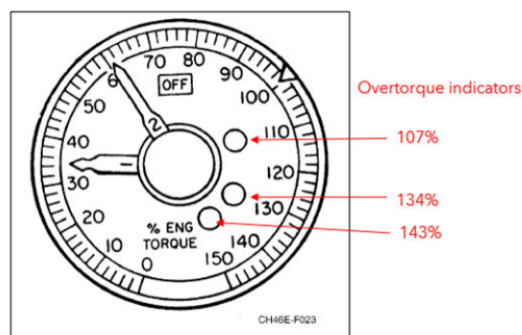
Figure 2-16. Dual Torquemeter

When the PIC heard the overtorque alarm and saw a split in the torque needles, he diagnosed the problem as a “high side failure,” meaning that the engine was producing uncommanded maximum/topping power. However, neither pilot said that they looked to see if either rotation speed of the power turbine (Nf) needles were at zero; in fact, the PIC saw that both Nf needles were reading accurate power turbine speeds. After the PIC retarded the No. 2 engine, the overtorque tone did not go away once the engines were indicating less than 100% torque. Because the pilot’s torquemeter (which records overtorque events generated by the No 2 engine signal conditioner) indicated 143% overtorque, and all 3 overtorque indicators were red, the No. 2 engine signal conditioner likely malfunctioned and provided false torque readings and overtorque warnings.

The flight crew’s misidentification of a No. 2 torque sensing system signal conditioner malfunction when both engines were performing normally, which resulted in their attempt to execute a single-engine steep approach and landing without sufficient engine power. Contributing to the accident was the failure of the torque sensing system signal conditioner.

Two dual torquemeters (Figure 1) were mounted on the instrument panel in the cockpit. Two signal conditioners, two integrated tone generators, and a relay box were mounted in the nose electronics compartment. The signal conditioners and tone generators provided the input signals to the cockpit torque meters. An overtorque tone would be generated if the system sensed torque greater than 100% for both engines or 134% on either engine. The tone was silenced once the torque was reduced below 100%. The overtorque indicators turned red at 107%, 134%, and 143% indicated torque. Both engines must exceed 107% for longer than 5 seconds before either 107% indicator would trip; once tripped, the No.1 engine overtorque would display on the copilot's torquemeter and the No. 2 engine overtorque would display on the pilot's torquemeter. Once tripped, the indicators continued to indicate red until reset by maintenance personnel.

Figure 1-Figure of the cockpit dual torquemeter.
