# Aviation Investigation Final Report

| <b>Location:</b> | Cougar, Washington | <b>Accident Number:</b> | WPR22LA339 |
| <b>Date &amp; Time:</b> | September 7, 2022, 15:55 Local | <b>Registration:</b> | N66HJ |
| <b>Aircraft:</b> | Bell 205A-1 | <b>Aircraft Damage:</b> | Substantial |

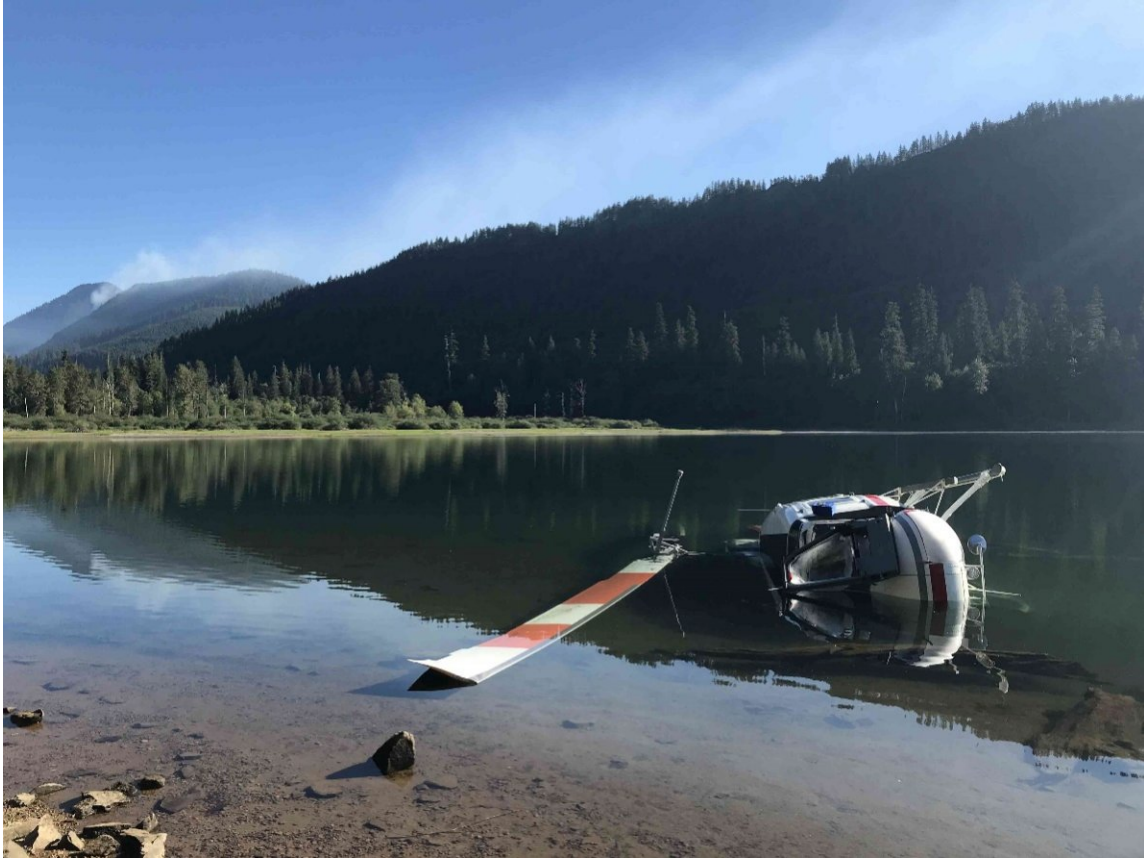
The helicopter came to rest partially submerged on its right side on the north end of the western shore of Merrill Lake, about 2 miles south of the fire. The lake was at an elevation of about 1,550 ft msl and along the southwest foothills of Mount St. Helens (elevation 8,363 ft). The lake was within a bowl-like depression surrounded by rising terrain (see Figure 1).

Figure 1 – Helicopter at the accident site with fire in the background.

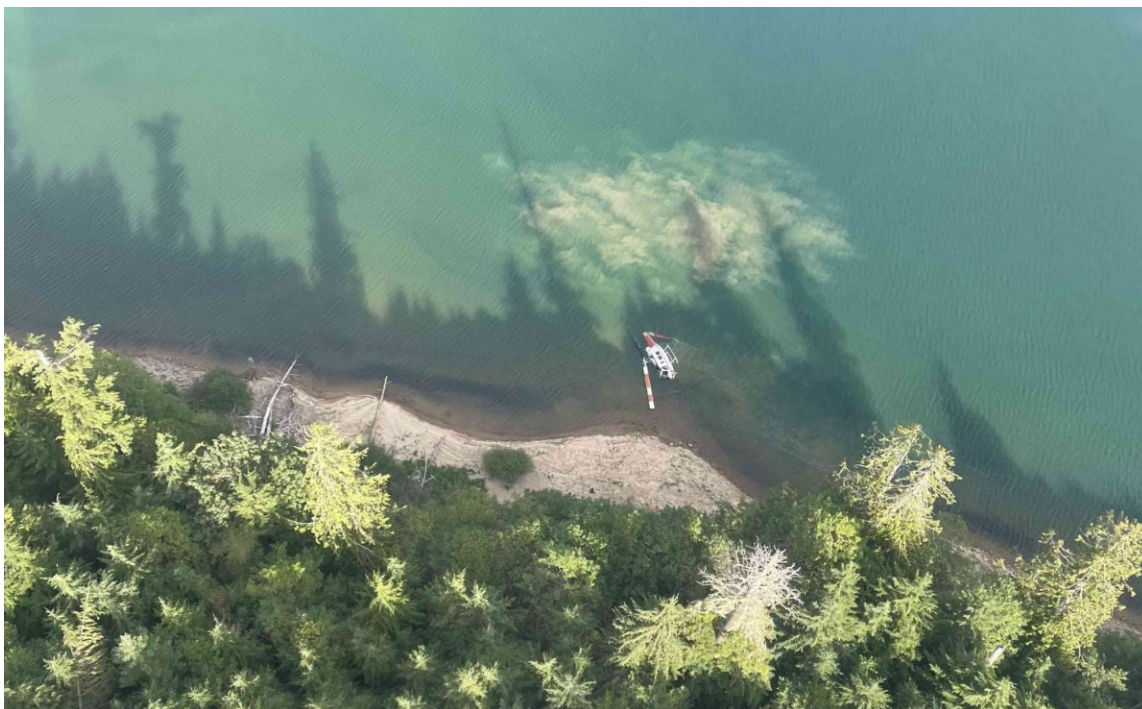
The helicopter was largely intact except for the tailboom, which had bent forward and underneath the main cabin after partially detaching about 2 ft forward of the horizontal stabilizer (see Figure 2). The vertical fin exhibited diagonal crush features along with a cut on its right side consistent with tail rotor blade contact.

Figure 2 – Helicopter at the accident site (photo taken about 10 minutes after the accident).

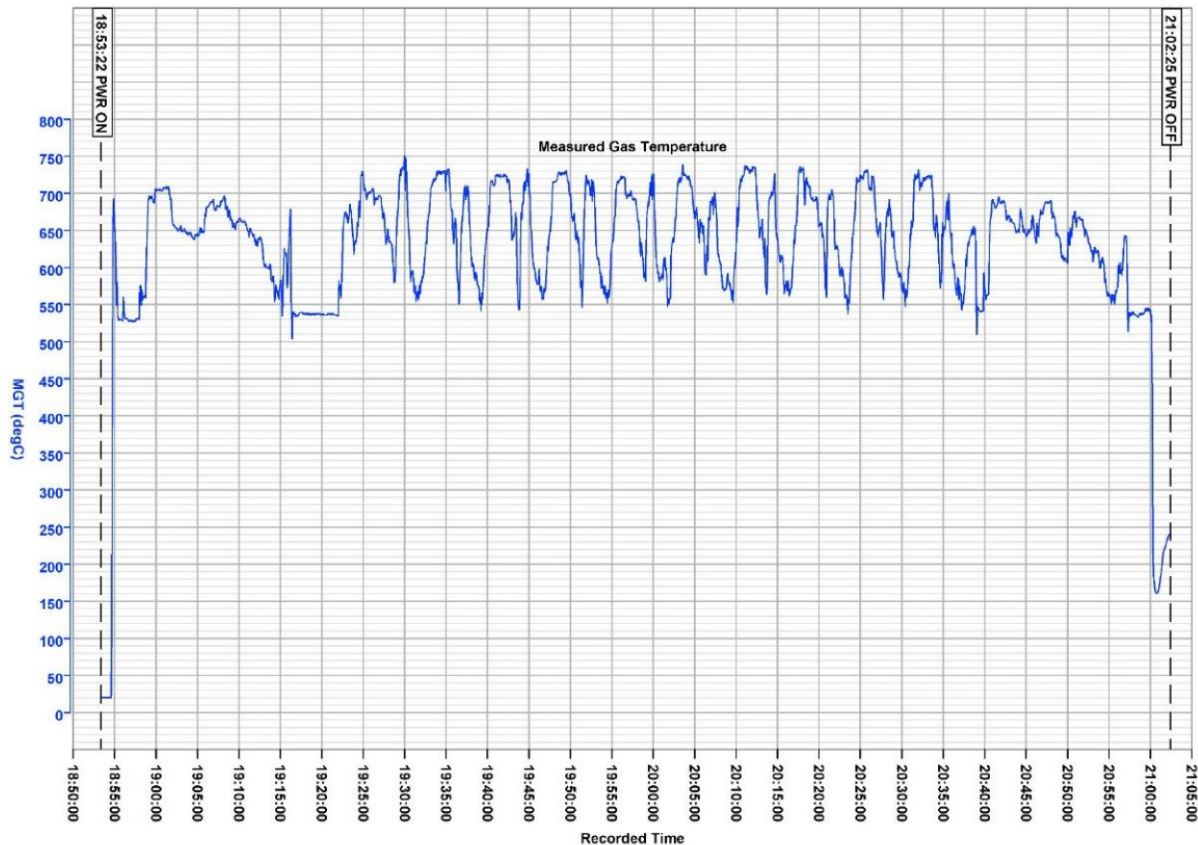
The data for the first flight cycle indicated that shortly after power up, MGT climbed from 20°C to about 690°C consistent with engine start. Over the next 18 minutes, MGT varied between about 505°C and 710°C. The then MGT began a series of repetitive cycles with temperatures varying between about 550°C and an average of 730°C, with nine cycles completed in one hour. Each cycle included a primary temperature spike of about 730°C that lasted about 2 minutes, followed by secondary shorter spike of about 1 minute at a lower average temperature of about 710°C. The temperature changes appeared to be consistent with the water pickup, dump, and return to hover cycles described by the pilot. The data continued for about 18 minutes after the final cycle, and was characterized by a series of downward trending temperature variations of between 670°C and 530°C. Over a 60-second period the temperature then dropped to 160°C, consistent with engine shutdown, and then for the final 90 seconds it began to climb back up to about 240°C consistent with postshutdown engine heat soak (see Figure 3).

Figure 3 - MGT plot of the previous power cycle.

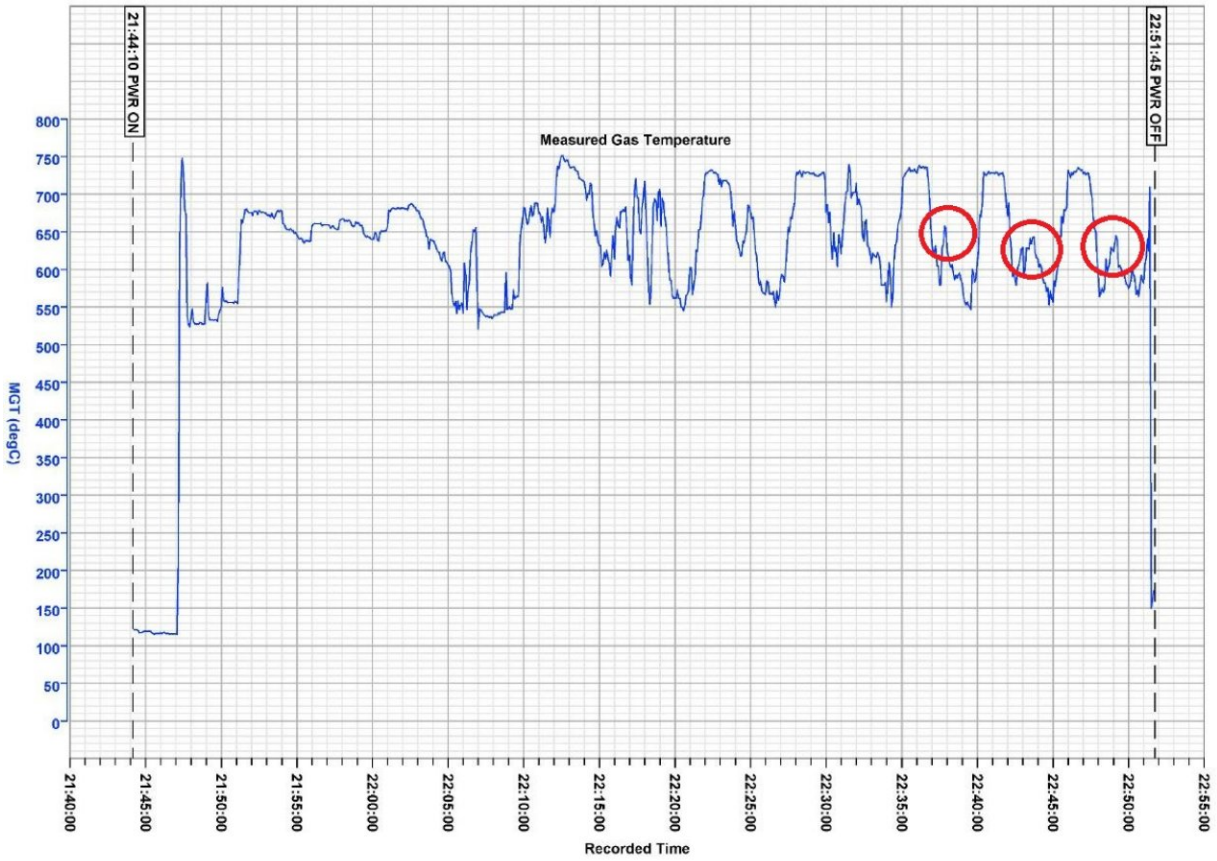
Furthermore, review of the MGT data indicated that for the three cycles leading up to the accident, less engine power was required to transition to the water dip hover, which indicated wind strength had likely increased during the short time leading up to the accident.

The second recording started at 1501 and revealed similar temperatures as the first engine start sequence. At 1534, a comparable set of five cycles began, with primary peaks of about 730°C. For the last three cycles before the accident, the secondary peaks were at a reduced temperature of about 640°C when compared to the previous flight cycles which indicated 710°C (see Figure 4). For the sixth cycle, MGT began to rise until it reached about 710°C when it suddenly dropped to 150°C 15 seconds before the data ended (see Figure 4).

Figure 4 - MGT plot of the accident power cycle. Reduced MGT circled in red.
