# Informational Summary Report of Serious or Near Serious CAL FIRE Injuries, Illnesses and Accidents

## GREEN SHEET

### Fire Engine Rollover

26-CA-SCU-003908

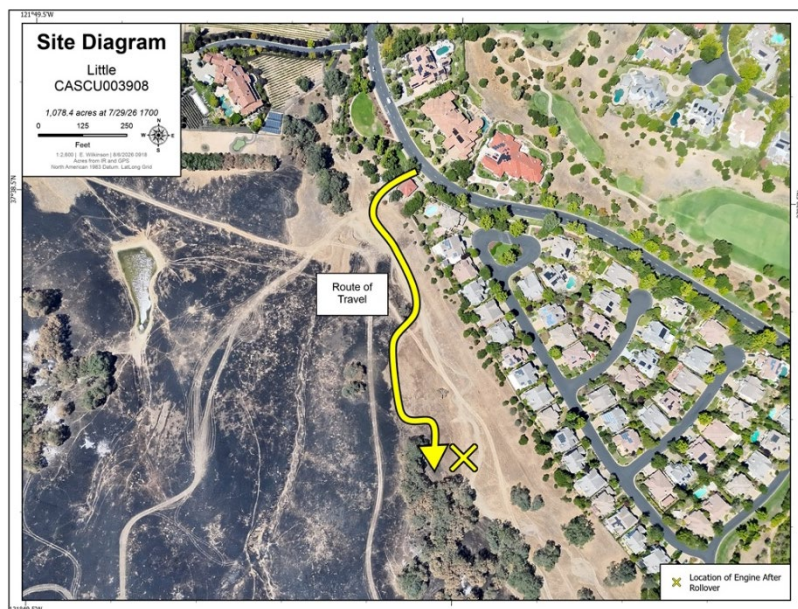
Figure 2: Incident area with path of E1

E1, along with three other engines, made access to the fire through a maintenance gate off West Ruby Hill Drive. As the engines arrived, they met with a CAL FIRE Battalion Chief (BC1) who was assigned as Division Mike. At this time, the fire was at the top of the ridge and started to back downhill toward their location. BC1 conducted a briefing with E1 and the three additional engines assigned to Div Mike. BC1 directed the four engines to allow the fire to back down to the service road behind the structures and hold the fire at the service road. BC1 departed E1's location to brief and direct additional incoming equipment. As E1 and the three engines began to deploy along the service road, there was an increase in the wind, which intensified the advancing fire towards E1's location. A CAL FIRE Fire Captain (FC1) on a second engine (E2) directed E1 and the two other engines to go direct and initiate mobile attack fire suppression operations.

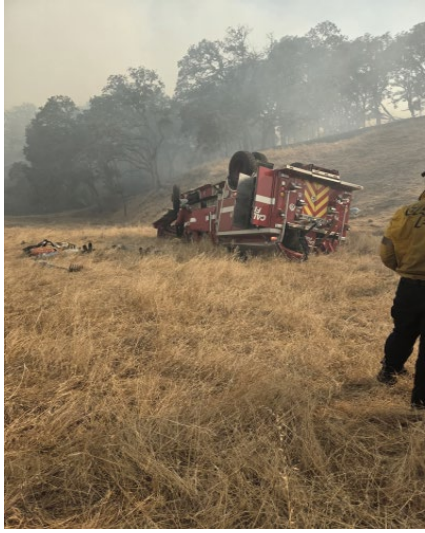
*Figure 3: Rear view of overturned engine*

- FAE1 suffered three fractured ribs, and minor contusions and abrasions.
- FF1 and FF2 did not suffer any documented injuries, but experienced general soreness after the incident.
- E1 sustained major damage, resulting in complete loss of equipment.

- Know the size and performance limitations of your vehicle when operating off-road in varying conditions ([Fire Operations Handbook 7060.2: Off-Road Apparatus Operations](#)).
- Conduct a risk assessment before implementing a plan, and ensure all risks align with intended objectives.
- Ensure all loose items in the cab are secured in accordance with [Mobile Equipment Handbook 6709-1: Exhibit - Mobile Equipment General Safety Standards](#).
- Review and understand the Emergency and Incident within an Incident (IWI) policies and procedures ([Safety Handbook 1711-1 Emergency and IWI Process](#) and [1711-2 Emergency and IWI Flow Chart](#)).

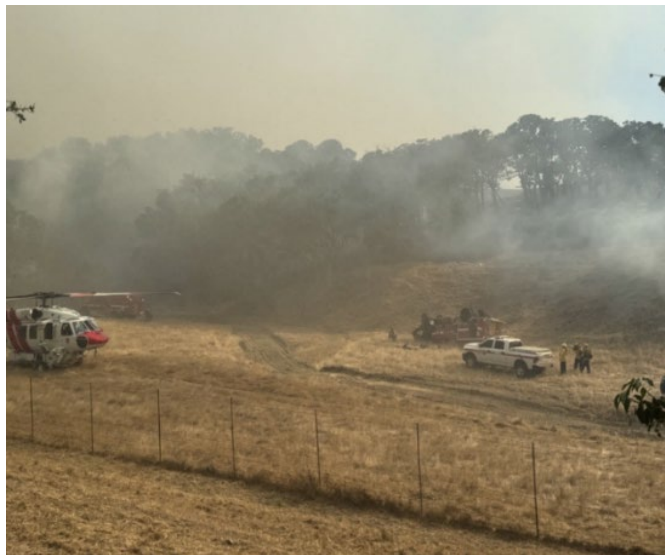
*Figure 4: View of incident scene with responding air unit after the rollover.*

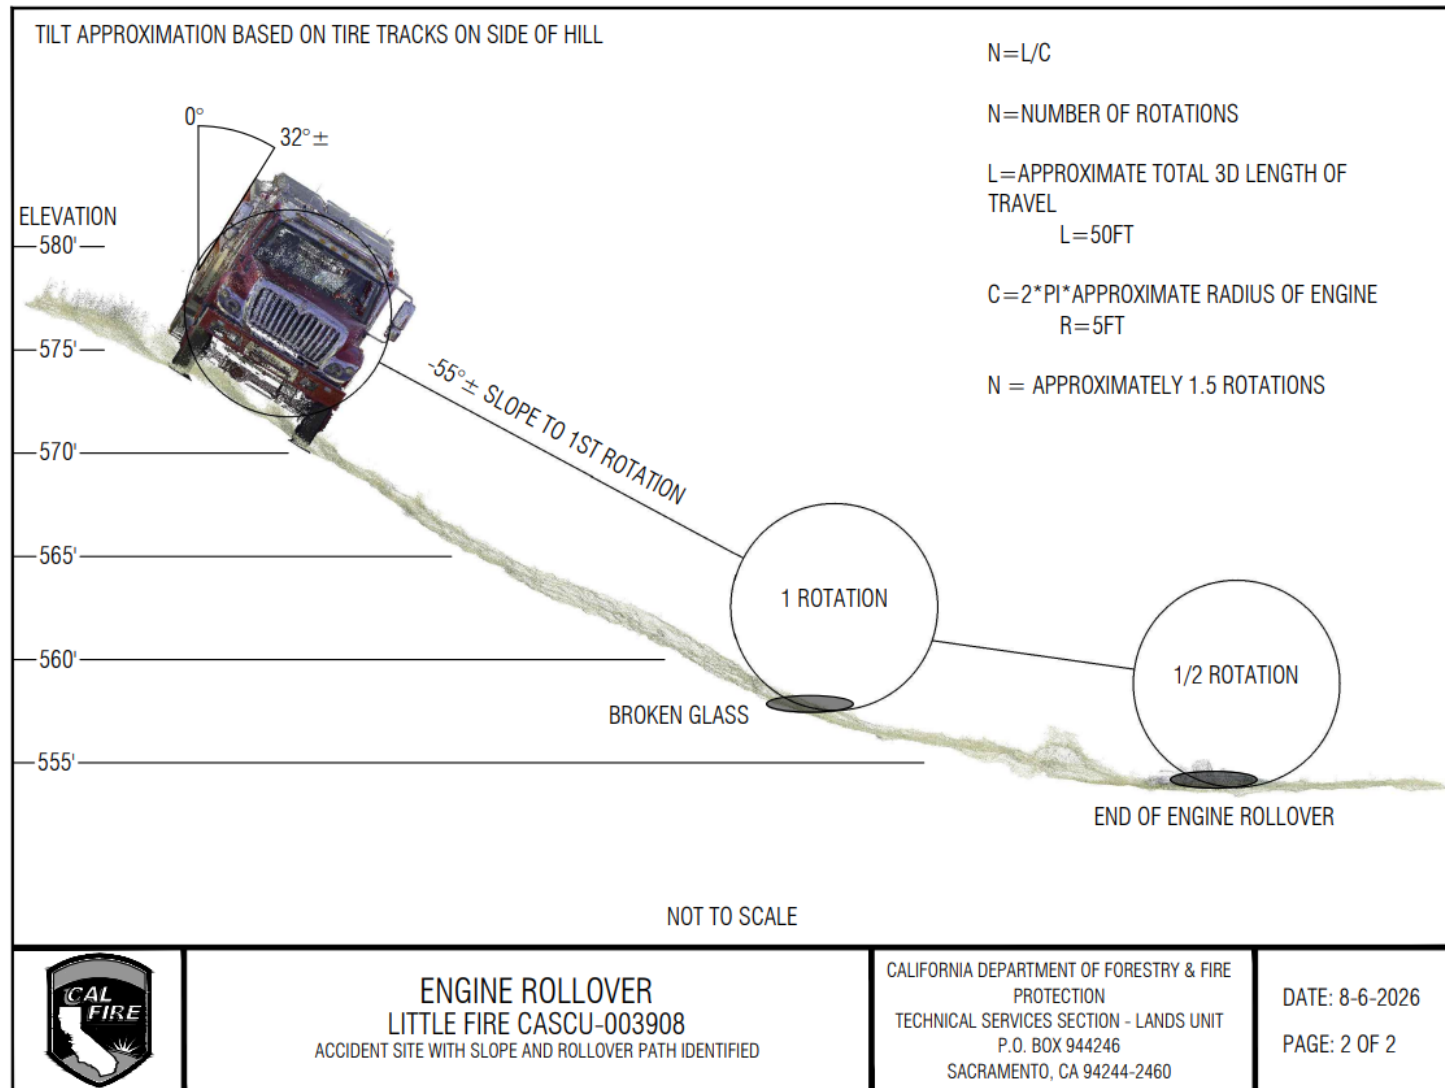
Figure 7: Accident diagram with slope calculations and elevation changes

The average slope across the fire perimeter was approximately 30%, and minimal roads within the interior. The location where the incident occurred was on a 55% slope that descended into a dry creek bed.

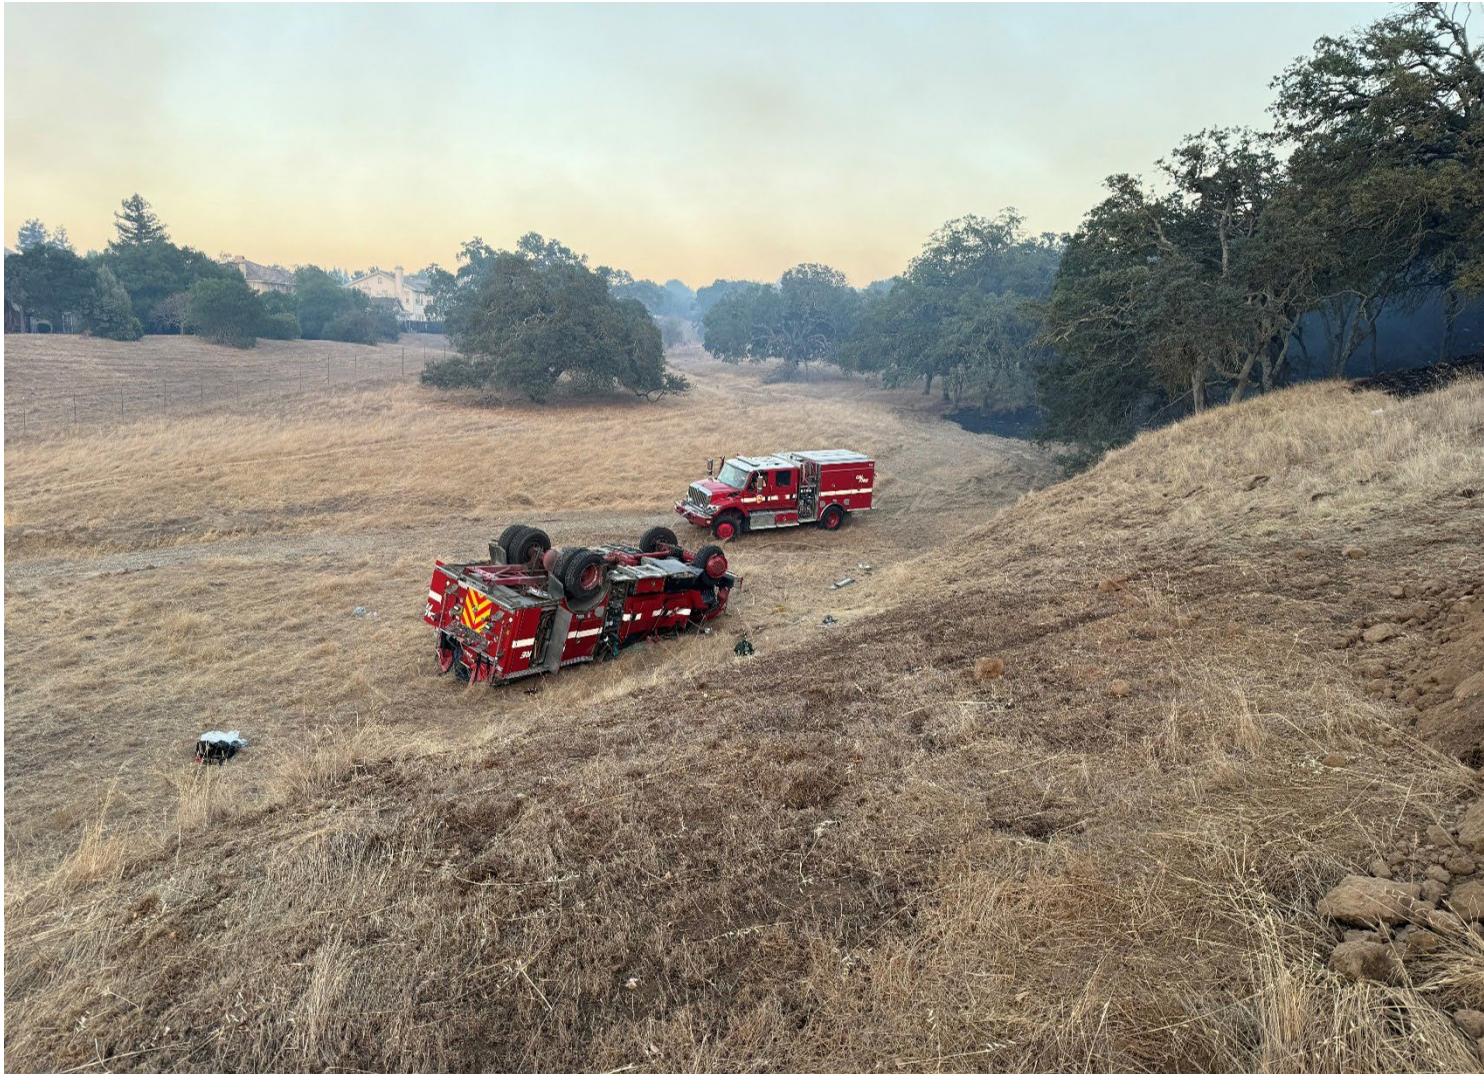
*Figure 8: View of overturned engine from top of hill*

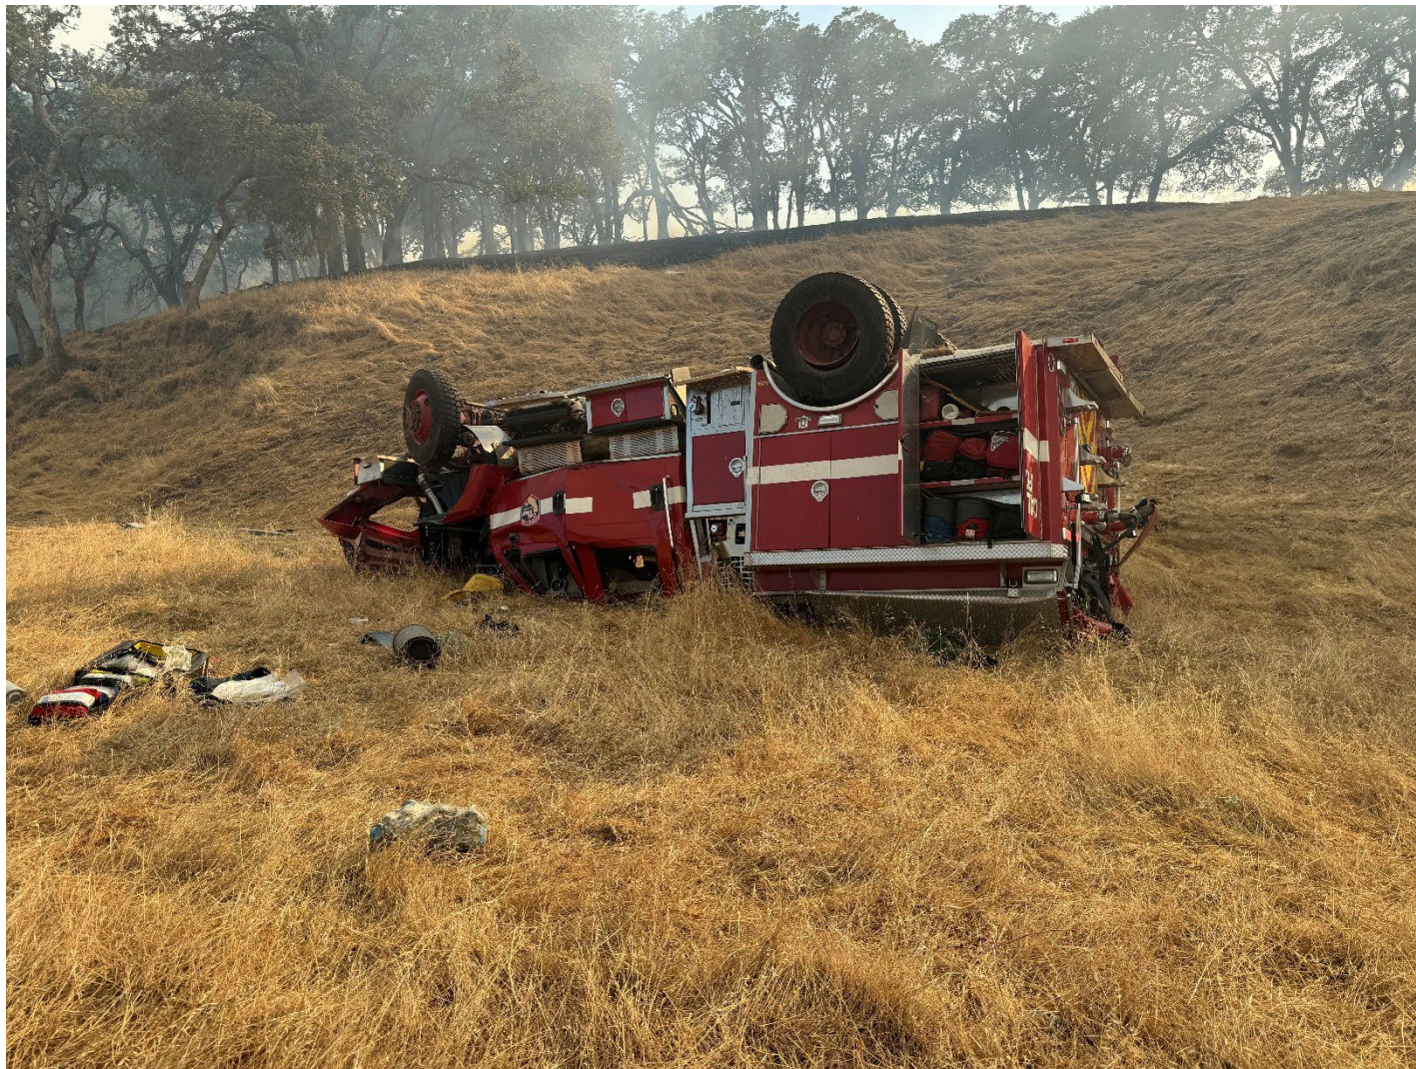
*Figure 9: View of overturned engine from bottom of hill*
