# Aviation Investigation Preliminary Report

| <b>Location:</b> | Cove Fort, UT | <b>Accident Number:</b> | ANC26FA079 |
| <b>Date &amp; Time:</b> | August 7, 2026, 10:44 Local | <b>Registration:</b> | N793HT |
| <b>Aircraft:</b> | Helicopter Transport Services<br>(Sikorsky) CH-54A | <b>Injuries:</b> | 2 Fatal |

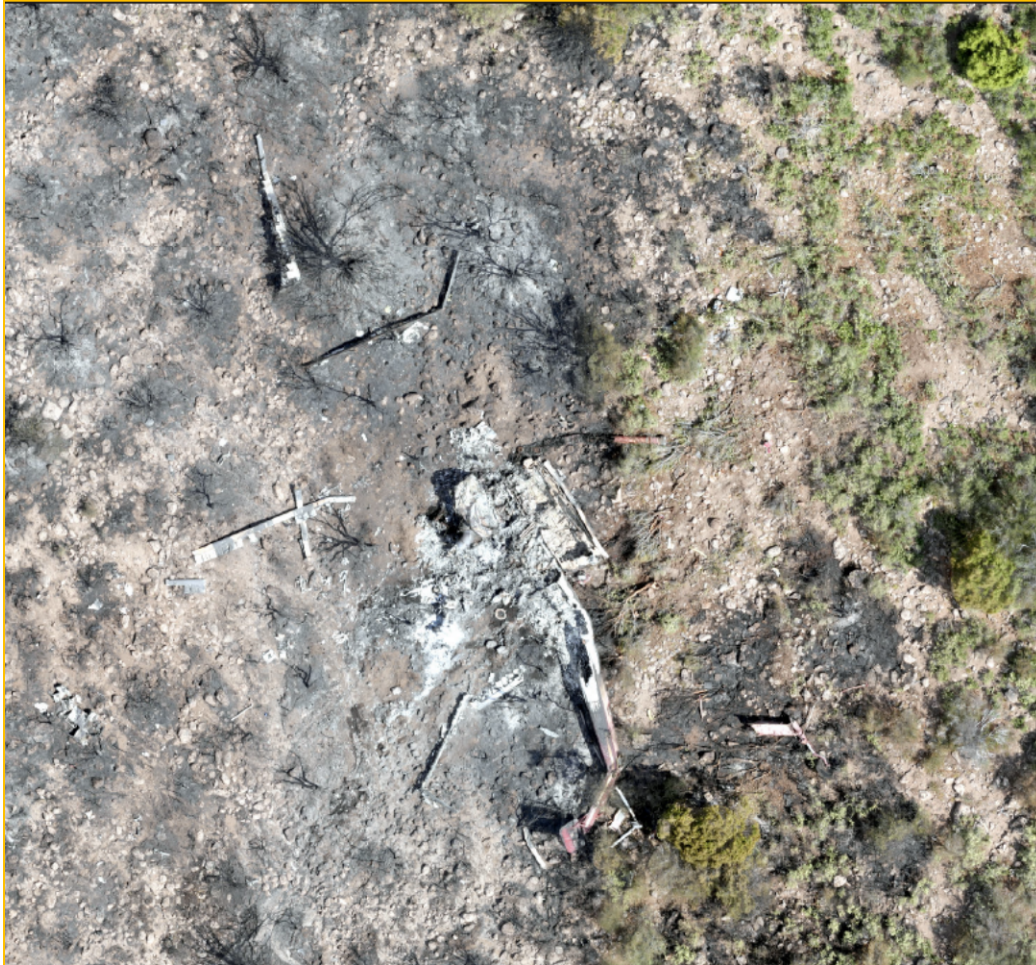
The helicopter impacted rising terrain, and a post-crash fire consumed much of the airframe (see figure 1).

Figure 1. Aerial overview of accident site. (U.S. Forest Service Drone Photo)
