# Rapid Lesson Sharing

**Event Type:** Snapped Wheel Studs

**Date:** August 1, 2026

**Location:** U.S. Route 6 South of Castle Gate, Utah

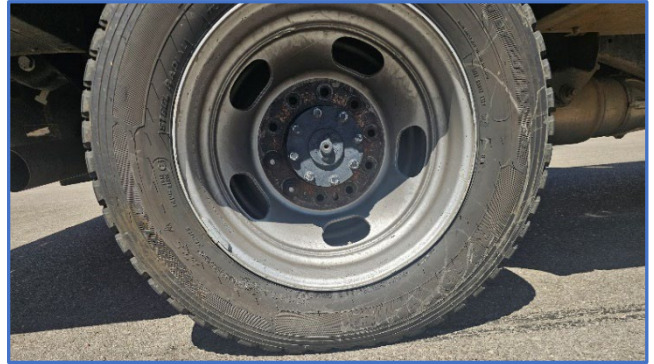
Upon inspection, they noticed that all tires were still inflated but that the right rear duals were missing eight of their ten wheel studs. A crewmember (FFT1 Trainee), checked the torque on the remainder of the wheels and discovered that the left rear wheel was not torqued to the correct torque of 129 foot-pounds—per the specifications for Ram Heavy Duty Trucks.

**Top Photo** – Taken immediately after discovering that eight of ten wheel studs were missing.

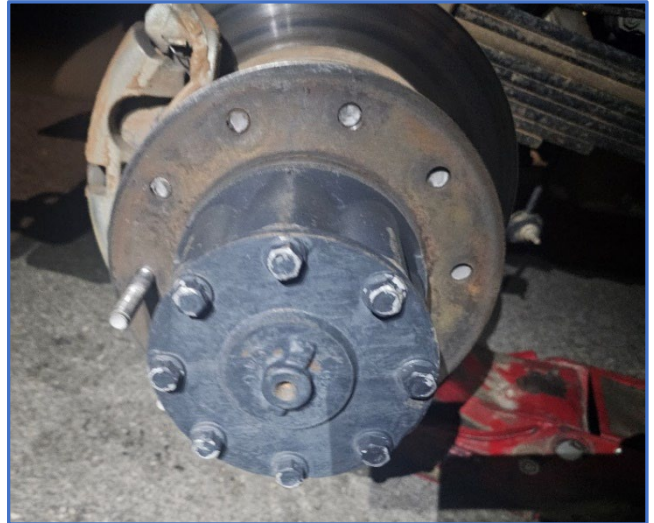
**Middle Photo** – Right rear hub after the remaining two lug nuts and the two right rear wheels were removed.

- ❖ The crew successfully diagnosed the most likely cause of nearly all of the wheel studs simultaneously failing to be the failure of a mechanic to properly torque the wheel studs on the most recent tire rotation, which had occurred roughly nine hundred miles before this.

At approximately 0200 hours in the morning, the service truck arrived from a private towing service located in Price, Utah. The mechanic was able to replace the wheel studs, but noticed that both wheels were destroyed, with six of the 10 holes on each wheel elongated.

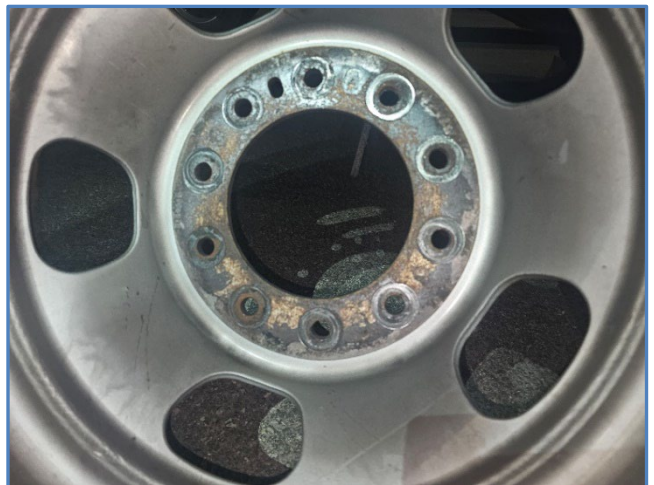
**Bottom Photo** – Elongated holes were discovered on both wheels resulting from the wheel stud failure and vibration.

Because this was Sunday and E323 needed to be on the fire in south central Oregon by 1800 hours on Monday, the Engine Captain talked the service truck driver out of his spare, and another spare he had back at his shop.
