**Event Type:** Response to Helicopter Crash

**Date:** August 7, 2026

**Location:** Widemouth 2 Fire, Utah

## **The Story and Lessons from this Entrapment Incident During an Attempt to Access a Helicopter Crash Site**

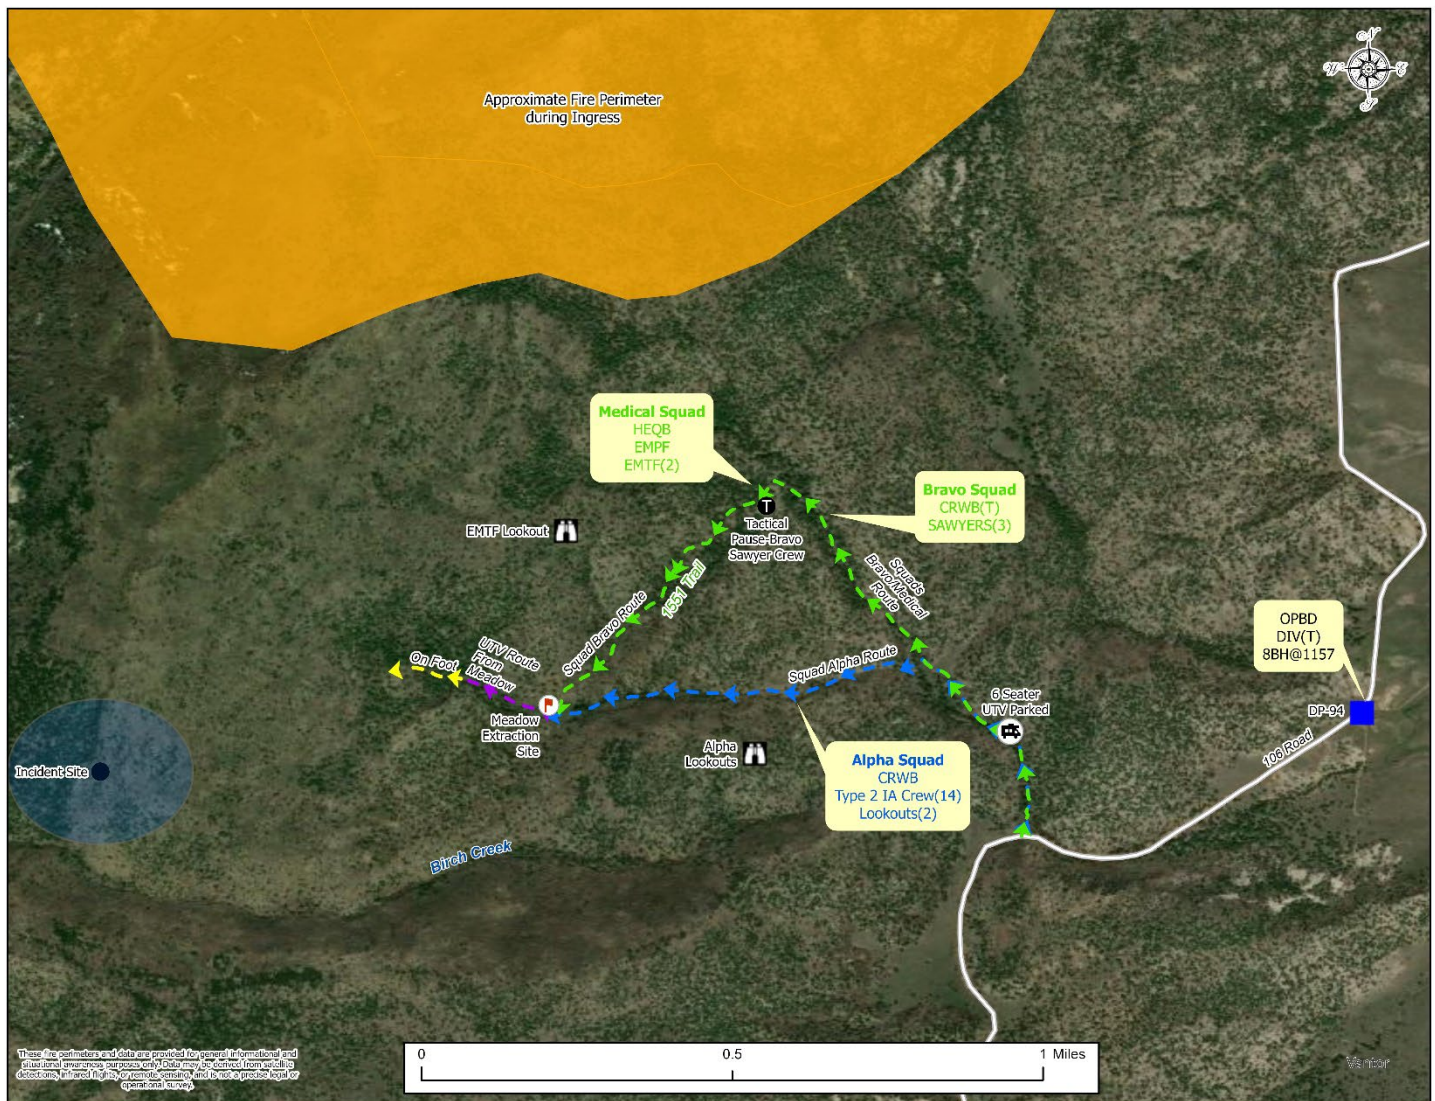
Bravo Squad, the smaller group, responded with their six-passenger UTV, consisting of: CRWB (t); two crew members; and three medical personnel (an EMPF and two EMTFs); along with a Stokes stretcher, chainsaws, and other equipment. They were to follow the route that the HEQB had taken. However, they could not see a trail or UTV tracks. They did not make it far (see Figure 1 below) before the untraversable trail and terrain stopped them.

**Figure 1. The paths of the two squads as they attempted to gain access to the helicopter crash site.**

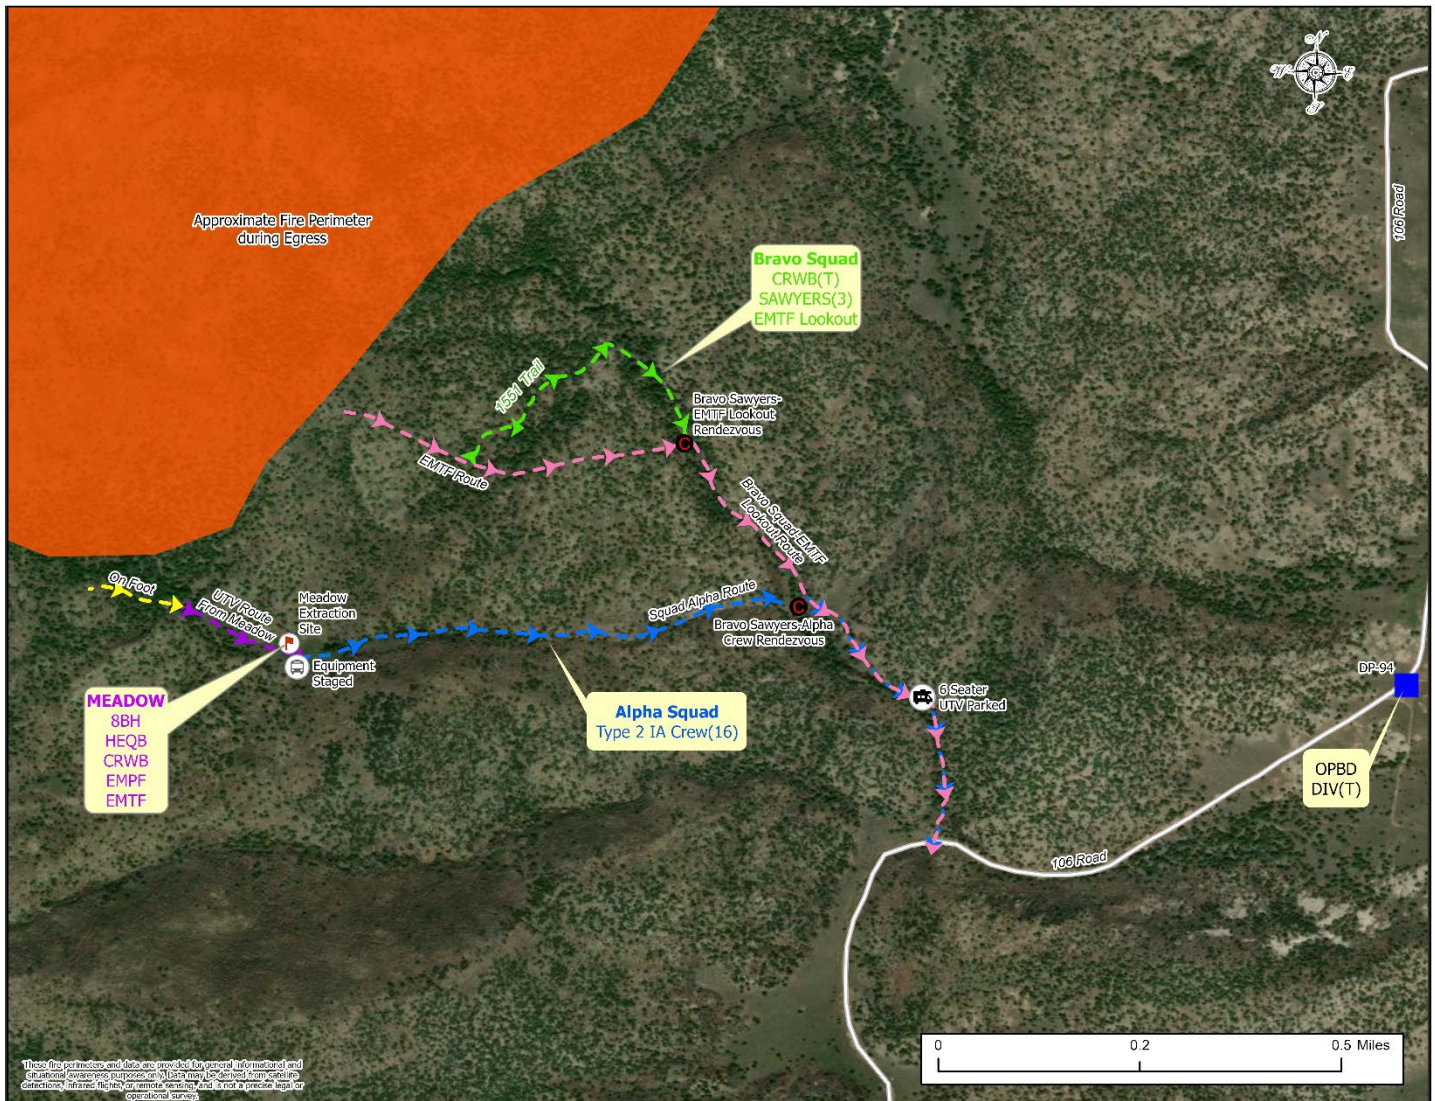
**Figure 2. The escape routes from the advancing Widemouth 2 Fire, depicting the egress routes of the EMTF Lookout and sawyers, Alpha Squad, as well as the meadow site.**

A decision by the HEQB and EMPF was made to continue beyond the meadow in the UTV, utilizing the crew resources at the meadow to help create better access through the dense brush toward the crash site. Shortly after, the HEQB with medical personnel in the UTV came upon rocky terrain that was impassable. Additionally, they discovered that some of the medical equipment and one of the EMTF's pack and fire shelter were missing. At this point, the HEQB directed the EMTF to return to the meadow and tie-in with most of the Type 2IA crew. Reference Figure 2, above, to track the movements of the personnel in their egress from the advancing fire.

Meanwhile, the EMTF, who was acting as the north Lookout, was making rapid egress, running—due to the approaching flame front—from that location in a beeline southeast until eventually joining members of the Type 2IA crew and followed them out.

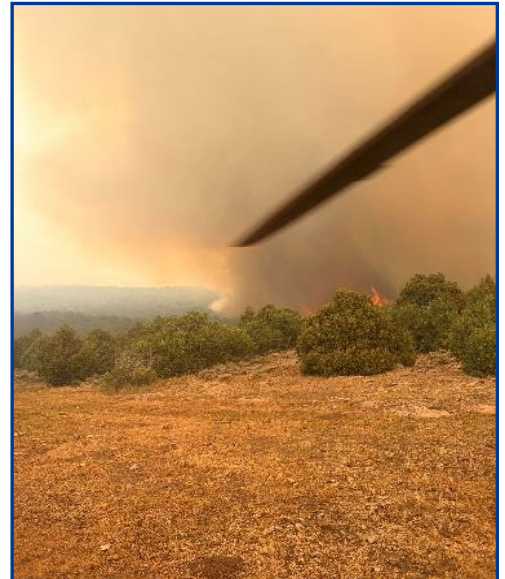
8BH remained at full power at DP94 and quickly returned for the remaining two individuals in the meadow. Figure 3, above, was captured during this last flight out of the meadow. (A helicopter "hot landing" is a maneuver in which the

*Figure 3. Last flight out of the meadow during helicopter extraction.*

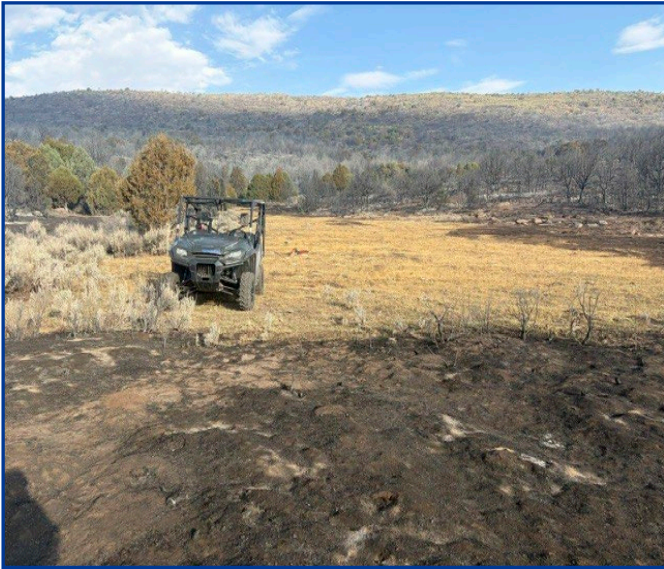
As seen in the photo above, the UTV was basically undamaged after the fire passed through the meadow—with only minor plastic deformation.

Photos of the aftermath of the fire passing the meadow area indicates it was likely a survivable site, although fire shelters may have been necessary. The Risk Management process used by decisionmakers during this incident produced a good outcome, with no injuries and only minor equipment damage.
