Rapid Lesson Sharing

Event Name: Engine 6 Battery-Caused Fire

Date: July 1, 2012

Location: Enroute to Cemetery Road

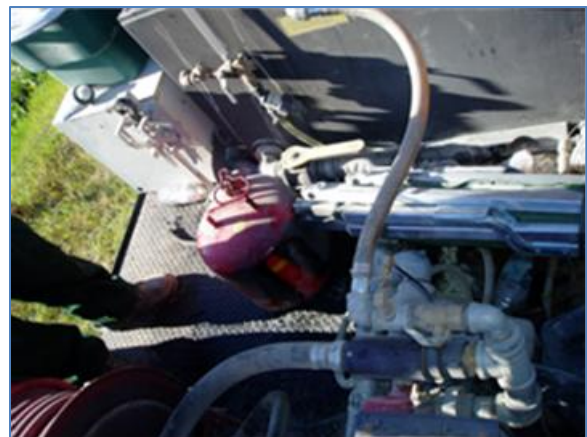
Upon arrival, Safety Officer Mervin Lent noted fire scars on the engine bed, water tank, and gas can. He asked the engine operator to replace all the equipment back onto the engine—in their original positions prior to the fire. (See Figure 1.)

The operator noted that the battery cover was off and had a broken clip, intended to hold the cover in place. The Safety Officer noted fire damage on the sleeping cot cloth and frame as well as electrical arch damage to the gas can.

Figure 1 – Gas can and cot in back of engine.

In addition, the location for storing fuel cans and fusees should be as far away from the battery area as possible. (While fusees were not involved in this incident, they should be considered.)

Special consideration should be given concerning where to store other equipment—such as cots. If possible, reengineer to support better storage and still be functional.

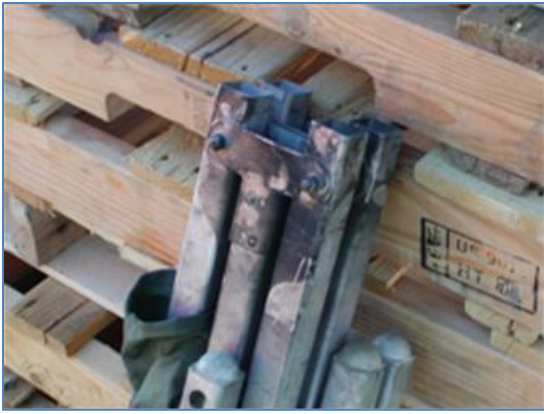
It was determined that while driving down the dirt road, the cover had bounced off the battery. The cot (see Figure 2) then made repeated contact with the battery terminal and the gasoline can. This created two small openings in the gas can (see Figure 3)—allowing fumes and liquid gas to escape from the tank and ignite from the arching.

Figure 2 – Damage to folded cot.

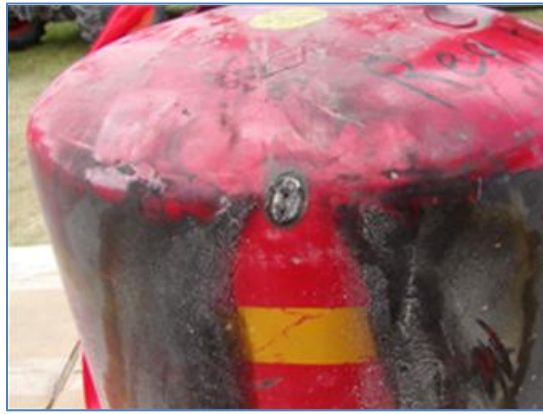
Figure 3 – Double pinhole damage from arching.

Of question here is the use of a U.S. Department of Transportation (DOT) safety can (Figure 4) to carry fuel that is different than the federal fire fuel cans (Figure 5). There is a possibility that, using the federal fire fuel safety can, it might have taken longer to burn the two holes into the can from the arching (Figure 3).

The battery cover should also be inspected on a regular basis. If the straps are worn or damaged, they should be replaced.

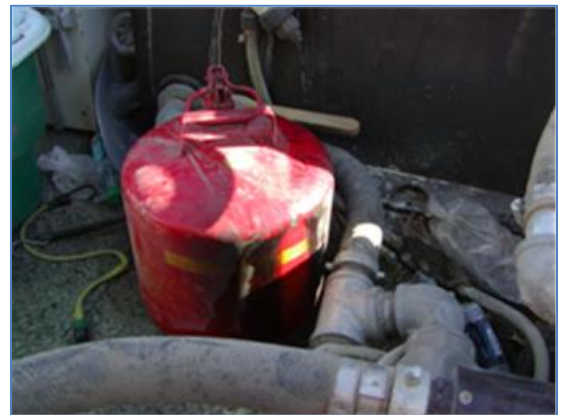
Figure 4 – U.S. DOT safety can.

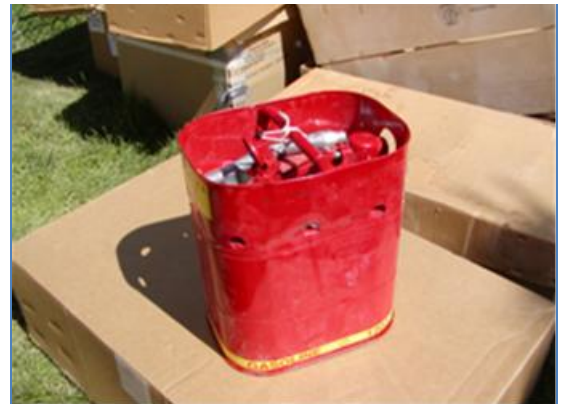
Figure 5 – Federal safety can.
