Blacks Creek Smokejumper Accident

Accident Investigation Report
Bureau of Land Management Great Basin
Smokejumpers
April 15, 2015

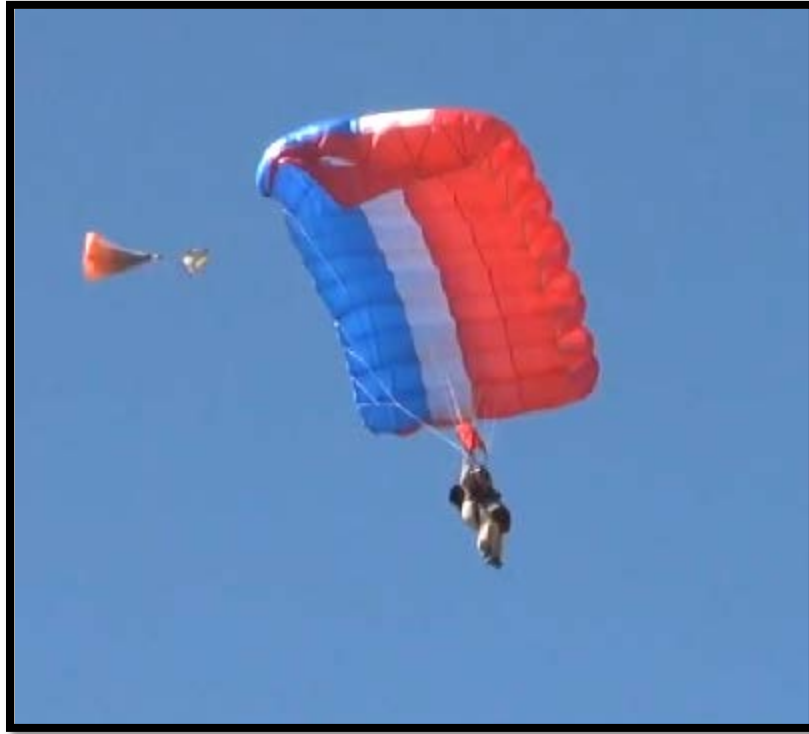
Photo 1: Jumper 6, 11 seconds before landing facing into the wind. This image is a screenshot taken from video shot from the exact center of the jumpspot. Jumper 6's canopy is aligned with the wind at this point.

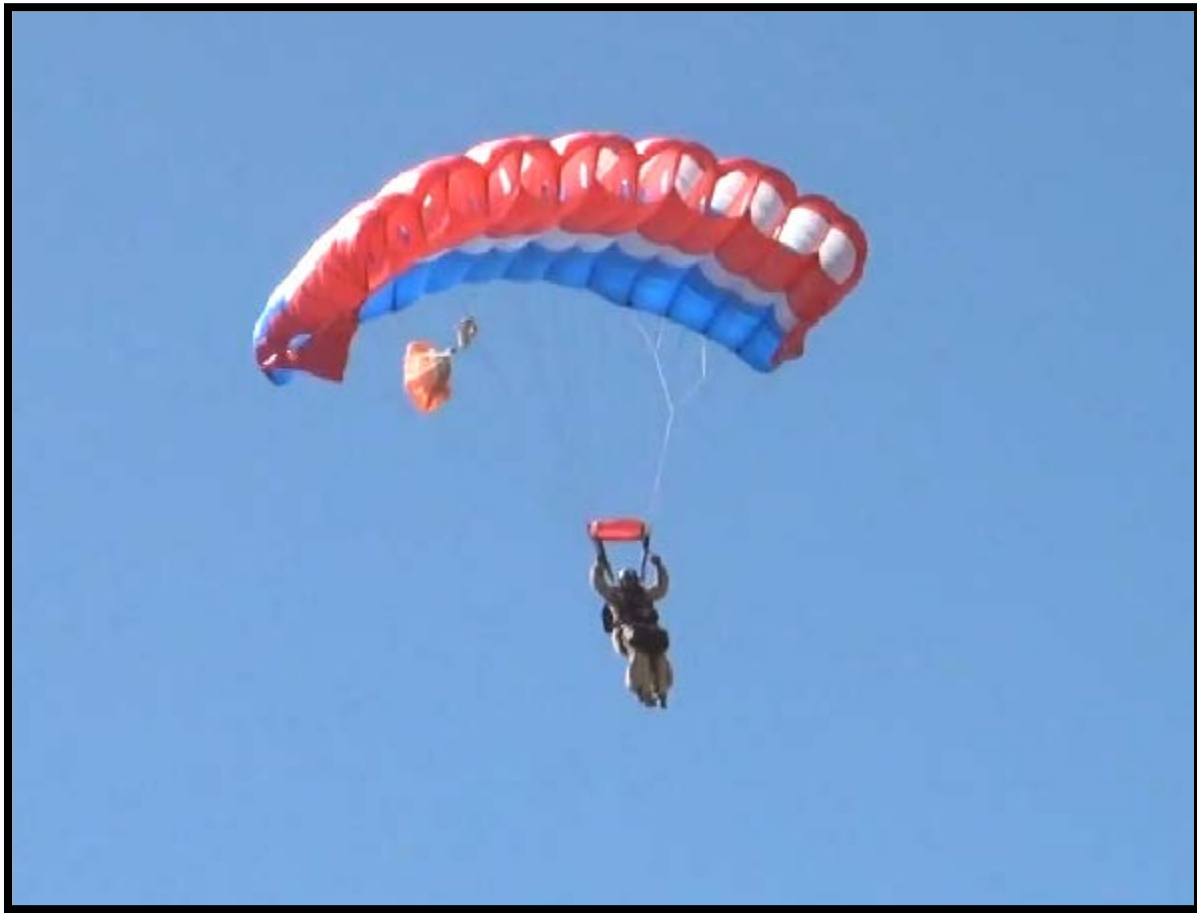
Jumper 6 failed to align his parachute directly into the wind. The investigation team estimates, by video analysis, that his canopy was approximately 20 to 30 degrees off the wind line. This caused him to accelerate and hit the ground at a high rate of speed.

Photo 2: Jumper 6, six seconds before landing, canopy out of alignment with the wind. This image shows that Jumper 6 has turned his canopy slightly to his right.

Recommendation: Utilize video footage of this incident to reinforce the importance of landing directly into the wind on high-wind jumps.

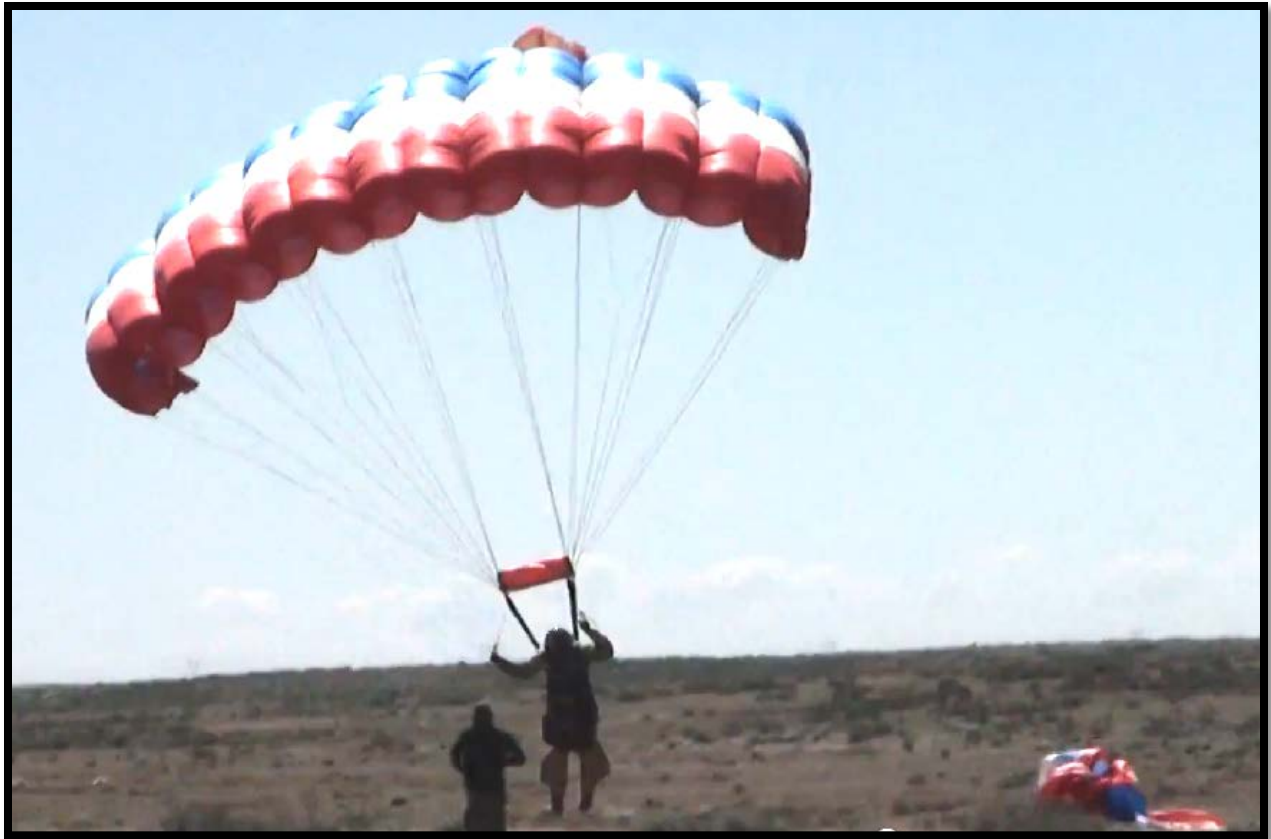
Jumper 6 had a severe landing. Video evidence shows that he had misaligned his chute to the wind line during his final 50-100 feet before landing. His canopy was approximately 20 to 30 degrees to the right of direct alignment to the wind line, reducing his canopy's ability to penetrate the wind. This misalignment compounded his backward movement and created

Photo 3: Jumper 6 position prior to landing. This image shows that Jumper 6's canopy is not directly in alignment to the wind.

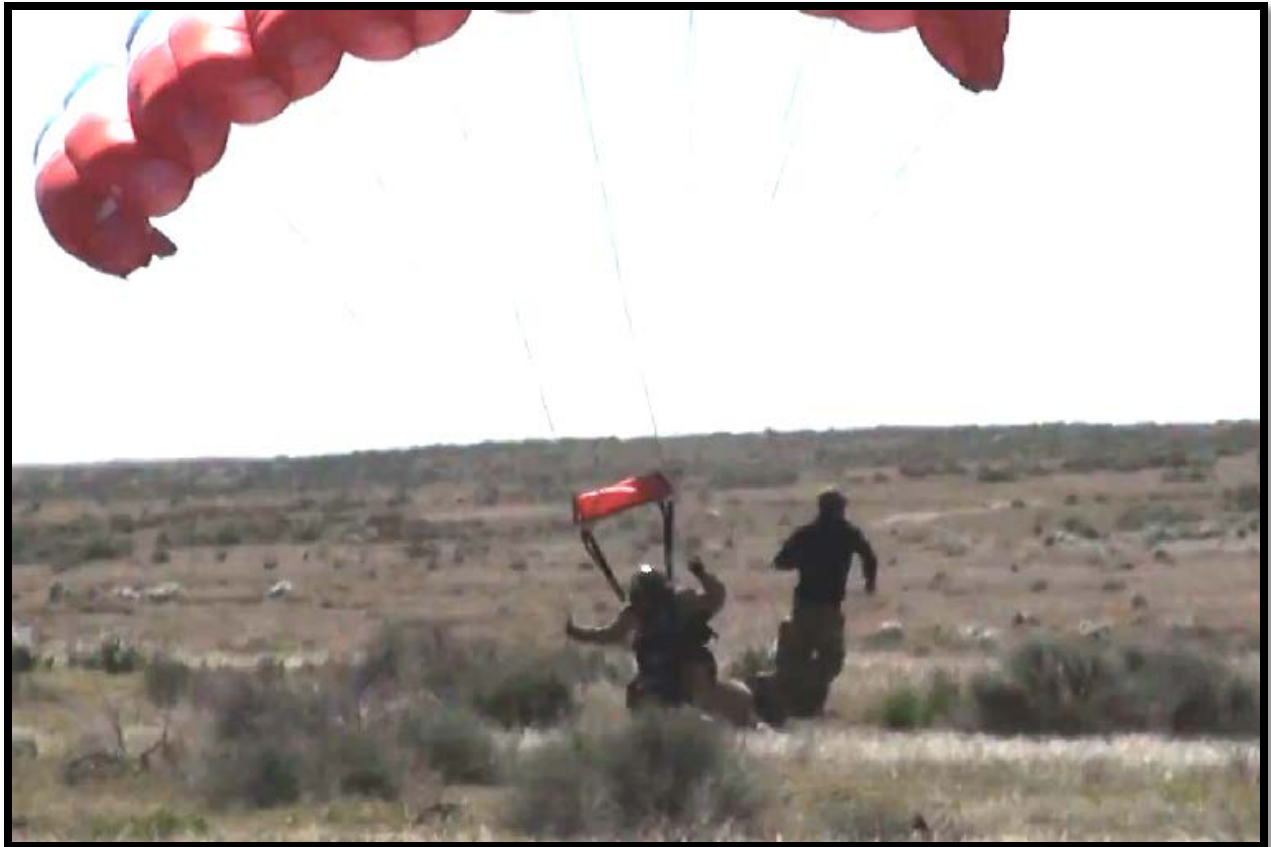
The speed at which Jumper 6 contacted the ground precluded his ability to execute an effective PLF. That, combined with his arm position, contributed to his injuries.

Discussion: FL Jumper 3 was running to the aid of Jumper 5 (who had just landed) when he passed below Jumper 6. Video footage of the accident reveals Jumper 6 made slight contact

with FL Jumper 3, clipping the FL Jumper 3's legs and tripping him. FL Jumper 3 stated that he "got tunnel vision" and lost situational awareness while going to the aid of Jumper 5. FL Jumper 3 could have been injured by Jumper 6 had their contact been more severe.

Photo 4: Jumper 6 when feet impact ground, hands in raised position, right arm extended. Photo shows FL Jumper 3 (right) just before he fell after being contacted by Jumper 6.

Recommendation: Utilize this incident to re-emphasize the importance of proper body position (arms in) during PLF instruction and evaluation.

Recommendation: Emphasize to ground personnel at jumpspots the importance of maintaining situational awareness while jumpers are still in the air.

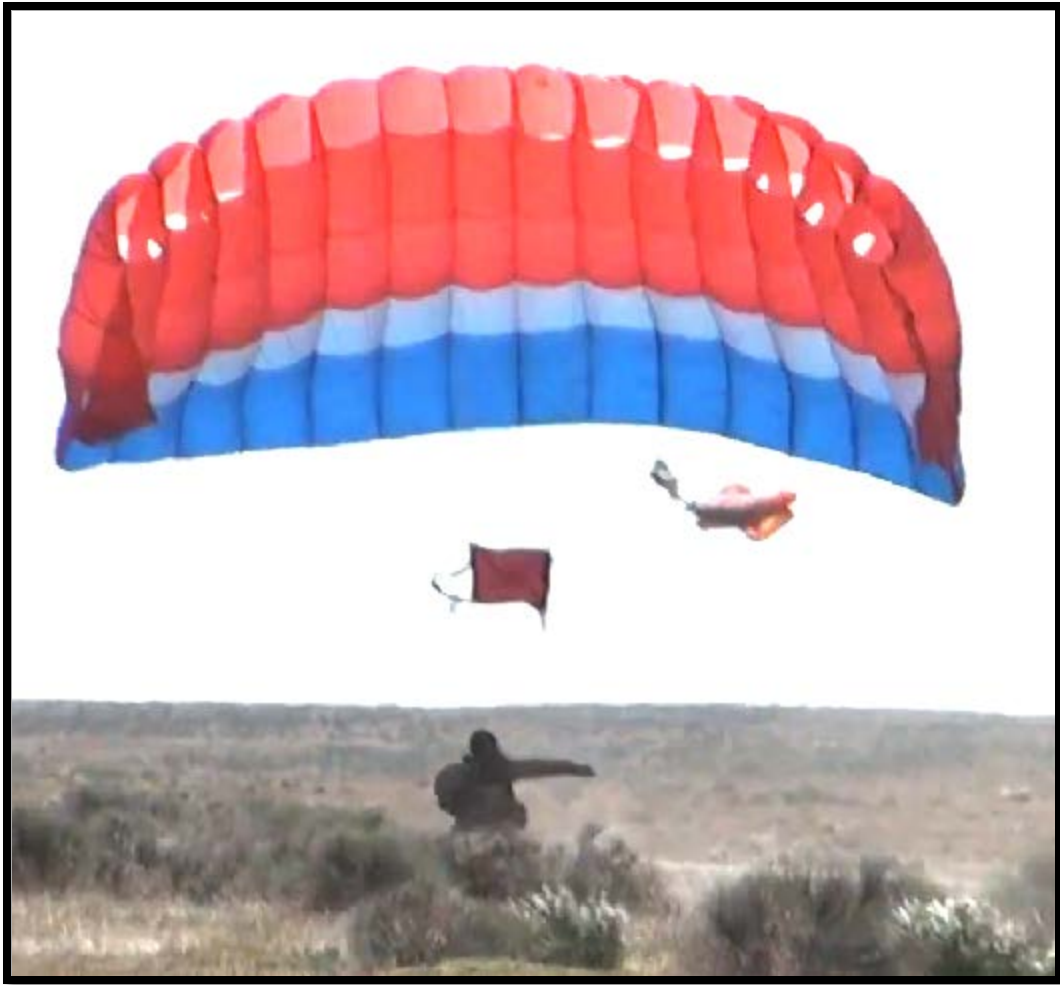
Photo 5: Main canopy is released by Jumper #6. Note cutaway accomplished with his left hand, because of damage to his right arm.
