Rapid Lesson Sharing

Event Type: Blasting a Hazard Tree

Date: July 13, 2015

Location: Rogue River-Siskiyou
National Forest

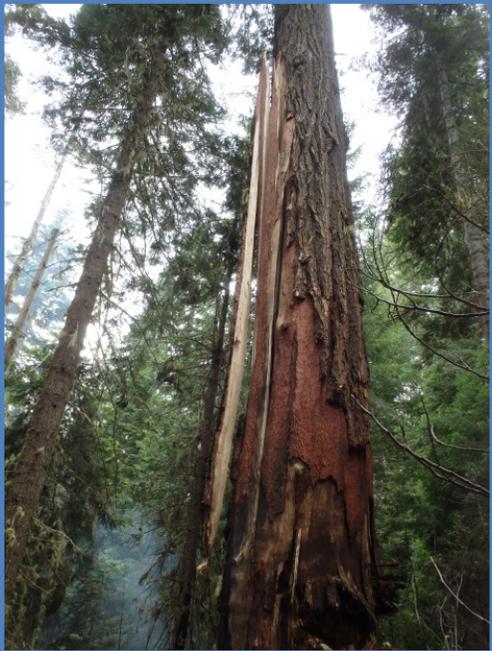
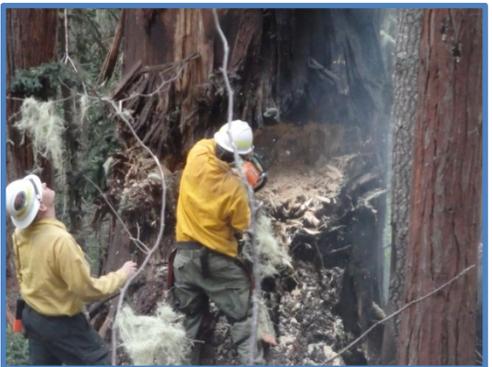
First Blast Fails to Drop Tree

The blast did not transition the tree to the ground. However, it did create two holes in the tree's base, splintered 30-40 feet up one side. **(See photos.)**

Although the tree shook violently, very little transitioned to the ground. The post inspection also determined that the tree was still stable enough to initiate a second blast.

Utilizing one of the created cavities, it was enlarged with a chainsaw to accommodate explosives for more of an internal load. **(See photos.)**

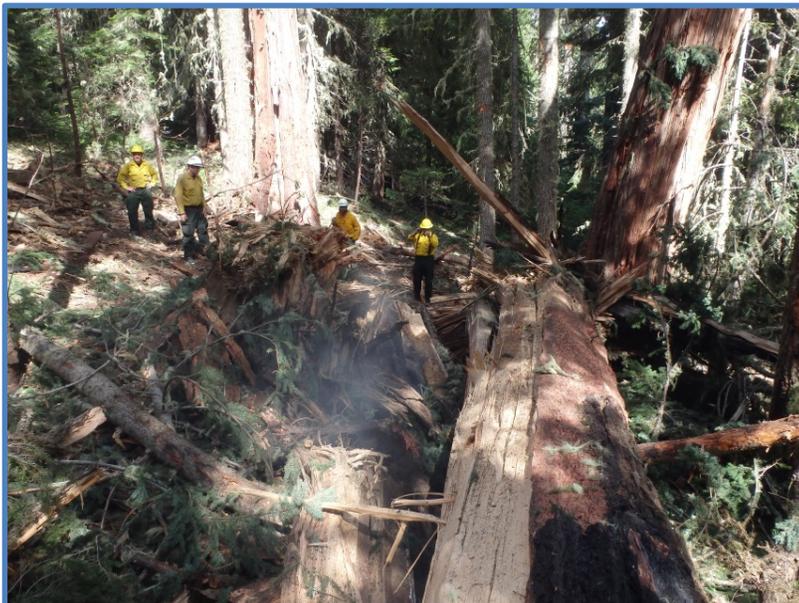
The second blast was successful in transitioning the entire tree to the ground.
