Rapid Lesson Sharing

Event Type: Burn Damage to Engine

Date: July 31, 2017

Location: Pole Creek Fire, Nevada

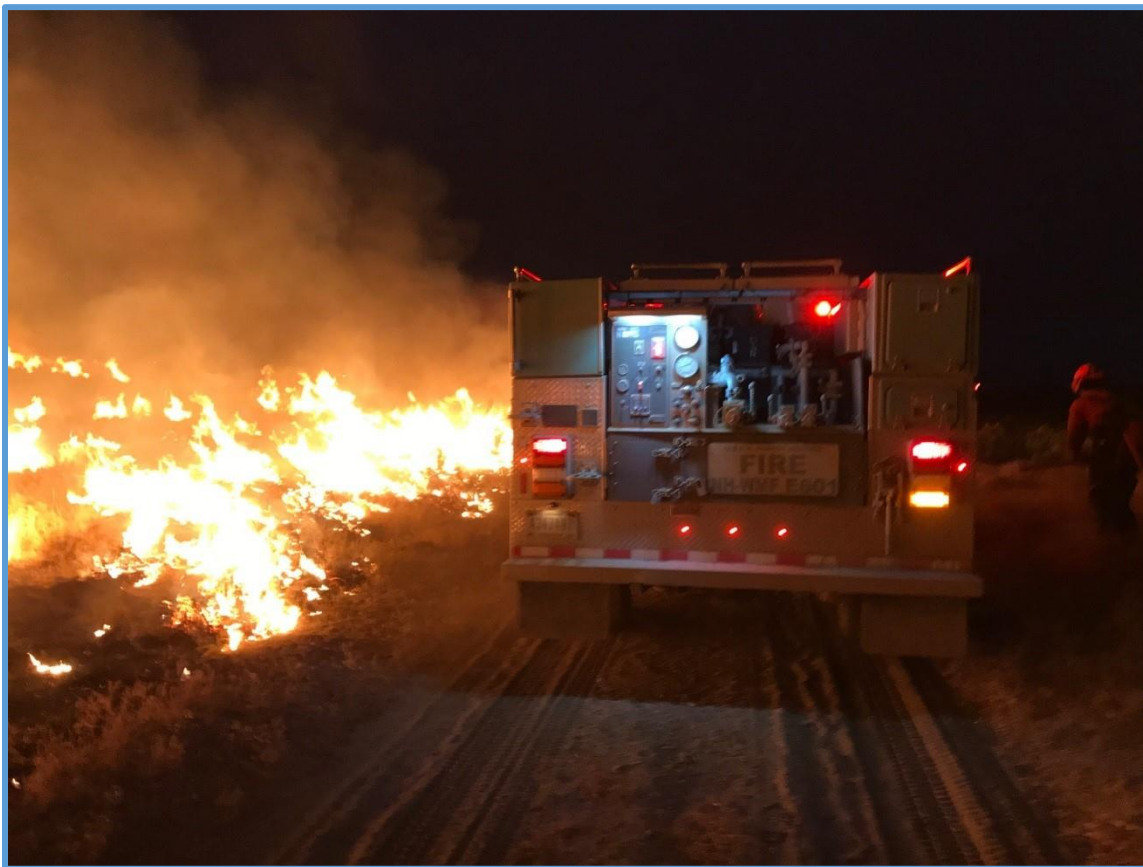
Fire behavior
beside Engine
E601 during the
burn out
operation.

The fuels burned very hot. However, E601's driver did not believe they were intense enough to damage the vehicle as the Engine Boss and Hand Crew did not have any difficulty standing adjacent to the burn out.

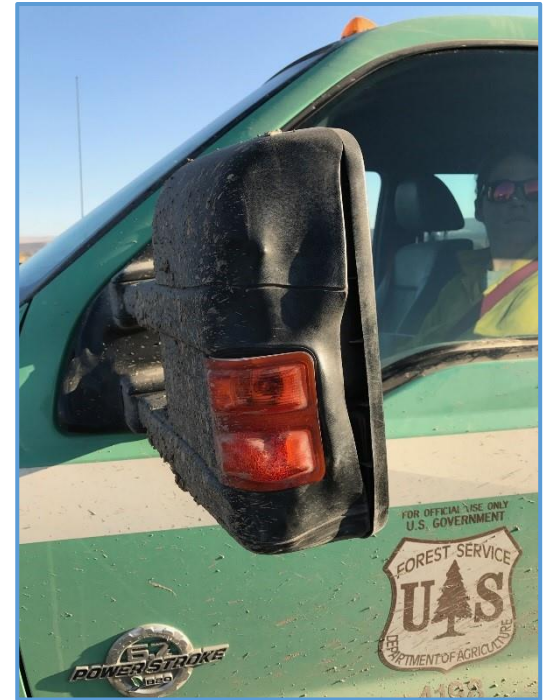
The morning after the operational period, during the daily PM check, E601's crew members noticed scorched decals and a melted driver's side mirror on the engine. It was determined that this damage likely occurred during the burn out operation when the visibility had been poor for that one-half hour time period.

Radiant heat damage to driver's side mirror on E601.

Take a tactical pause to make sure all resources understand and are comfortable with operations. Know the limits of your equipment and your personnel during operations.
