Informational Summary Report of Serious CAL FIRE Injuries, Illnesses, Accidents and Near Serious Accidents

CAL FIRE Academy Dozer Accident

June 3, 2015

Heavy Fire Equipment Operations Academy #41 Dozer Accident

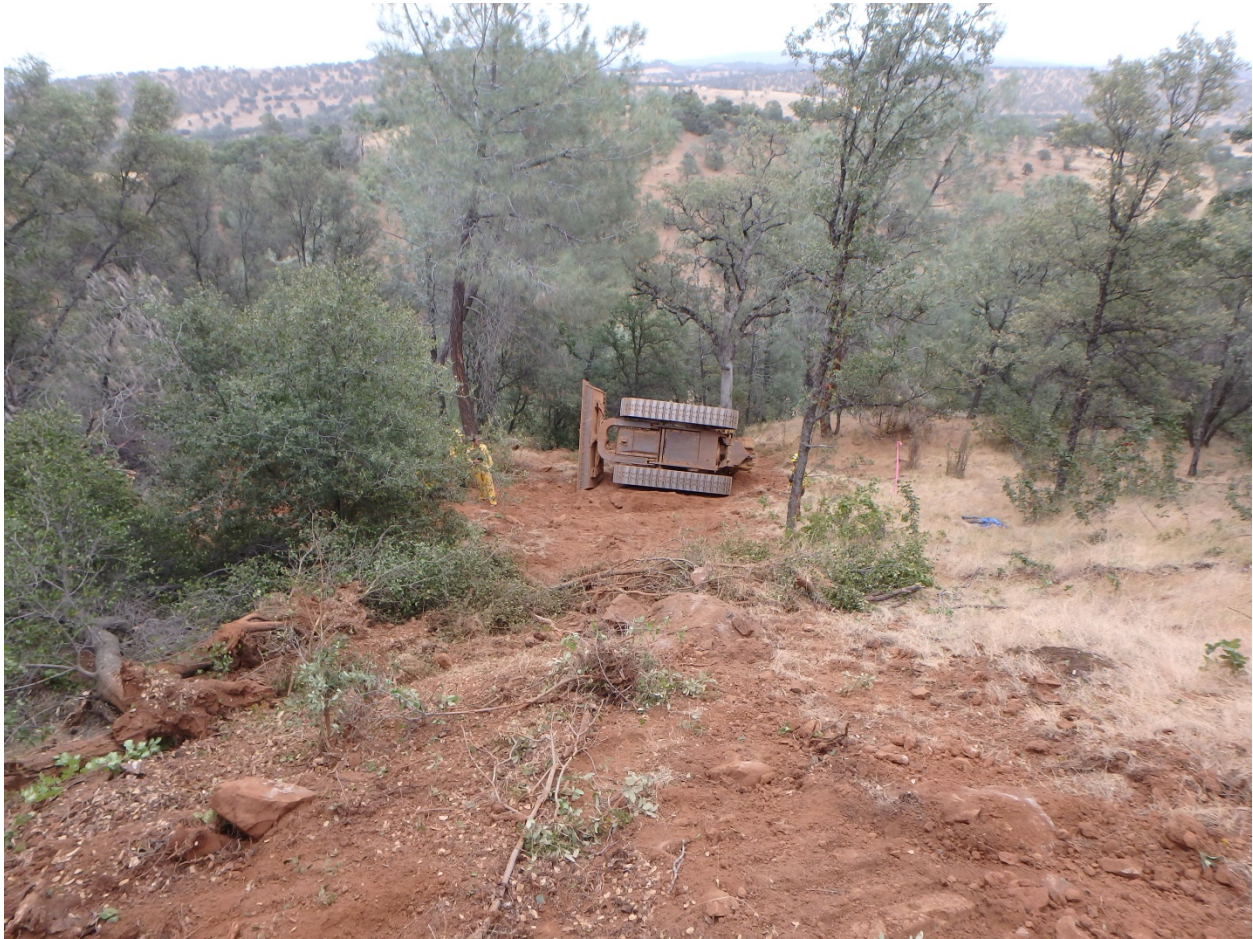
At approximately 1800 hours, HFEO1 was following the pioneered line of a lead dozer with instructions to improve the existing dozer line to one and one-half blade widths. During this operation, HFEO1 encountered a large, boulder-sized, float rock in the middle of the existing dozer line. HFEO1 adjusted D3140's route to avoid the rock. In maneuvering around the first rock, the right side track of D3140 made contact with a second buried rock below the larger rock. This smaller rock measured approximately 4 feet, 11 inches long and 4 feet wide at its greatest points of length and width, and a height of approximately 2 feet, 3 inches on the downhill side. When D3140 made contact with the smaller rock, the grousers of the right side track lost traction and slid downhill. The orientation of D3140 at the moment the slide began was approximately 45 degrees to the fall line of the hillslope. After the grousers of the right side track slid across the rock, the center rear of the belly pan became momentarily high-centered on the rock. The orientation of D3140 was approximately 90 degrees to the fall line of the hillslope. D3140 was completely perpendicular to, rather than parallel, with the slope. This positioning resulted in the right side of the dozer facing downhill. D3140 became unstable while balanced on the rock and immediately began a slow roll on to D3140's right side. D3140 rolled one and one quarter times downslope for a total distance of approximately 60 feet (slope distance). D3140 came to rest on its right side. Both adjunct instructors and HFEO2 witnessed the rollover from their locations on the dozer line. Instructor2 immediately contacted HFEO1 by radio at the conclusion of the roll. Instructor2 inquired if HFEO1 was okay, and directed HFEO1 to shut off D3140. HFEO1

View of D3140 looking downslope on partially constructed dozer line at resting location following rollover accident. Notice rock in center foreground upon which D3140 appears to have initiated slide and rollover.

- The exposure and presence of large rocks during dozer line construction calls for careful review of proposed dozer routes and pre-planning of contingency actions to avoid slips and slides on rock surfaces.
- Smaller, and partially buried rock boulders, can be deceptively hazardous to heavy fire equipment operation.
- Maintaining dozer orientation parallel rather than perpendicular to the hillslope is important particularly when working in rocky soil types.

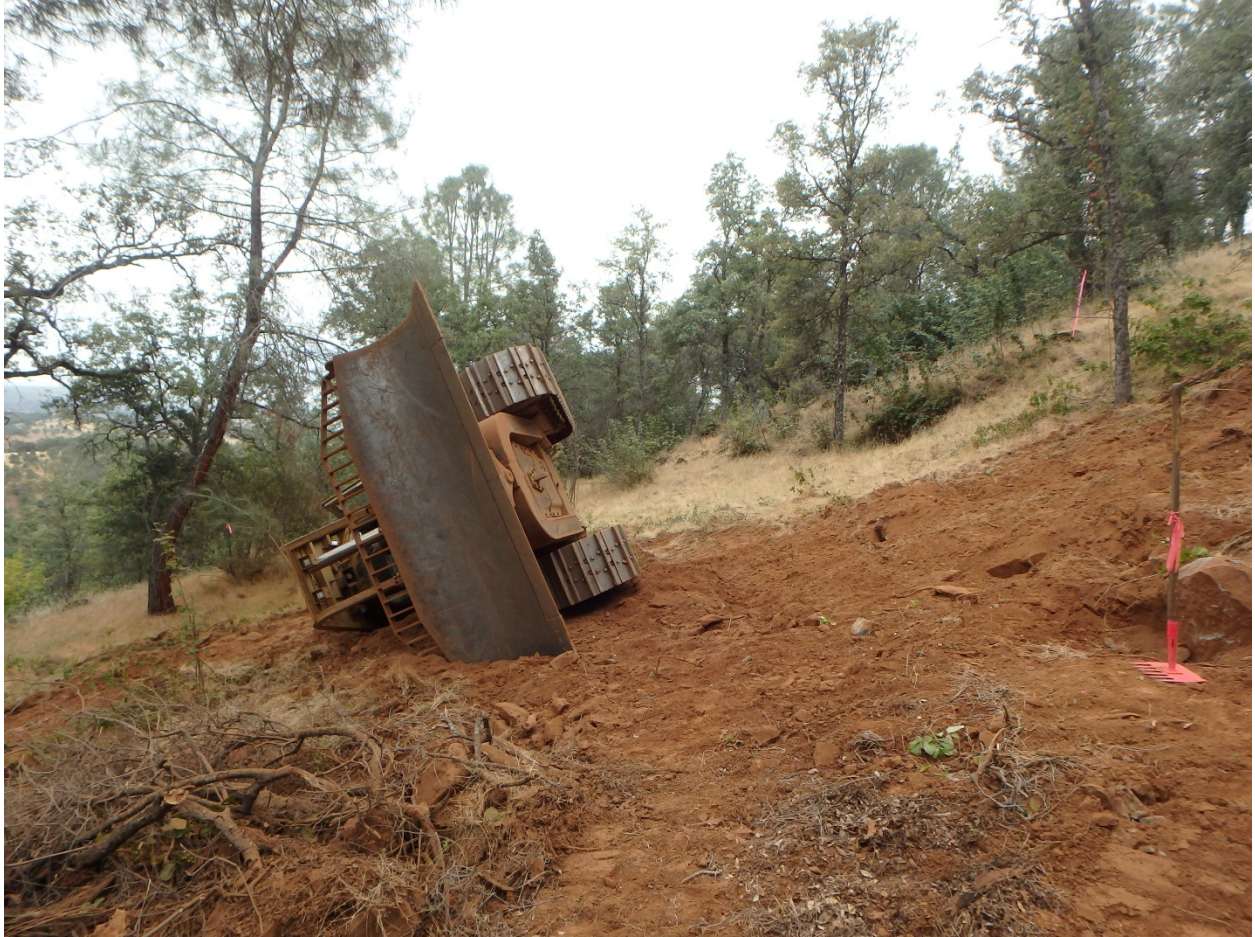
D3140 sustained visible damage to the right side, including but not limited to bowing of the right front sweep, and compression of the right side cockpit window screens also resulting in broken windows. D3140 was transported to a Caterpillar tractor repair facility and underwent a full evaluation of its mechanical and safety components, including but not limited to the Roll Over Protection System (ROPS). The ROPS was found to be undamaged. The repair of D3140's sweeps, window screens, and windows are underway.

View of D3140 perpendicular to the hillslope at resting location following rollover.

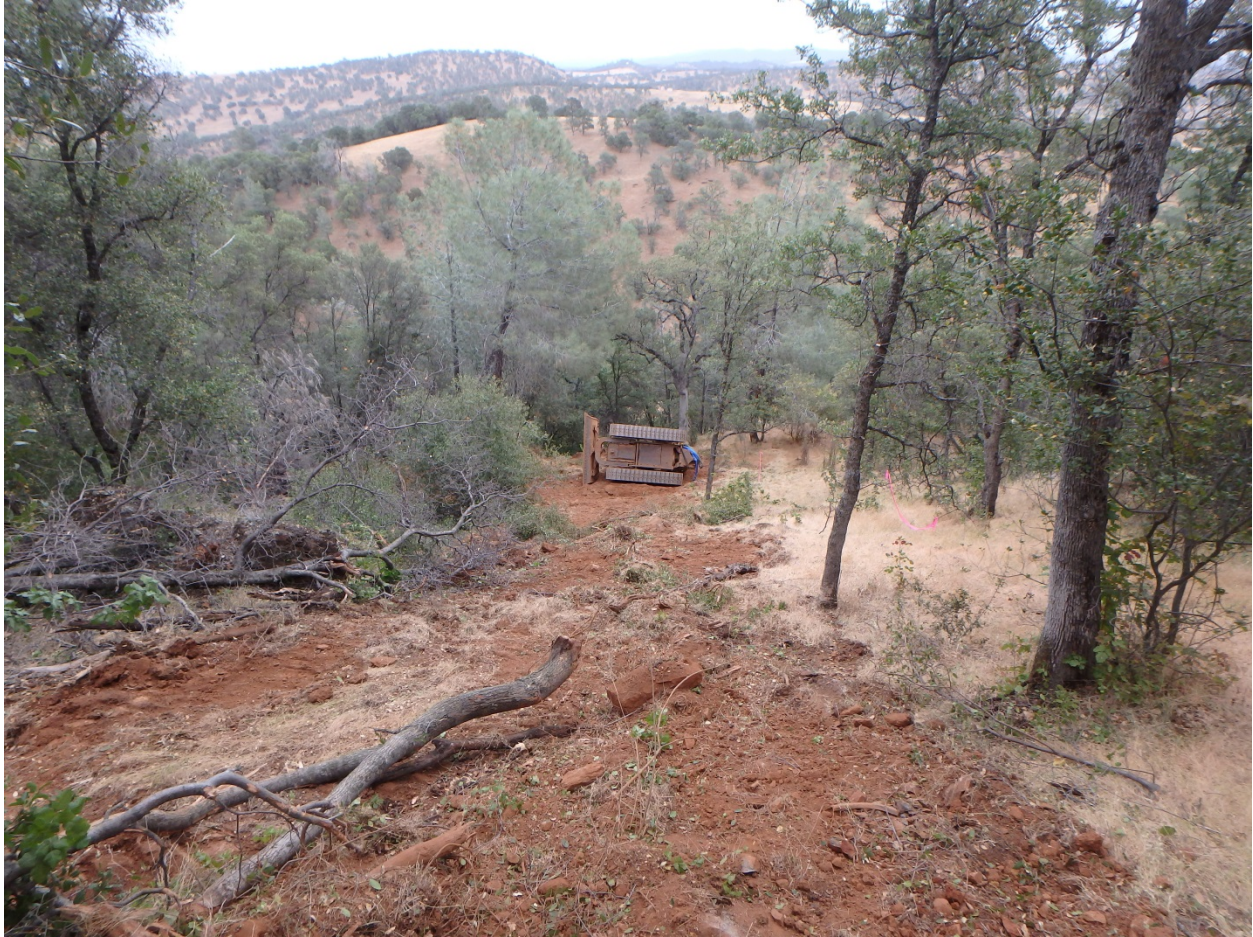
Topography and Soils: As described in the project description contained in the Whittle Vegetation Management Plan (Rx-CSR-052-TCU, 2012), topography is moderately steep to steep, heavily dissected, rocky terrain. D3140's rollover occurred on an approximately 60 foot (slope distance) section of dozer line with an average slope of 45 percent as measured by clinometer. Slopes in the area of the rollover generally vary between 20 and 45 percent. The prevailing soil type is the Loafercreek Series, a mix of clay and rock fragments formed from metavolcanic rock (mainly greenschist) that is moderately deep and well-drained. Soil conditions at the rollover site match this description well.

View of D3140 looking downslope on the partially constructed dozer line.
Prevailing slopes in this location measured by clinometer at 40%.

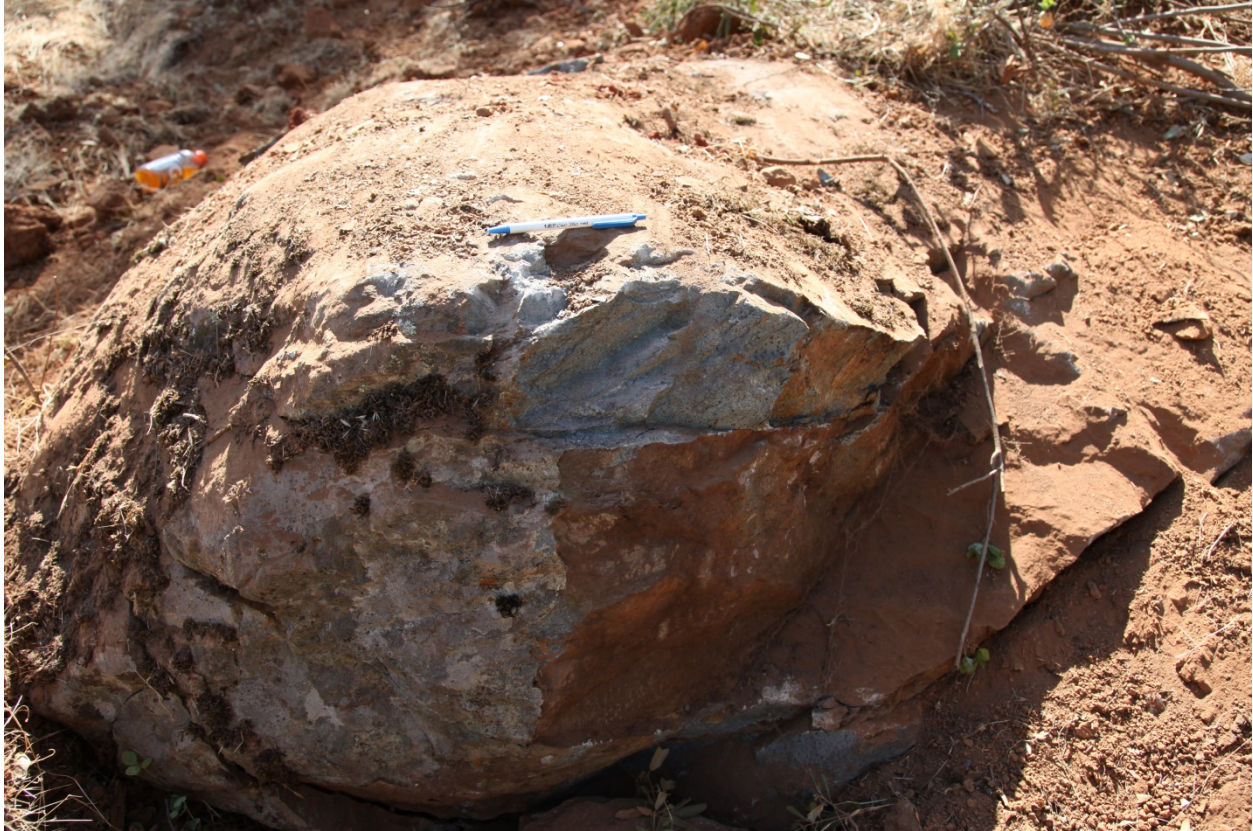
View of rock upon which D3140 initiated slide and rollover looking upslope on the partially constructed dozer line.
