After Action Review of Comp. 65 Prescribed Fire
From January 29, 2015
Kisatchie NF

February 6, 2015

Compt. 65 FY15
 612 acres

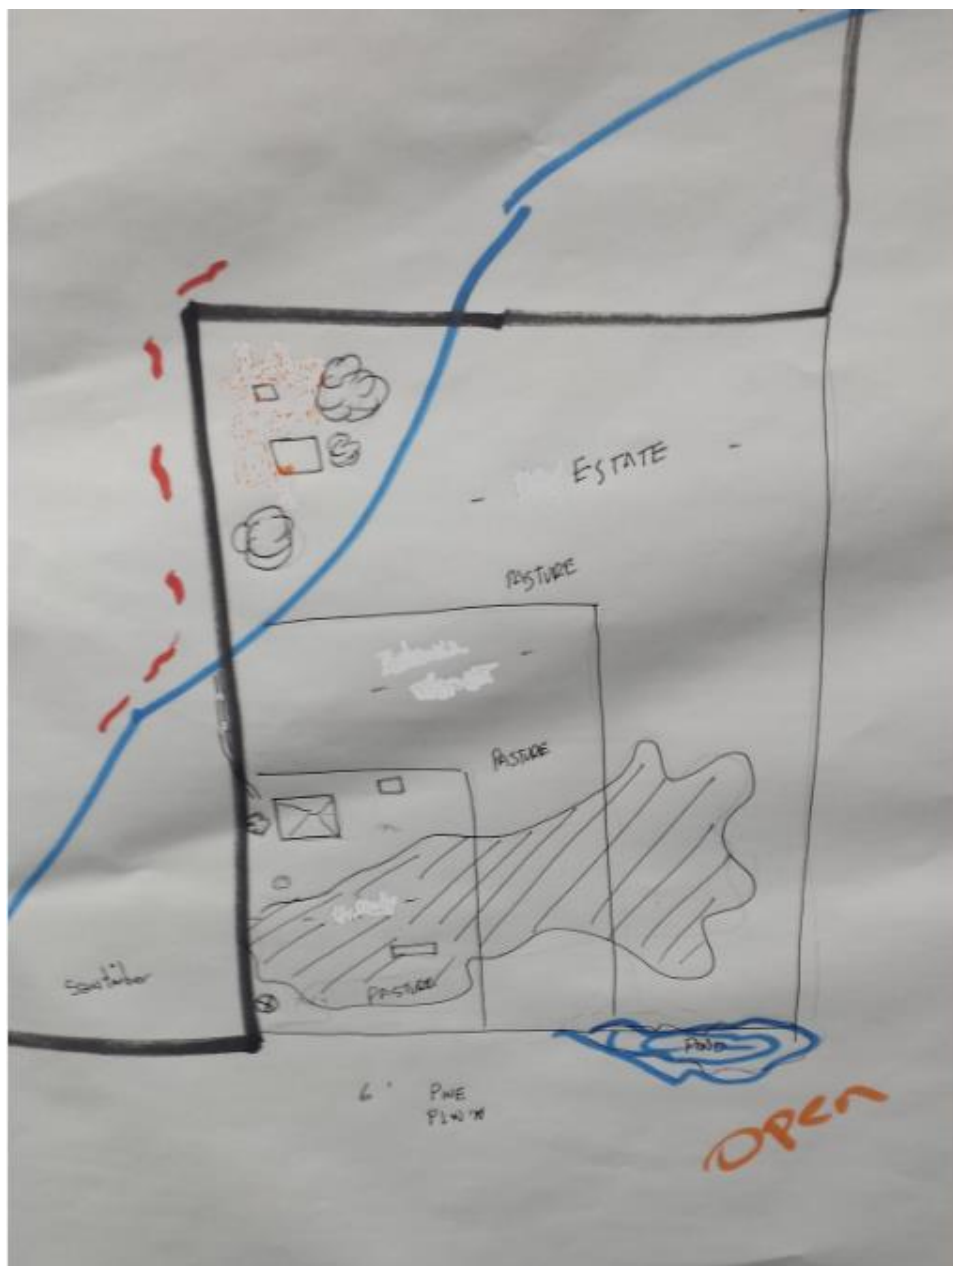
Spot fire #3 moved quickly through the FS land just south of the residence near G...spreading to the east and north. Once the fire moved onto private land, it was mostly in short, cured pasture. A dozer worked on FS land near the residence then worked the south flank along the FS-timber land company landline and tied into a wet area. The AFMO acted as the IC of Spot Fire #3 and suppressed the fire with the T6 engine in the pasture along the north flank from the residence. RXCM #2 continued using the leaf blower in front of the T6 which became stuck in the pasture. UTV's with water arrived to finish suppression along with the leaf blower in the pasture. Spot Fire #3 totaled 19.75 acres.

Photo 1: Map of Spot Fire #3. This map shows the three landowners with residences and outbuilding included. The spot fire is 19.75 acres on private land. The blue line is the parish road. The cross-hatched area is Spot Fire #3.

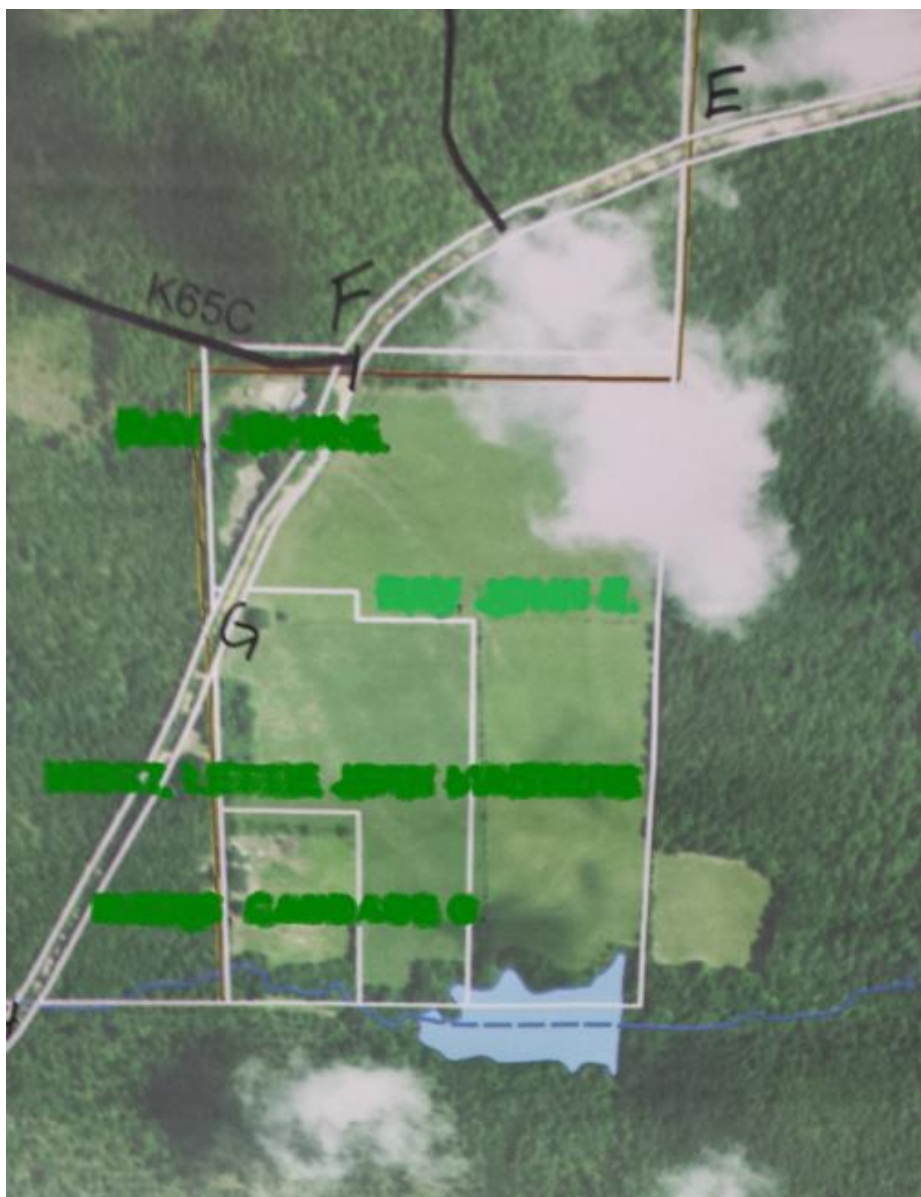
Photo 2: Aerial photo of the SE corner of C-65 showing the three landowners and the location of the residence and pastures.

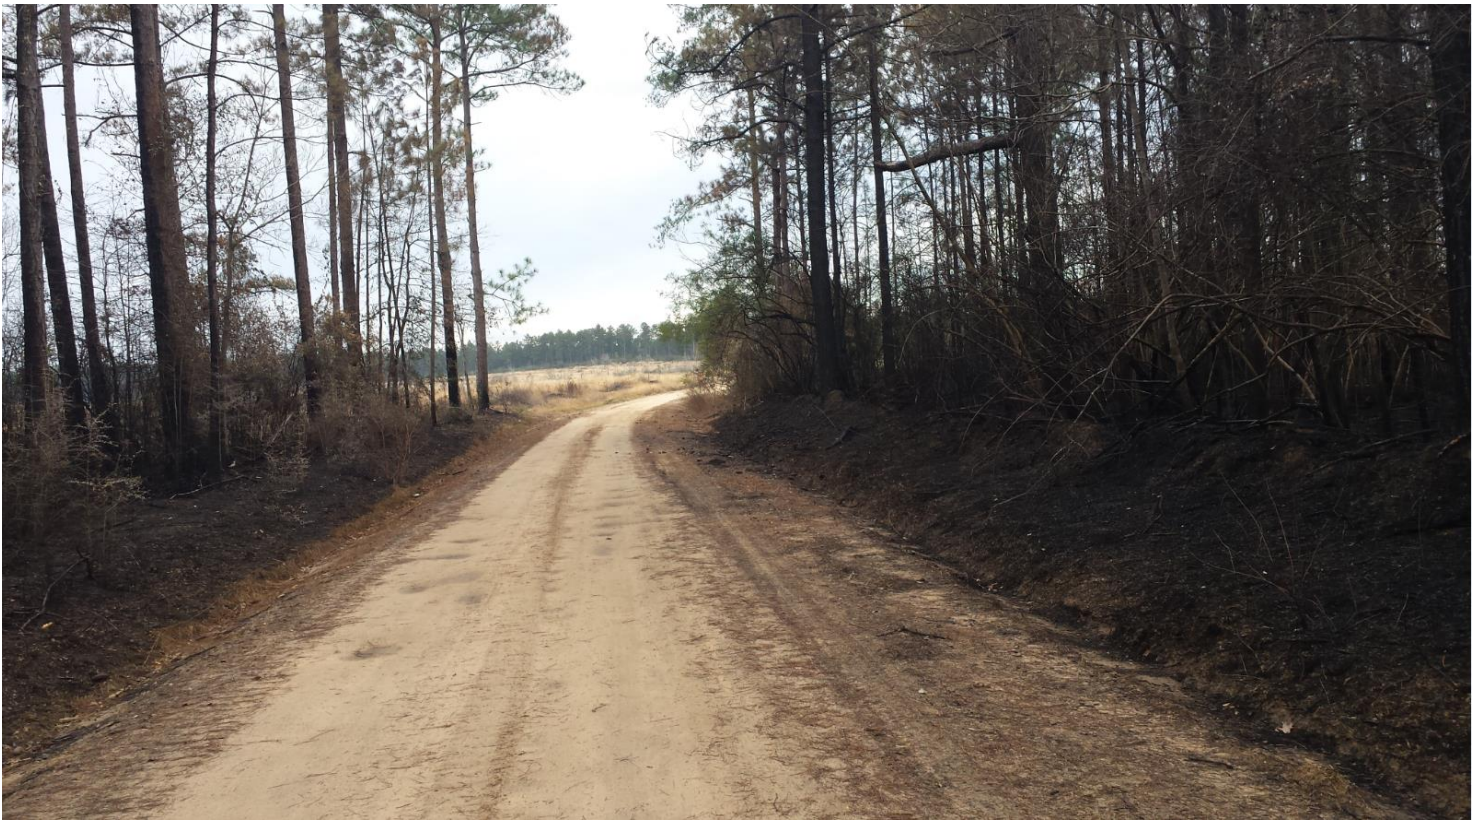
company land. The private land south of the H-I line is a very recent clearcut. The lack of blocking vegetation allowed wind free access to the flaming front. The area north of the H-I line is flatter and wetter than the rest of the burn unit...the low, wet ground has produced an impressive over-abundance of yaupon which was needle-draped. That portion of the burn unit has not gotten a clean burn for many years due to being wet and shaded by yaupon. As fire behavior increased near I, the fire was able to climb into the yaupon with the help of the needle-drape. As the fire behavior increased, stronger in-flow winds lifted the fire into the canopy which was composed of pole sized pine.

Photo 3: View taken just north of point H looking to the south showing the clearcut.

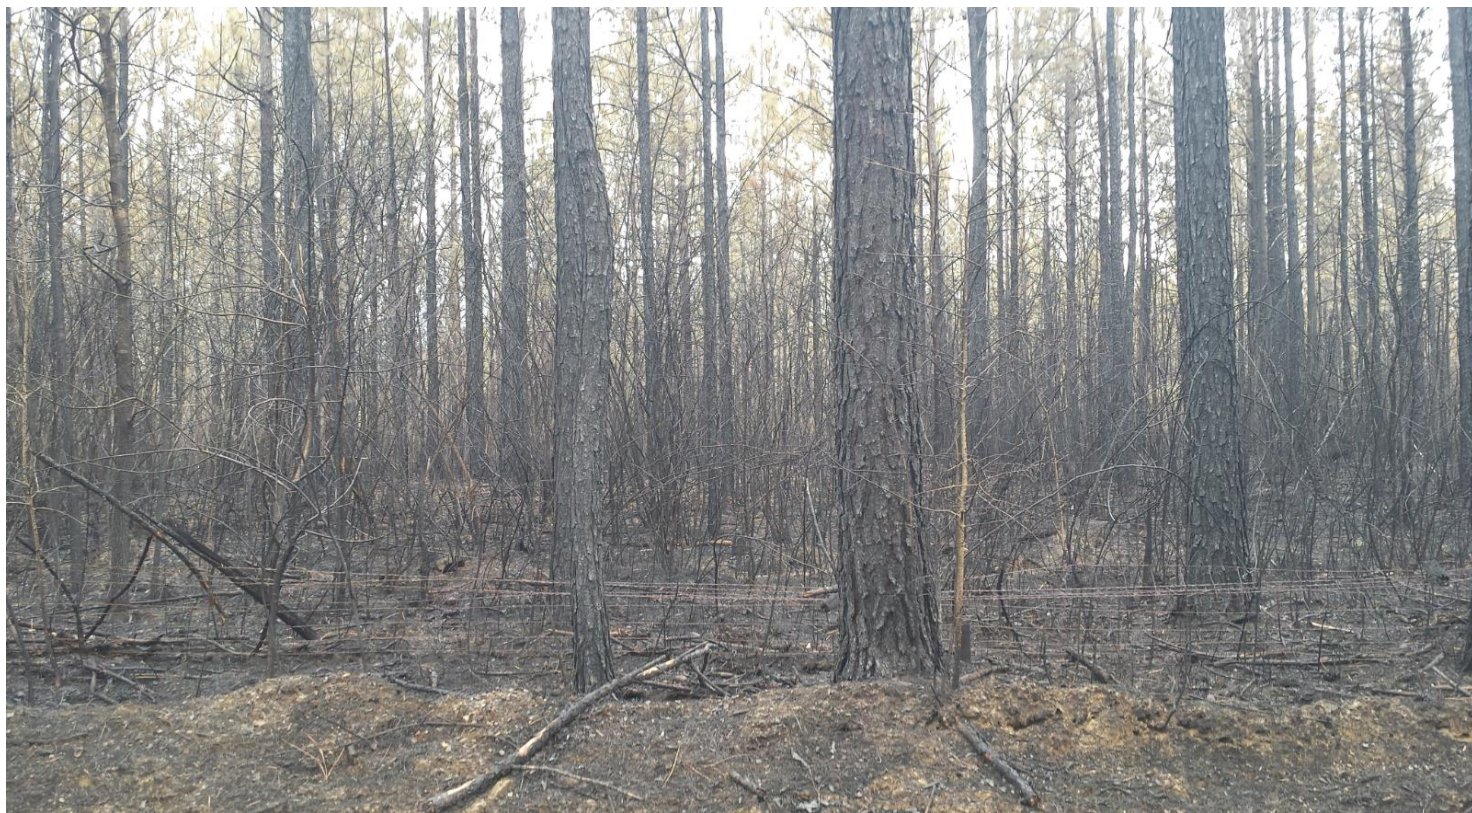
Photo 4: Fuels at point H looking to the west. This area is wetter than the rest of the compartment and has not had a good burn history. Yaupon was 10-12+' in height and needle-draped. Pole sized pine in overstory.

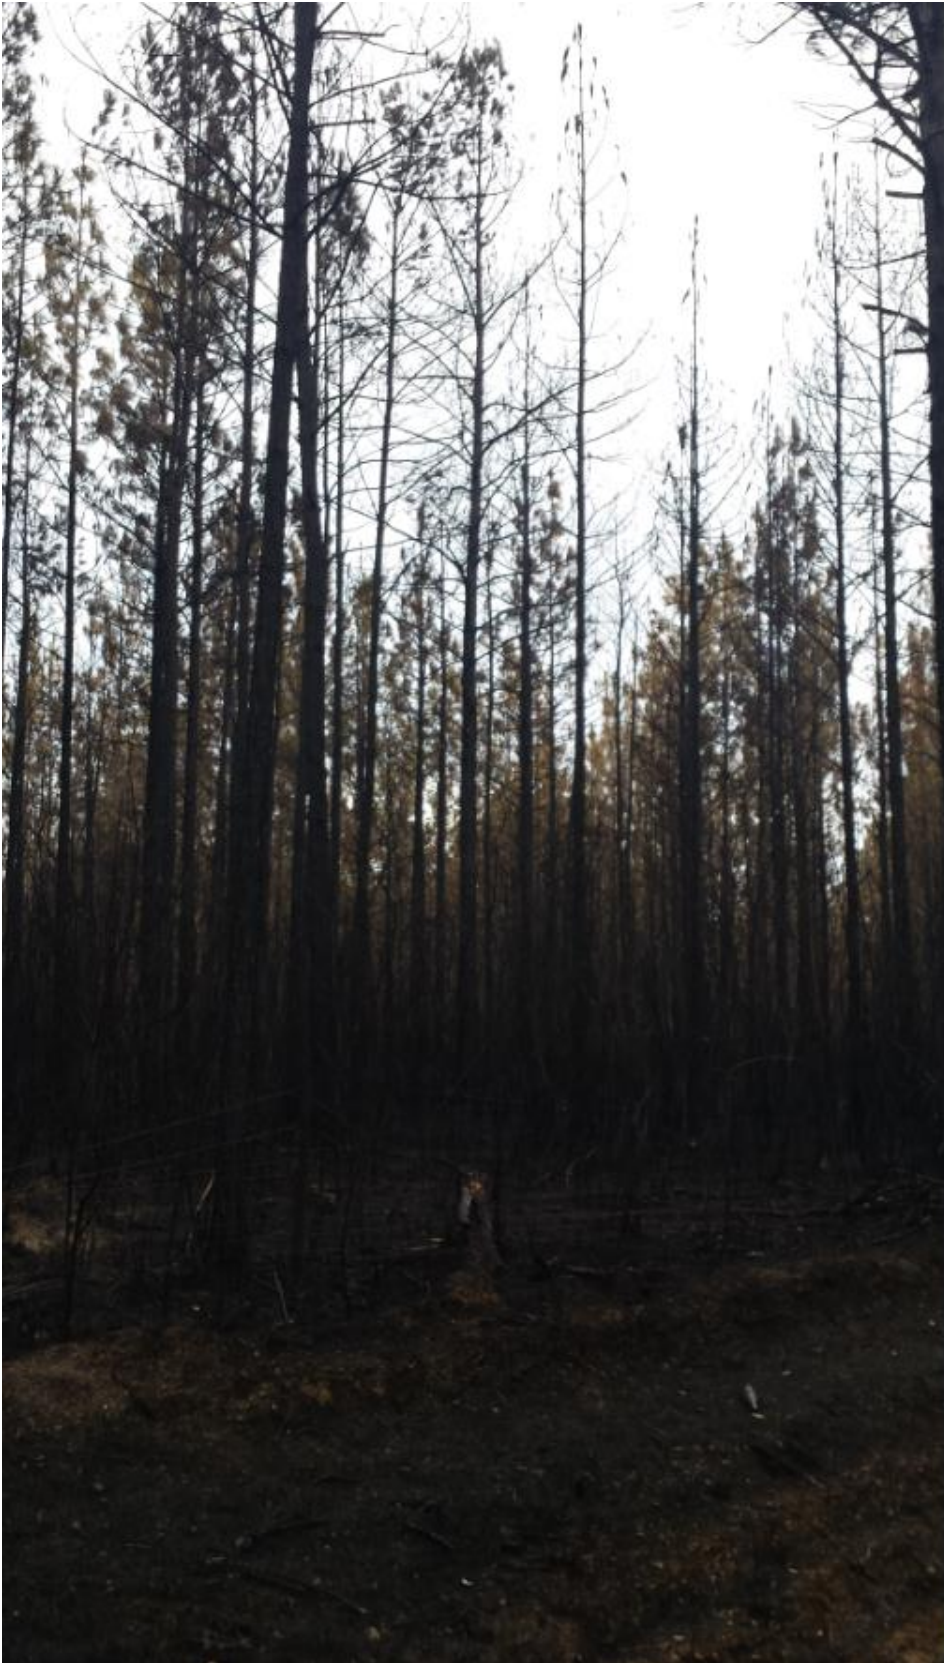
As the RXCM's on the J to I line hit the corner at I, fire behavior increased significantly and quickly. The RXB was stationed on the parish road south of H with a clear view of H-I line. As the RXCM's came to corner I, the RXB observed a rapid increase in fire behavior. As the fire behavior increased, a running headfire developed. The RXB drove up to H and observed that RXCM#2 had not had time to light the baseline to H, leaving a gap in the baseline. The RXB picked up the torch RXCM#2 had set down and ran to light off the remaining section of line to H. As the RXB closed the line, the running headfire transitioned into a crown fire and crossed the parish road.

Photo 5: Just north of H, looking west. This is the point where the canopy fire crossed the parish road. There was heavy understory and pole sized timber.

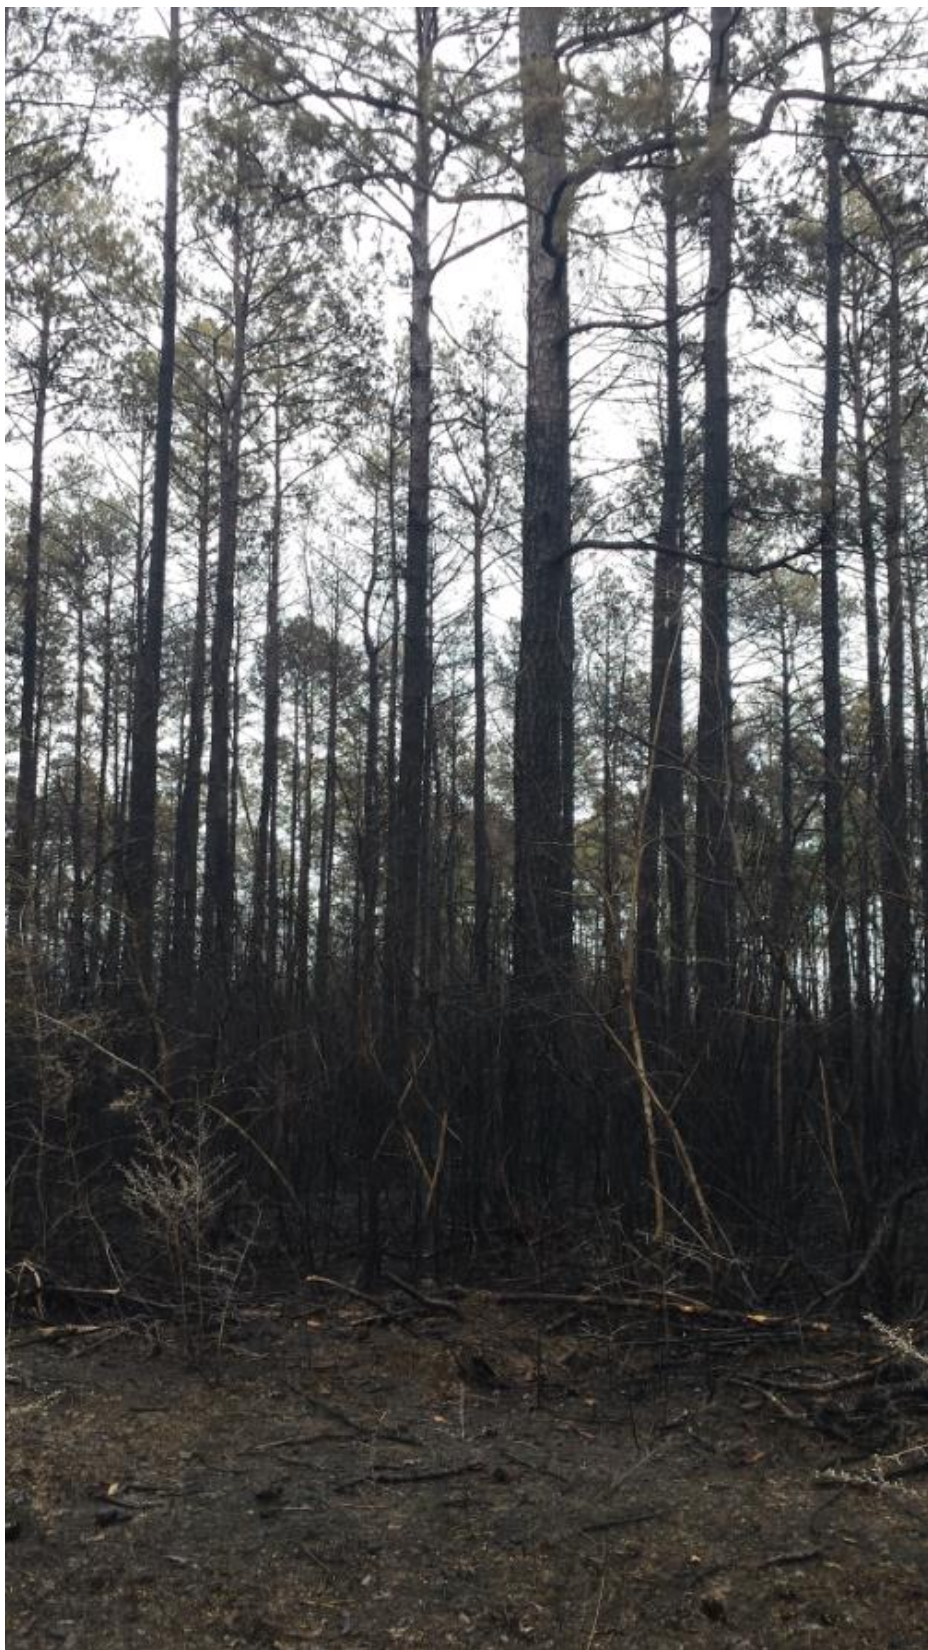
The crown fire crossed the parish road into saw timber sized pine...the surface fire quickly followed. The understory had a very heavy load of needle-draped yaupon; this portion of C-65 has not been burned for a very long period due to the close proximity of a residence. When the fire crossed the parish road, RXCM #2 moved the RXB's truck and picked up a leaf blower and began structure protection around the residence just south of G and very near the landline. The RXB requested both dozers and the helicopter. The DAFMO brought the T6 engine.

Photo 6: Just north of point H, looking east. This is the point where the prescribed fire left the burn unit. There was a very heavy needle-draped yaupon understory and mature sawtimber pine. The fire did not carry in the canopy but burned intensely on the surface due to fuel loading.

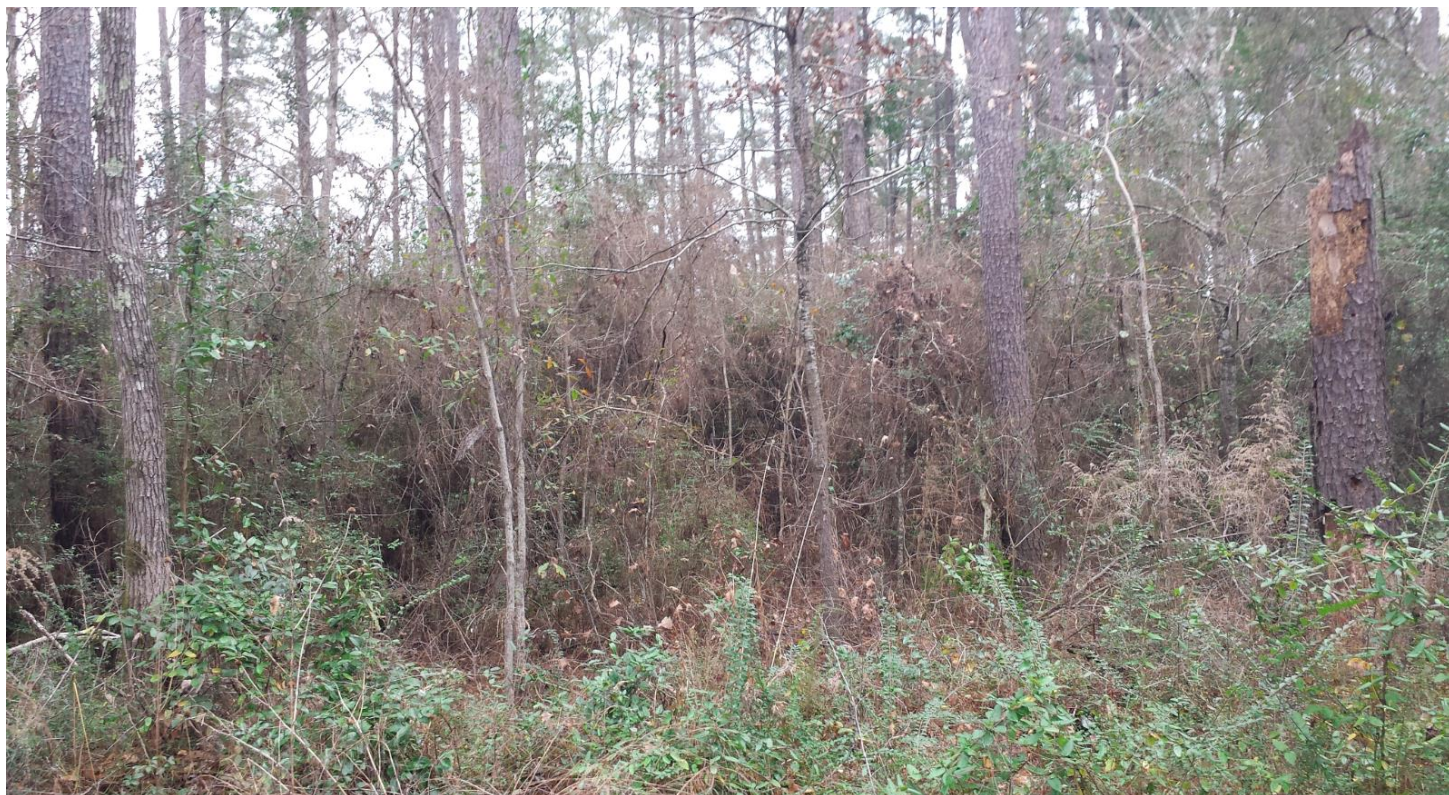
Photo 7: This is the unburned portion of the FS block near the residence at point G. Notice the heavy needle-drape and thick yaupon understory. This is typical of the fuel loading in the portion of C-65 outside the burn unit and adjacent to the residence near point G.

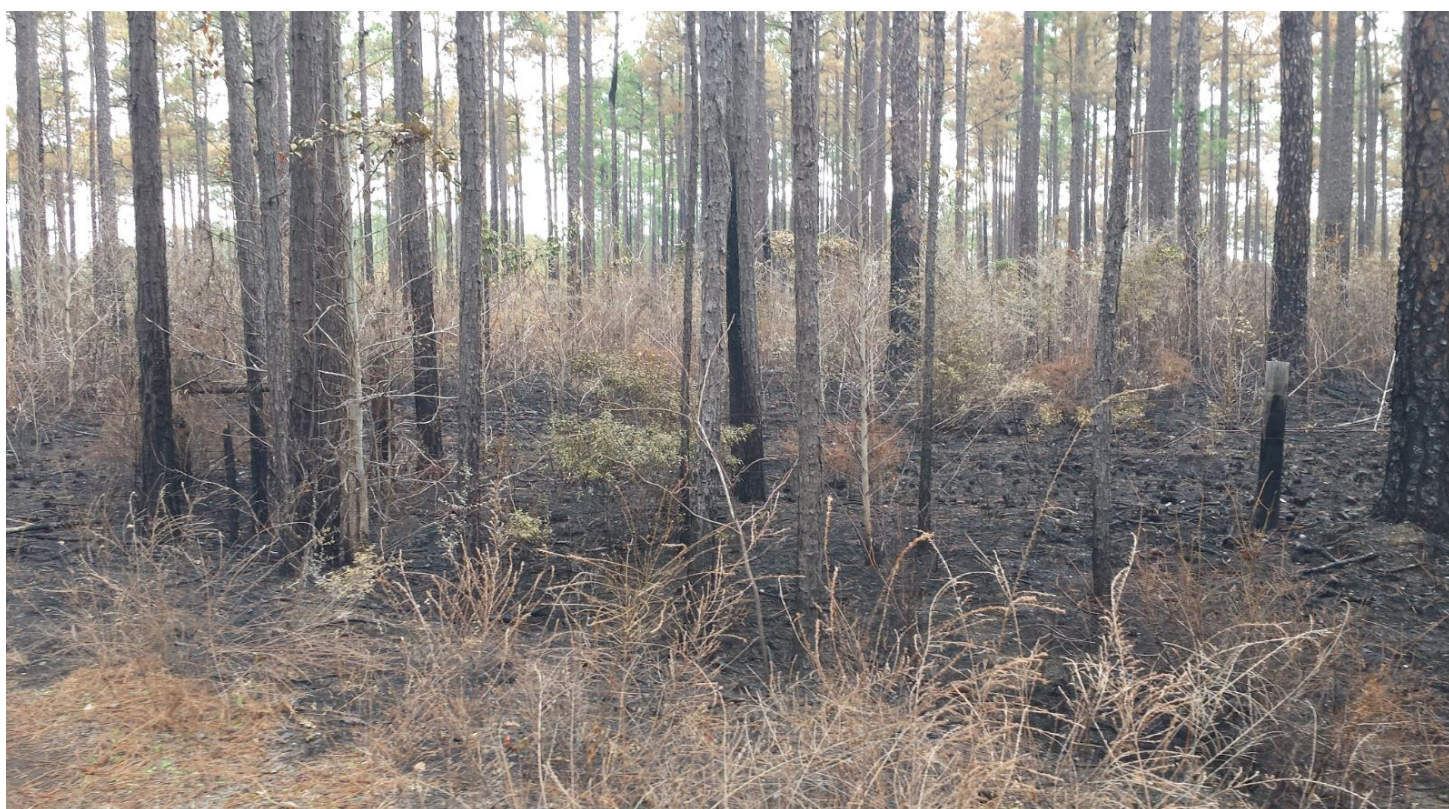
Photo 8: Fuels in a majority of the burn unit. This photo was taken near point E.
