NC DIVISION OF FOREST RESOURCES

Charles Taylor Road Fire

Accident Investigation Final Report

March 25, 2008

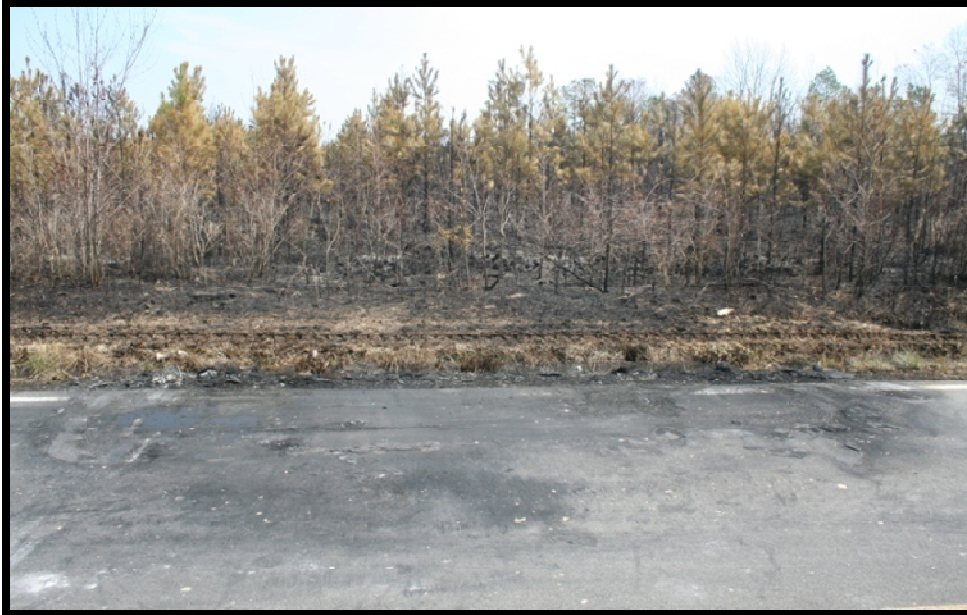
Photo 1 – Taken at Origin on Charles Taylor Road looking in the direction the fire spread.

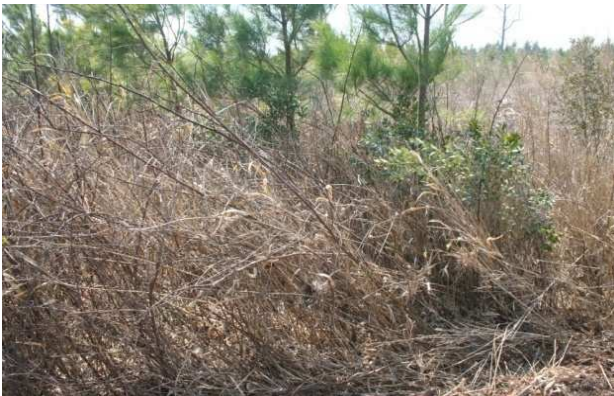
Photo 2- Representative fuels before the fire

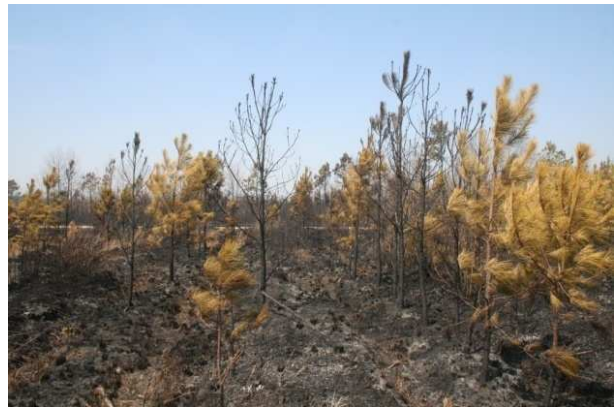
Photo 3 -Showing intensity in which the area burned

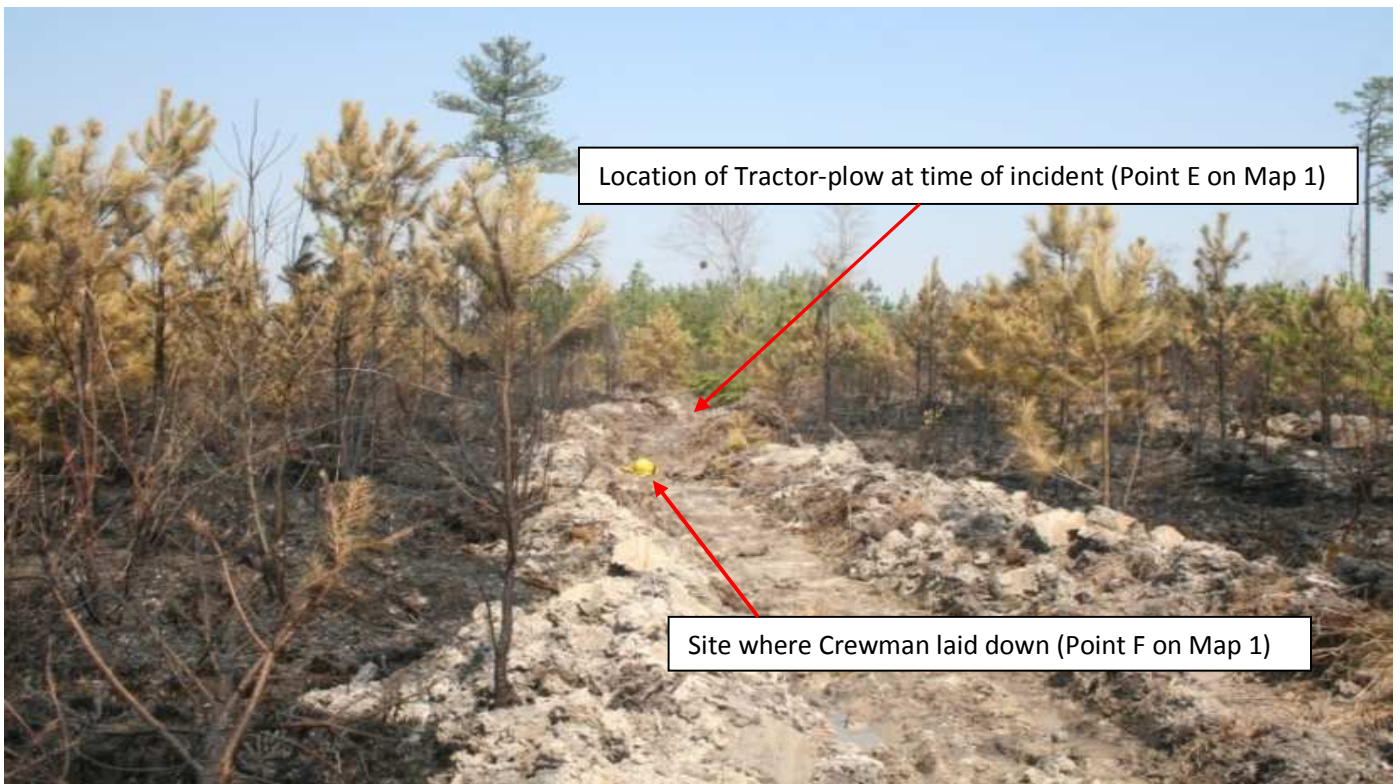
Line construction continued and the FFEO and Plane 12 pilot discussed trying to “Pinch the Head” if possible before it reached some larger timber. The FFEO proceeded with fireline construction for approximately 338 Ft. and was preparing to start to pinch the fire’s head until the Tractor Plow crewman observed a spot over across the fireline behind himself and the Tractor Plow (Point D on Map 1). The Tractor Plow crewman radioed the FFEO about the spotover and advised that he needed to “get out of here because there was fire all around me”. (Note – The crewman was at Point F on Map 1 at this time and the FFEO was at Point E on Map 1.) The FFEO stopped forward line construction and advised the Tractor Plow crewman to retreat to the “Black”. The Tractor Plow unit was within 120 Ft. of the Company Road at this point. The Tractor Plow crewman advised that he could not retreat to the “Black” and laid down in the fireline (at Point F on Map 1) with his head in the direction they had plowed from until the fire intensity subsided. (See Photo 4 below)

Photo 4 - Showing location where the Crewman laid down in the fire line, and the location of the Tractor-plow at the time of incident.

After careful review and discussion of the Accident Review Team, the following items have been determined as the major contributors to the burn over incident occurring. The FFEO and crewman did a great job anchoring the fireline and were constructing good quality fireline. The Scout Plane suggested to try to "Pinch the Head" to try to stop the fire from getting into a block of larger timber that was ahead of the spot fire on the right side of the Company Road. In an attempt to do so, it appears that the FFEO turned into the fire and was plowing too closely to the fire. Note on Map 1 how the fireline turns at Point C toward the fire, instead of keeping the original course of direction as was plowed from Point A to Point B to Point C. On the ground investigation shows an increase in fire intensity from Point C and Point E due to burn patterns, freezing of needles, alligatoring of bark, and fuel consumption. Once the burn out fire was set by the crewman in the plowed line, it was immediately meeting the flank fire resulting in high radiant heat output, and high fire intensity. The crewman advised during his interview that he was very hot behind the tractor. This is why the crewman could not retreat back down the fireline into the "Black" area. Had fireline construction continued in the initial direction as was

done from Point A to Point B, then Point B to Point C, line construction would have remained within the in-draft, and there would have been adequate time for the burnout fire to create the safety zone for retreat. This may have reduced the spotting potential as well. This was the Crewman's first season, and he should have communicated to the FFEO that he was very hot and to back off of the flank some. However, he didn't know all of the expectations of his position. This was an aggressive attack on this fire. Our personnel are trained to keep the acreage as small as possible, and to suppress a fire as quickly as possible. We need to remind our personnel to not jeopardize their safety for a few more acres burned. Keep the fire acreage small, but provide for safety first.

Recommendation – Don’t sacrifice safety for acreage by attempting to “Pinch the Head” when continuing to flank the fire will be the safest tactic to employ. Avoid plowing so close to the flank that it doesn’t give the burnout fire time to create an acceptable safety zone with the “Black line”.

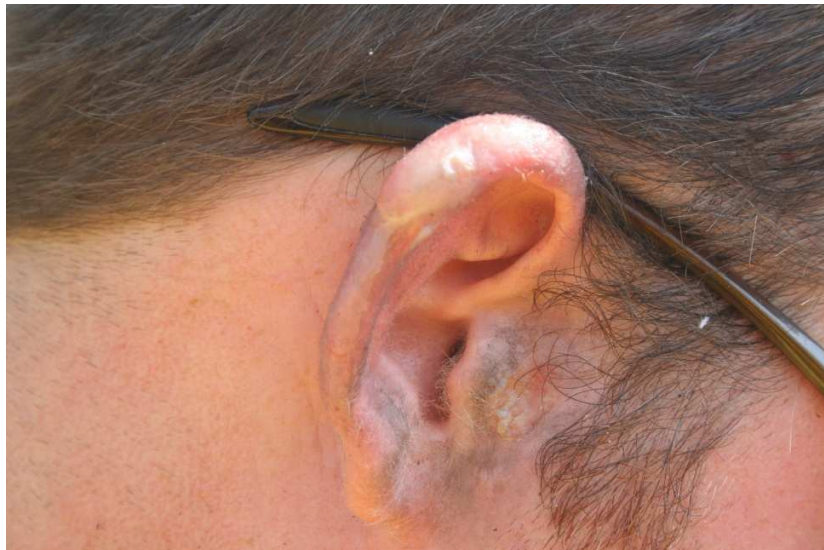
On March 26, 2008 the Tractor Plow crewman was directed to seek medical attention at Bertie Memorial Hospital due to a visible blister appearing on his right ear, and right temple. The Tractor Plow crewman returned to work that day after being diagnosed with 2nd degree burns to his right ear and temple. (See Photo 5)

Photo 5 – Second degree burns on ear and temple

The crewman reported that when the fire flared up with a sudden burst of intensity, his face and neck protector was not fastened in the front. This allowed the face and neck protector to fly up from the radiant heat, allowing for exposure of the ear and face where the 2nd degree burns were received. Had the face and neck protector been properly fastened, it would have prevented the burns received on the ear and temple.

PPE - The PPE that was being worn was examined, and was not compromised during the burn over. Therefore, failure of PPE was not a contributing factor to the injury. The PPE (face and neck protector) was not utilized properly, and contributed to the injury.

Recommendation - Encourage fireline personnel to properly fasten the front of their face and neck protectors to prevent them from blowing open and exposing skin to high radiant heat.

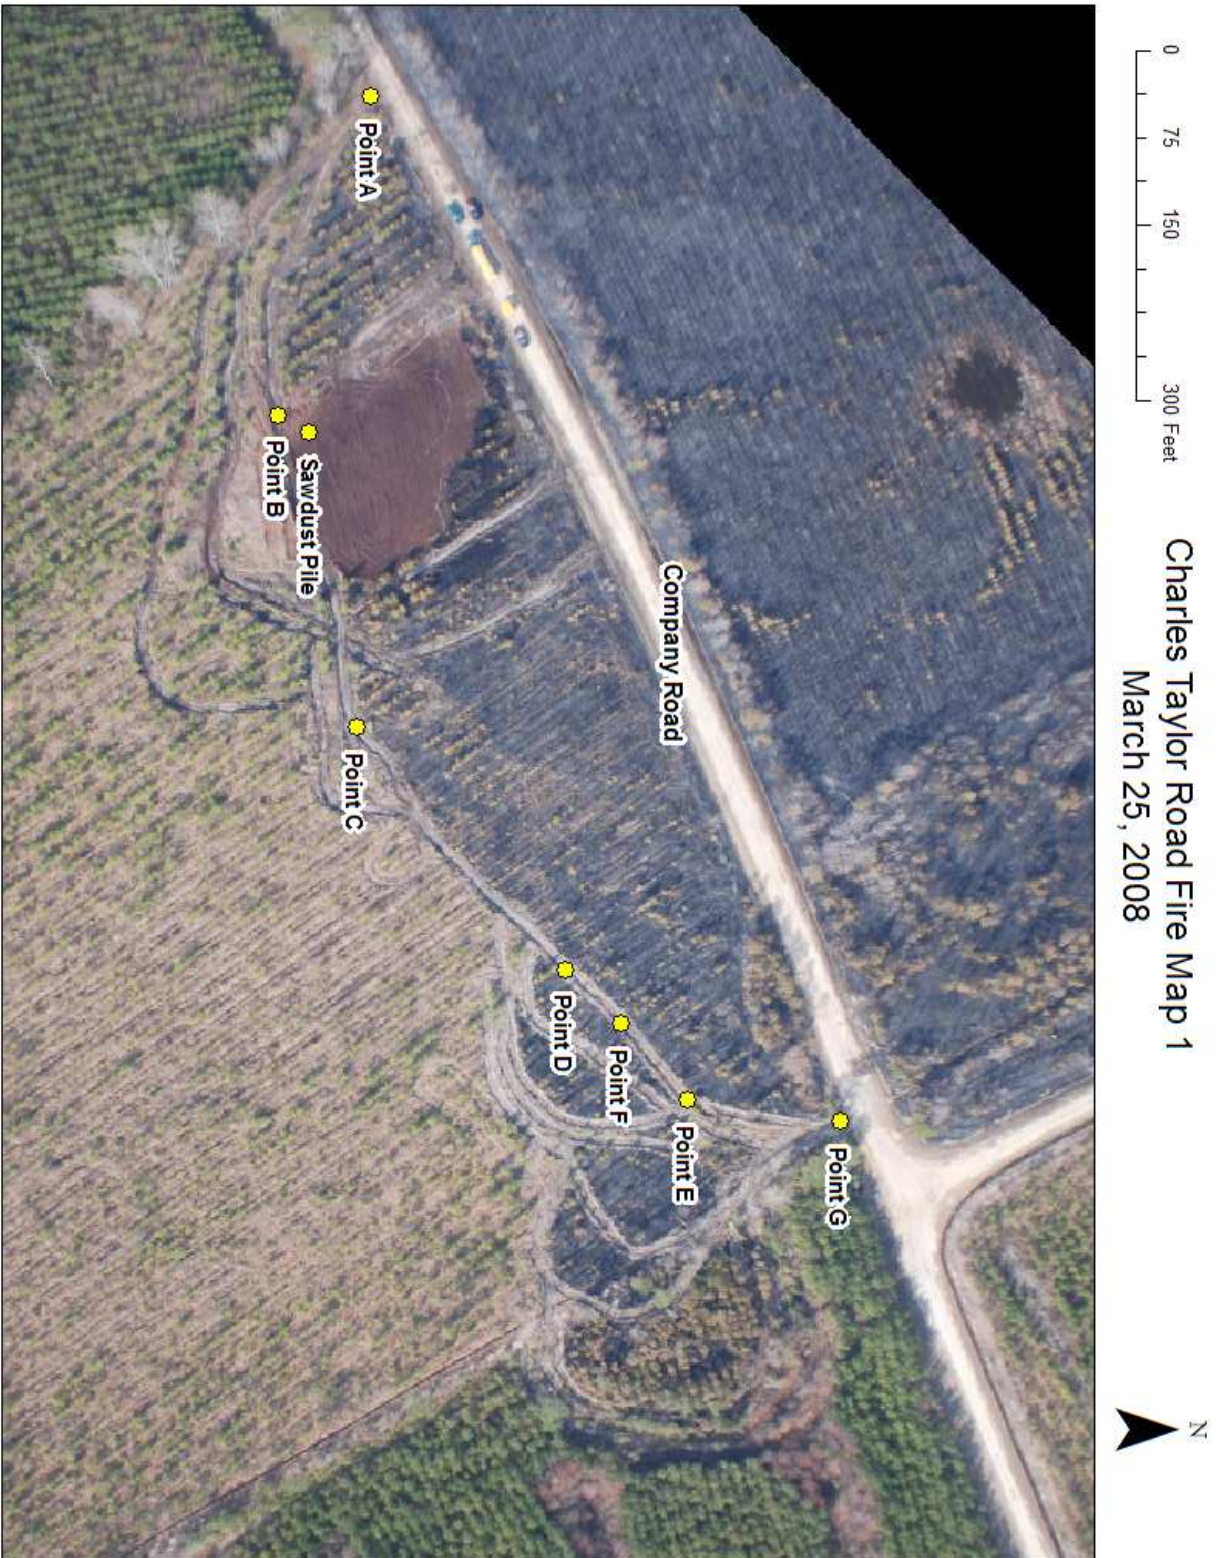
Map 1

(Point B on Map 1). After plowing approximately 157 Ft. through the old saw dust pile, the FFEO advised the Tractor Plow crewman that the fire behavior and intensity appeared to be increasing and for him to be aware for detecting spotovers (Point C on Map 1).
