ACCIDENT INVESTIGATION REPORT

**Firefighter Minor Injuries
Single Vehicle Rollover on Vegetation Fire**

April 17, 2008

**Chino Valley Independent Fire Protection District
CA-CHO-08002590**

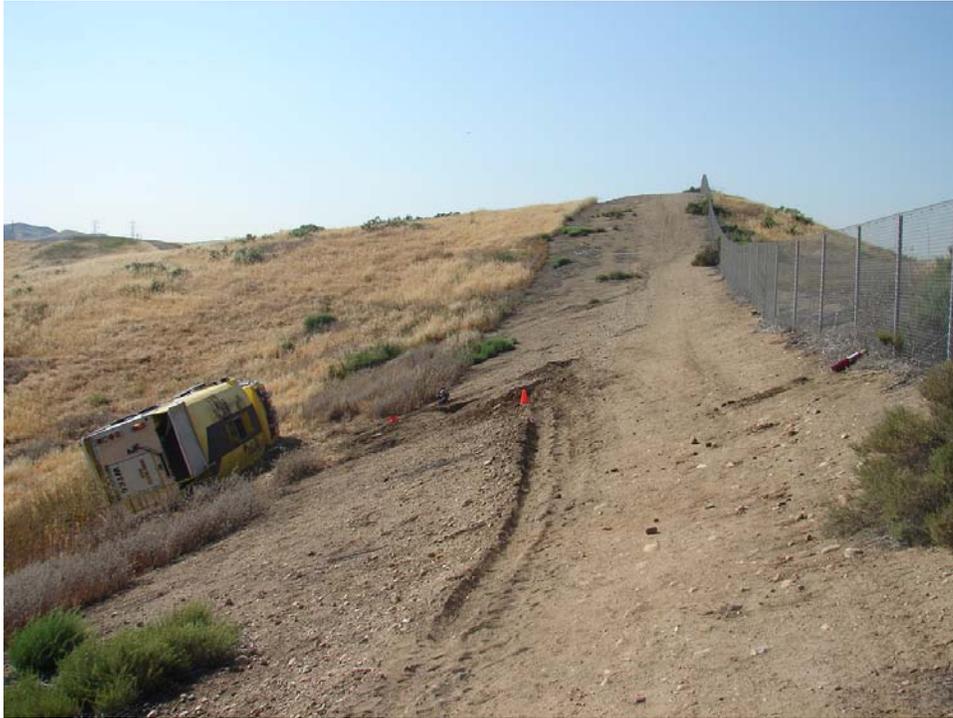
Tire tracks from Water Tender 66

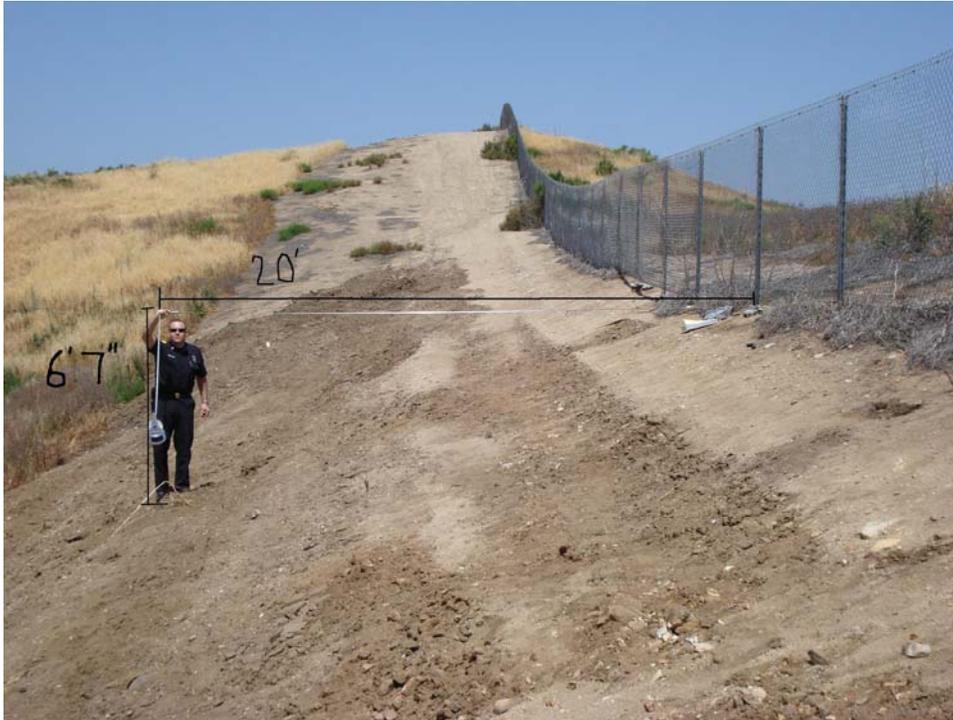
Twenty feet from the fence, there is a six foot, seven inch change in elevation.

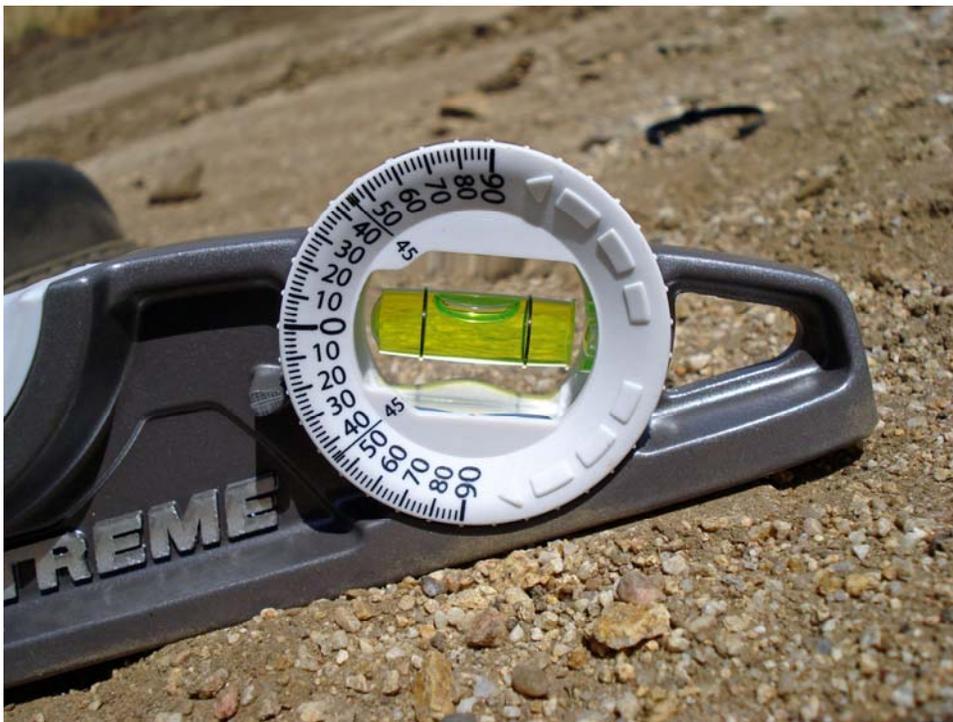
Angle measurement in the accident area.
