# **California Department of Forestry and Fire Protection**

## **Serious Accident Investigation Report**

**San Benito-Monterey Unit  
Bulldozer Rollover  
Fatality**

**October 8, 2007**

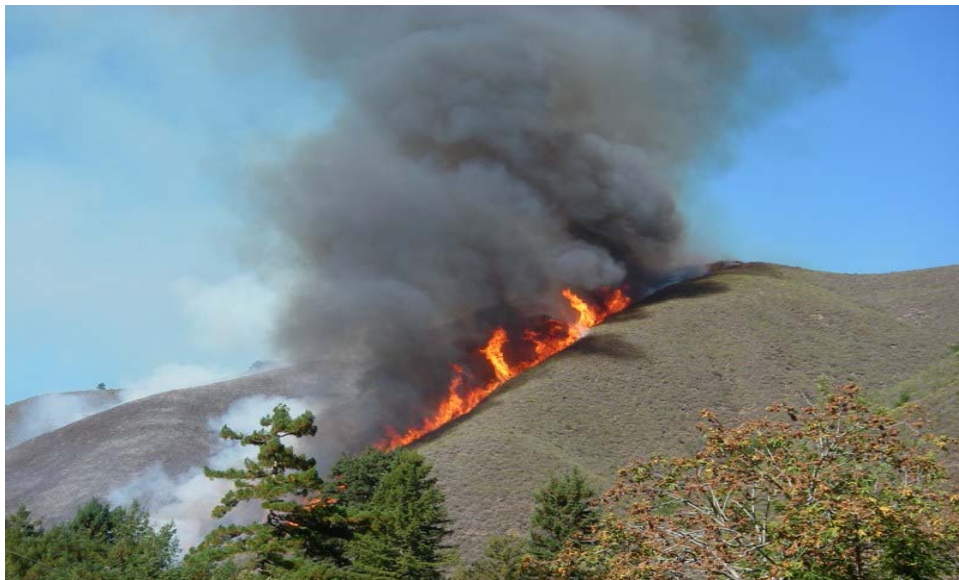
Colorado Fire Division S (Note upper portion of ridge with dozer line construction)

The slope at the top of the spur ridge on Division S was calculated to be approximately 64 percent, the side hill was approximately 83 percent; and the pitch of the constructed line was 62 percent. The prevailing ridge line (spur

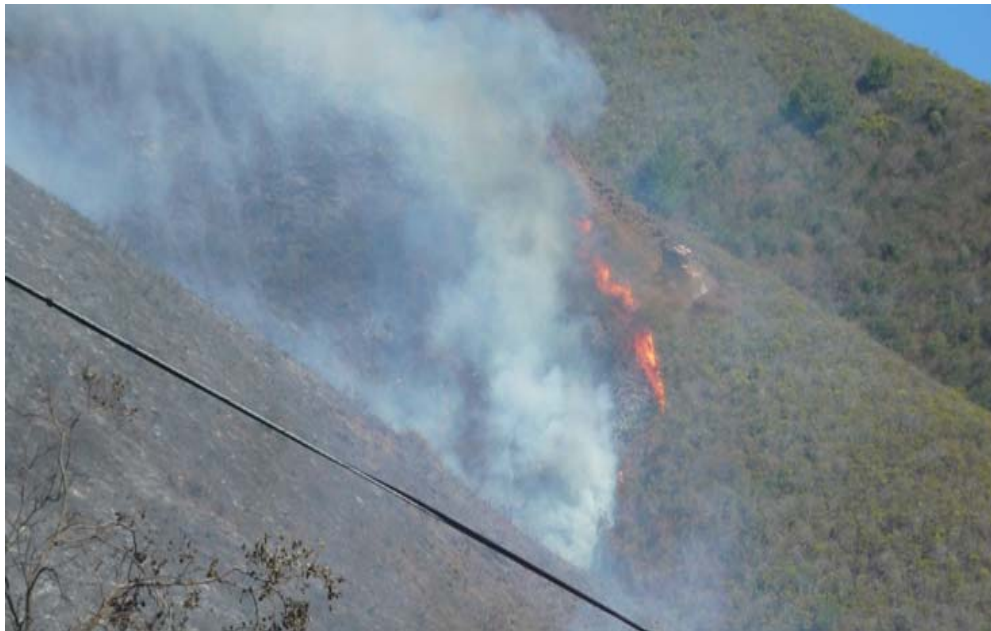
During line construction on Division S, D4641 created a berm (or windrow) of cut material. D4645 had to move the berm because the material was building up on the downhill side of his blade, pulling him into the drainage. D4645 communicated his difficulty to D4641 and requested that D4641 straighten his blade to reduce the berm/windrow. D4641 straightened his blade and continued down the slope. D4645 lost sight of D4641 due to the topography.

CAL FIRE D4641 constructing line on Division S

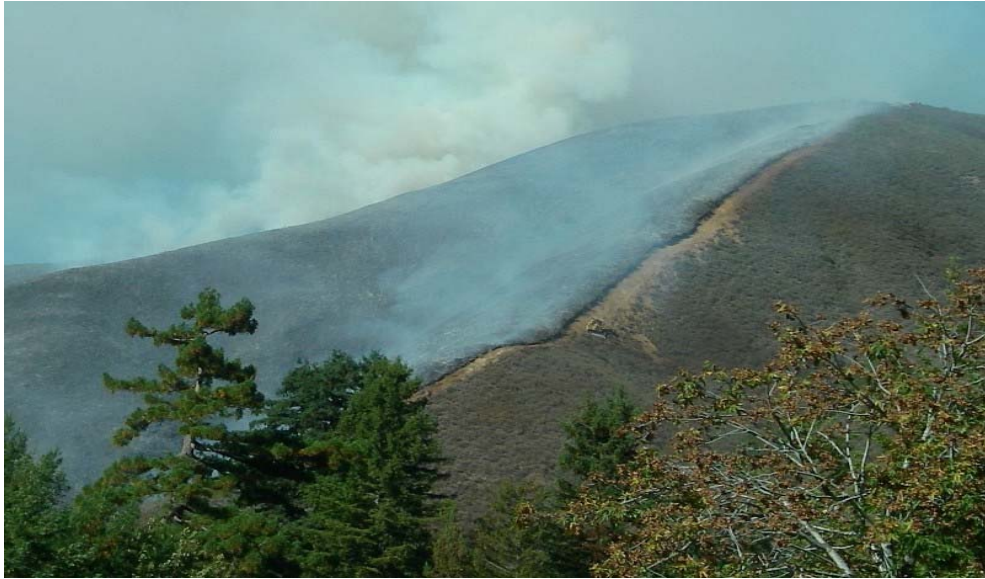
As D4645 continued downhill along the constructed dozer line, he began sliding then stopped because he could no longer safely move due to terrain and loose soil conditions (see Attachment 6.E.1 Soil Report). HFEO #2 nosed his dozer down slope and set his blade down into the soil for safety, exited the cab and notified Division M, via radio, that he was stuck and would need assistance getting out. HFEO #2 stated he was concerned about the dozer's stability on the steep slope.

CAL FIRE D4645 stuck on Division S (center of picture) prior to D4641 Rollover

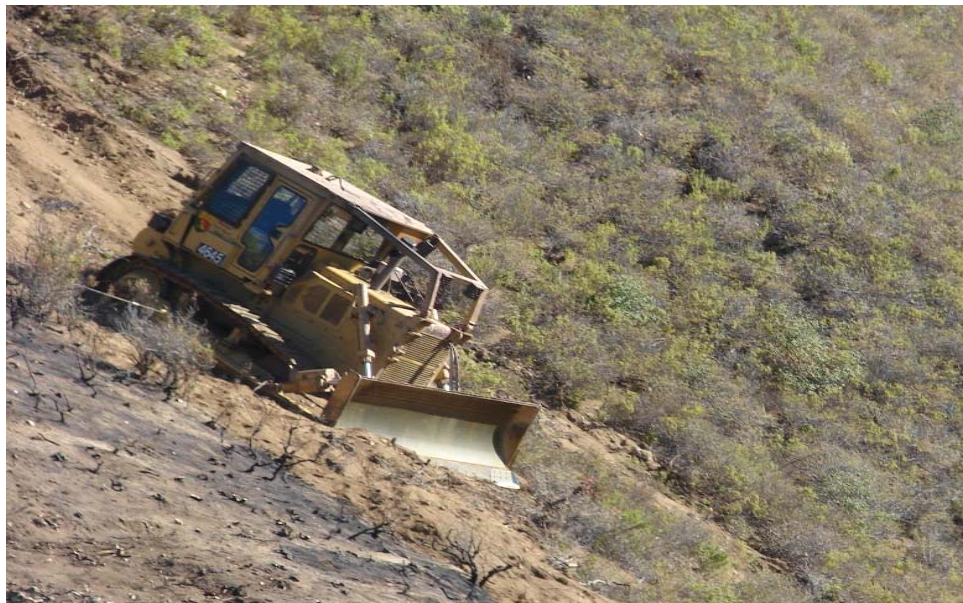
CAL FIRE D4645 stuck on Division S

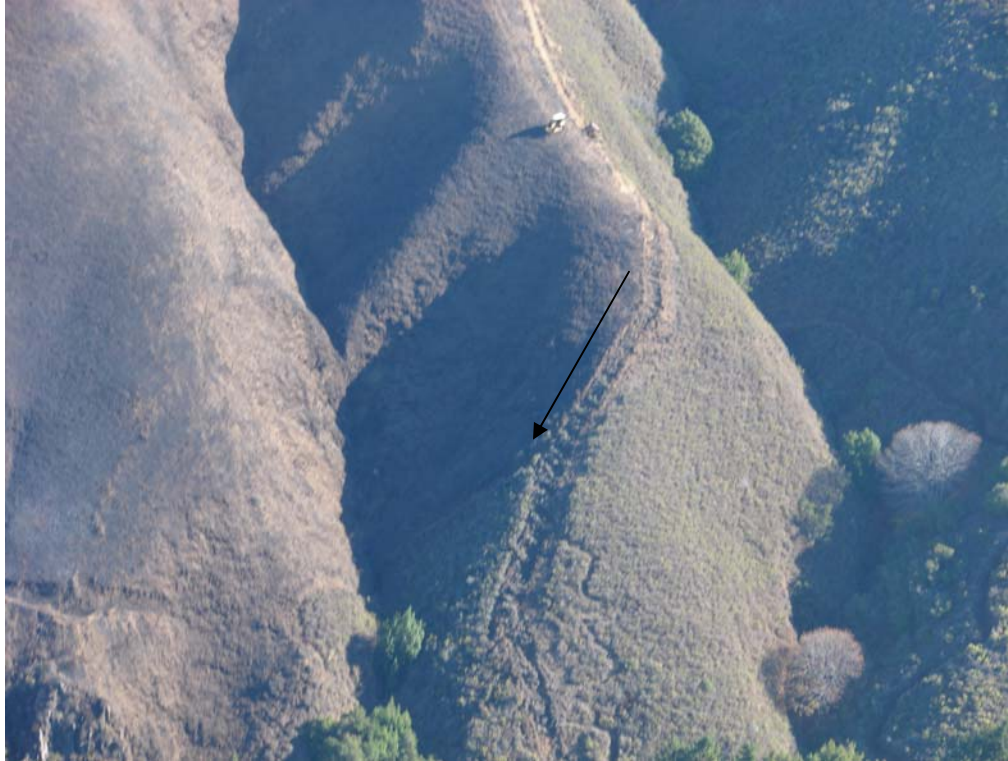
D4641 continued to the bottom of the ridge line on Division S, which is now covered in brush from hand crews doing line rehab. The slope at the bottom portion of this ridge is approximately 85 percent measured by a clinometer. Note the dozer on the right is D4645 and the dozer on the left is D4643 which was used after the accident to anchor D4645.

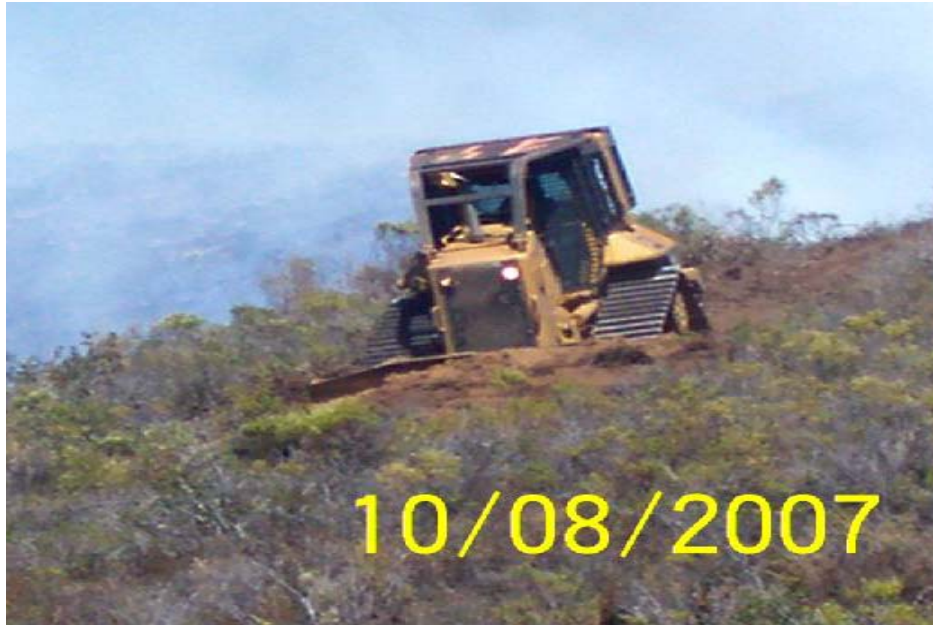
CAL FIRE D4641 during descent on Division S (Note large berm of soil in front of blade)

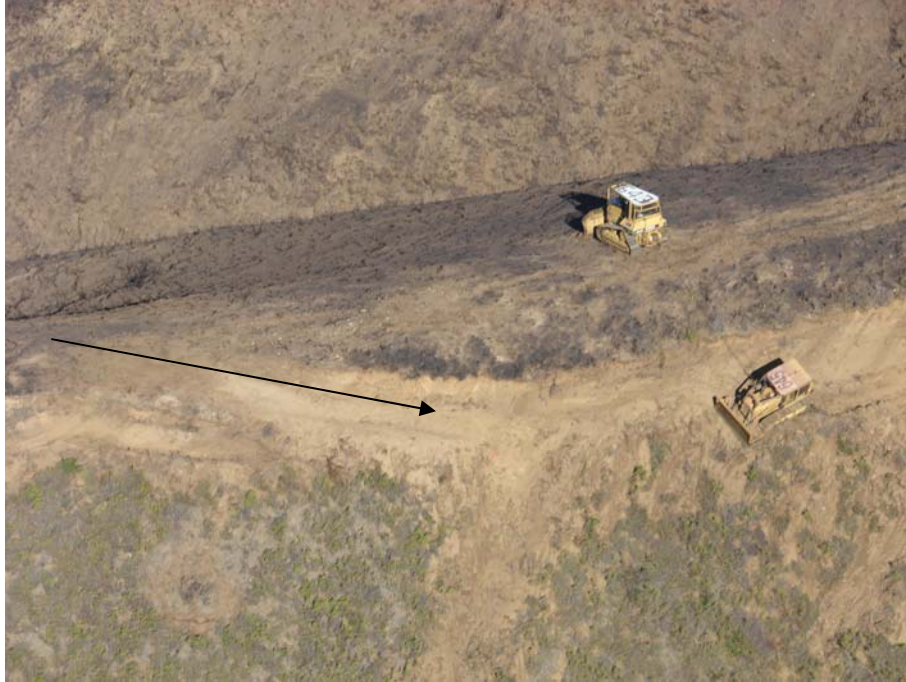
Aerial view of cut bench where D4641 was working towards D4645. Note  
The upper left dozer is D4643 used to anchor D4645 after the accident.

While waiting for the additional dozers to arrive, D4641 proceeded down the spur ridge approximately 100 feet below D4645 and turned around facing towards D4645. D4641 began constructing the bench to solid ground by pushing slough material, some of which went over the side slope.

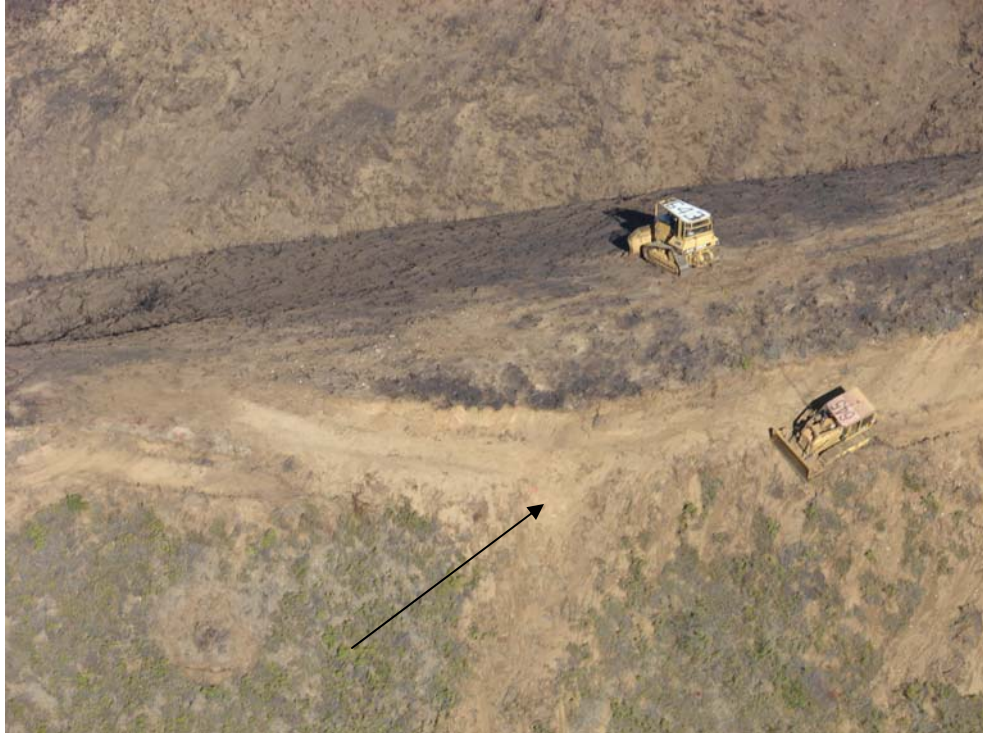
Point where soil became loose and Dozer 4641 started its decent.

D4641 rolled side-over-side 154 feet down a 83 percent to 94 percent slope into a drainage before coming to rest. During the plummet, the glass broke out from D4641's left side window. Towards the bottom of the drainage, D4641, while rolling mid-air, struck a large tree causing it to flip end-over-end. Either the sudden change in rotation caused by the impact or the centrifugal forces of the flipping and rolling pulled HFEO #1 from his seat (while still seat belted by a single lap-belt). The upper left rear of HFEO #1's unprotected head struck the metal mounting bracket of the heavy-mesh brush guard protecting the left side window and loose items in the cab of the dozer struck HFEO #1.

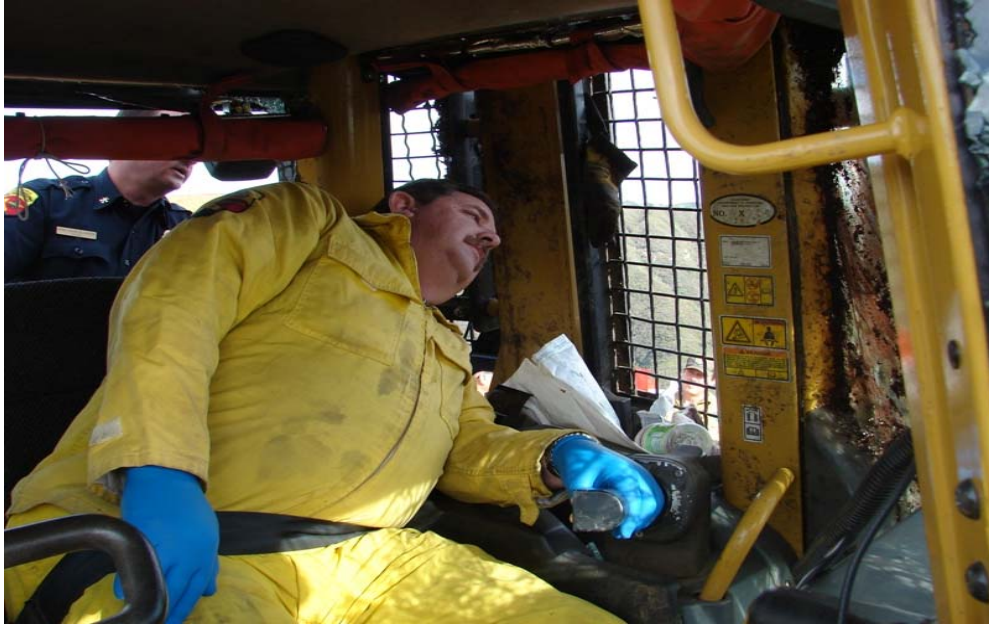
**Simulated movement within cab of CAL FIRE D4641 during rollover**  
(Note single lap belt)

9. HFEO #2 was standing behind and watching HFEO #1 construct the bench.
10. Dozer 4641 was equipped with only a single lap-belt.
11. HFEO #2 did not have portable radio communications (handie-talkie).

HFEO #1 was not wearing a helmet and his dozer was equipped with only a single lap belt restraint system. (Findings # 4, #10, #12, #13, and #14)

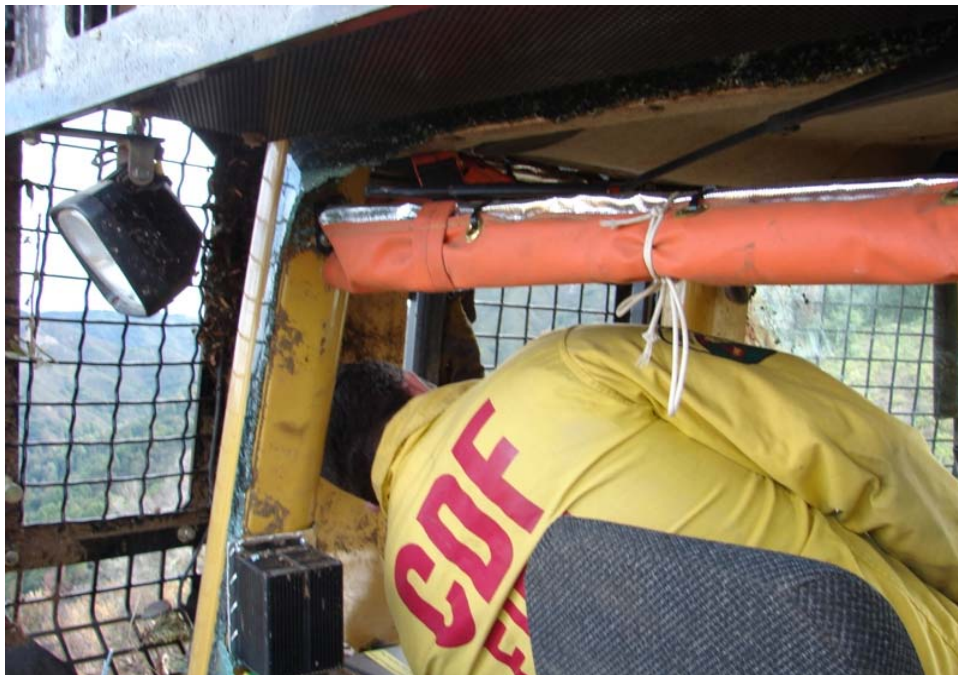
**Simulated movement within cab of CAL FIRE D4641 during rollover**

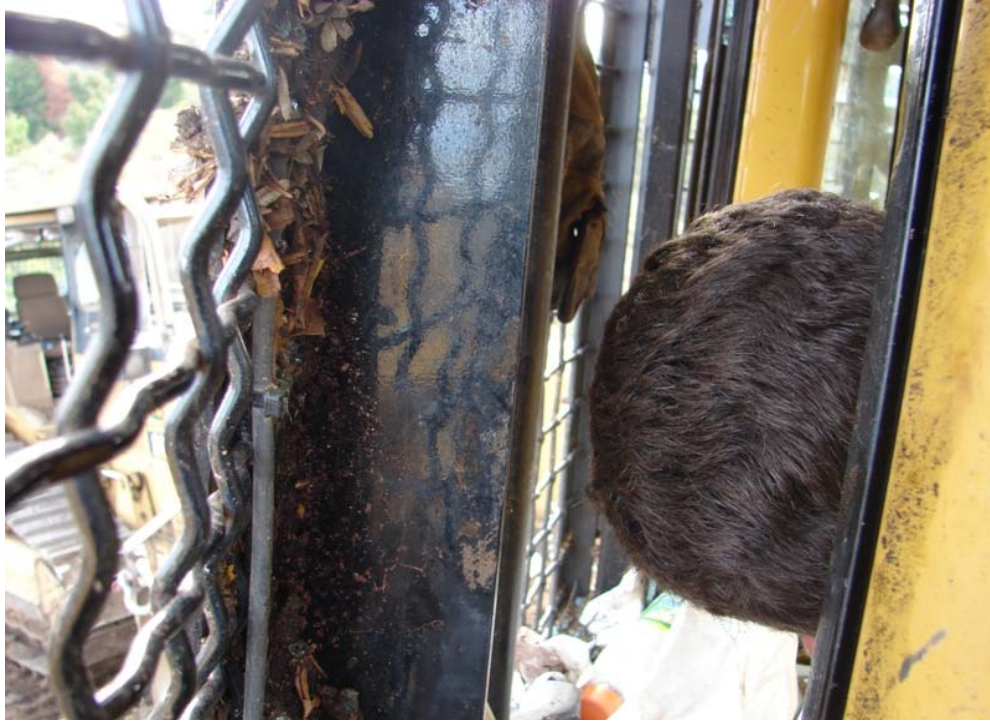
**Simulated movement and impact area within cab of CAL FIRE D4641 during rollover.**

13. Evidence shows that HFEO #1's head made impact with the side of the dozer's brush guard.
14. Evidence indicates the blow to the head penetrated approximately two inches into HFEO #1's skull.
