Davies Creek Ridge Helicopter Mission FLA

The objective of the Davies Creek Ridge Project is to install a weather station in the Upper Davies Creek Valley.

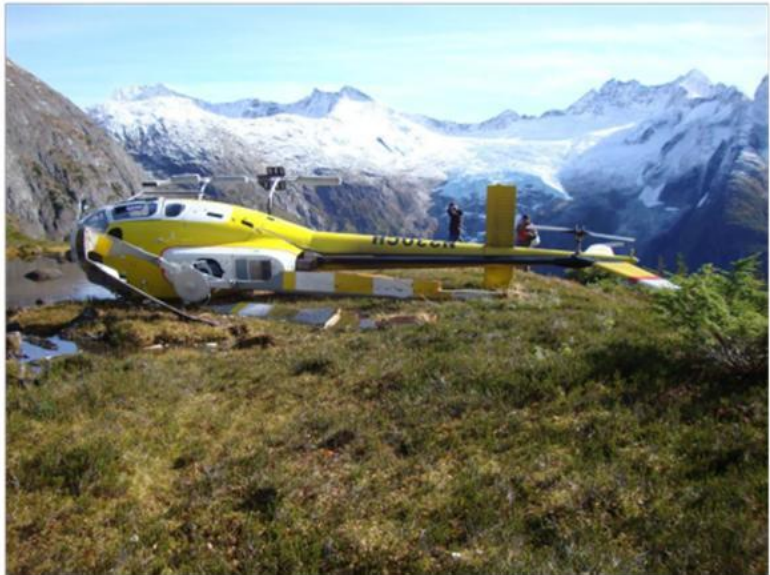
Approx. 1230 hours – Helicopter lifts, rotates, and violently flips over.

During the cool down process, the ship is more vulnerable to the adverse impacts of high winds as compared to during flight speed or at full shutdown. This cool down is a brief but uniquely risky point in time during the flight operation. The lesson learned is that the shutdown/ cool down period has increased risk compared to either flight idle or complete shutdown.

This incident led to several ideas the Tongass National Forest managers *will do next time* and good ideas for managers nationwide. The first is to provide extra emphasis to passengers to keep seatbelts, gloves, and helmets on—until the rotor is nearly completely stopped. Secondly, during this accident, when the rotor blades hit the ground, pieces of the blade and ground debris became deadly projectiles—presenting a serious life threatening hazard to anyone located nearby. We are extremely fortunate that the passengers who were to be picked up were still busy setting up a weather station some 300 yards from the landing zone.
