# Informational Summary Report of Serious or Near Serious CAL FIRE Injuries, Illnesses and Accidents

### County Cooperator Fatality

March 18, 2019

Doster Incident

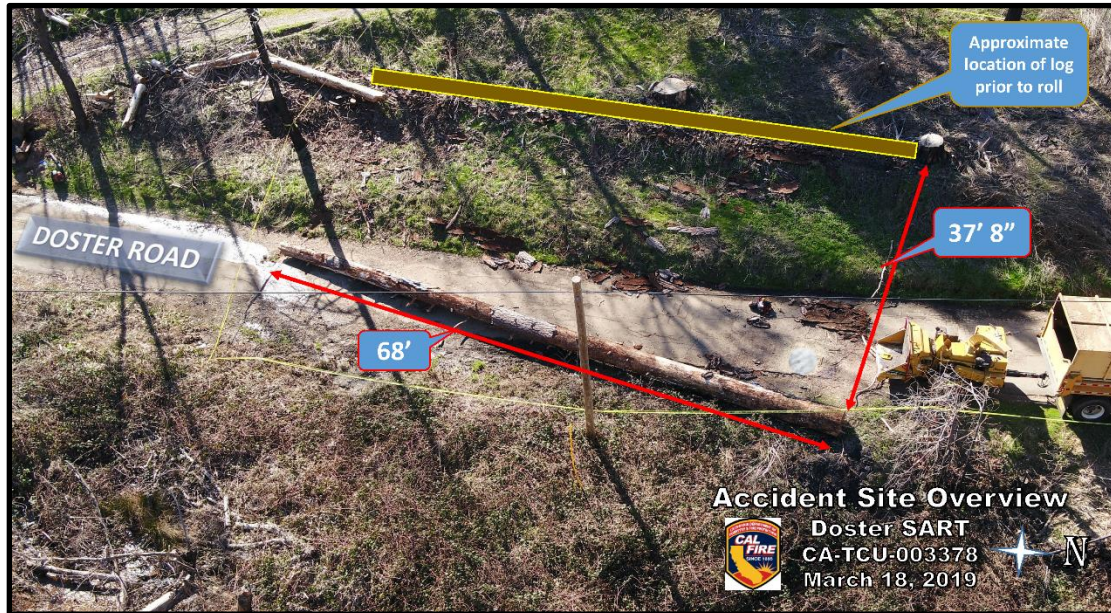
*Picture 1- Aerial photo of accident site*

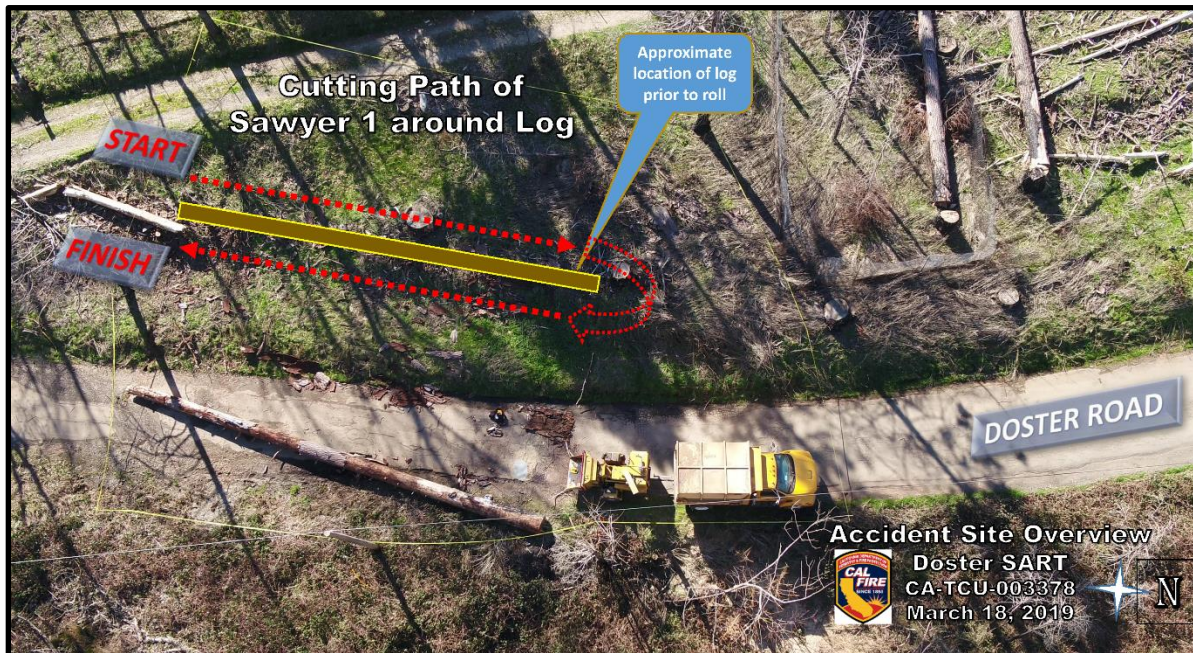
One of the primary objectives for Saw Team 1 was limbing branches off a dead and down Ponderosa pine tree that was felled in the fall of 2018. The tree was not felled by CAL FIRE personnel. The tree was resting parallel to the road, positioned on the outside edge of a small bench that dropped down toward the road. Starting on the uphill side of the tree, Sawyer 1 began cutting branches, progressing from the top of the tree back towards the stump. As Sawyer 1 reached the stump, he transitioned his position to the downhill side of the tree and cut the remaining branches, working back towards the top. Sawyer 1 noticed a number of branches pointed straight down into the soil underneath the log. He did not cut these supporting branches; however, the branches on the downhill side of the log which protruded laterally from the trunk were cut.

Picture 2- Aerial image of Sawyer 1's limbing route around log (Ponderosa pine)

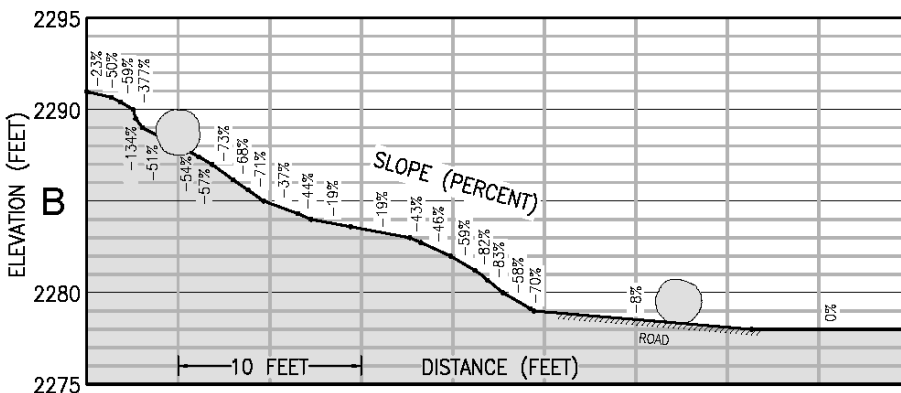
The log gained momentum as it traveled downhill. Within seconds, it advanced into the roadway. At the same time, Cooperator 1, who was on the road assisting crew members feed the chipper, turned to his left, looked uphill towards the log and quickly put his left arm out to brace for the impact. As the log hit Cooperator 1, the butt of the tree rose up and hit a crew member (Crew Member 1) in the back who was feeding the chipper. Crew Member 1 was not able to hear the verbal warnings because he was wearing earplugs and the noise of the chipper. Crew Member 1 was pushed away from the chipper and downhill off Doster Road. The log ultimately came to a stop on top of Cooperator 1.

Figure 1- Elevation and percent slope profile showing approximate position of log on slope and final resting place on Doster Road. Branches and slash would have been located uphill and downhill of log.

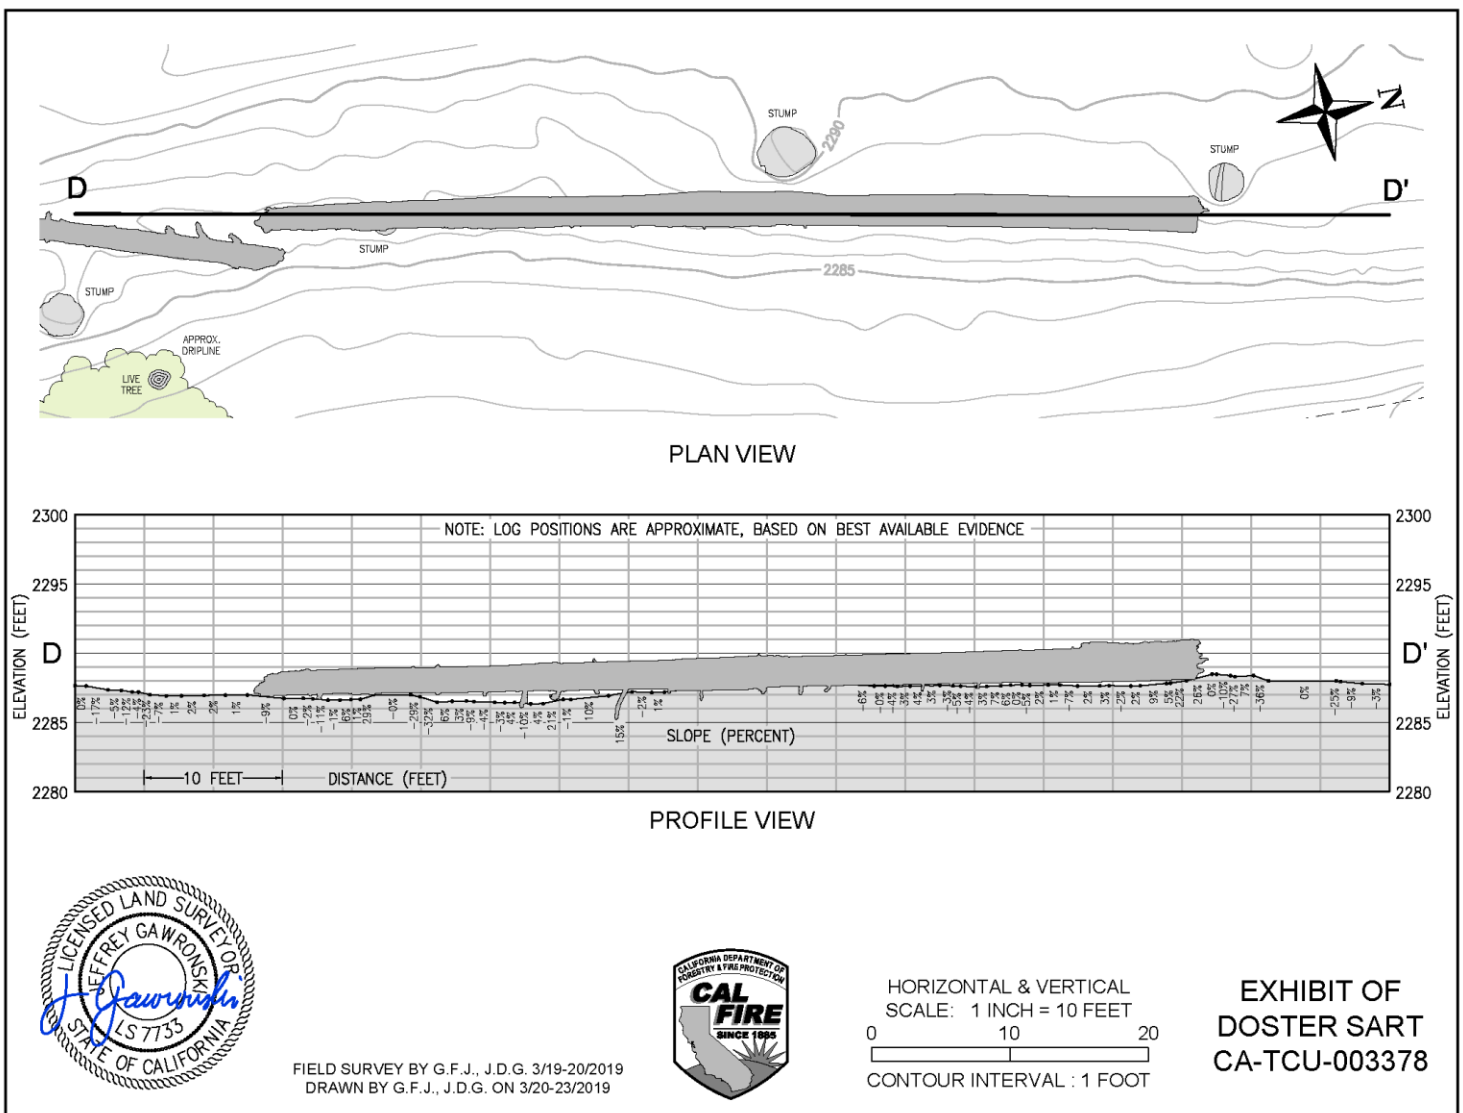
### LIDAR PROFILE VIEW OF ACCIDENT LOCATION

*(Profile view shows approximate position of log on slope prior to rolling downhill)*

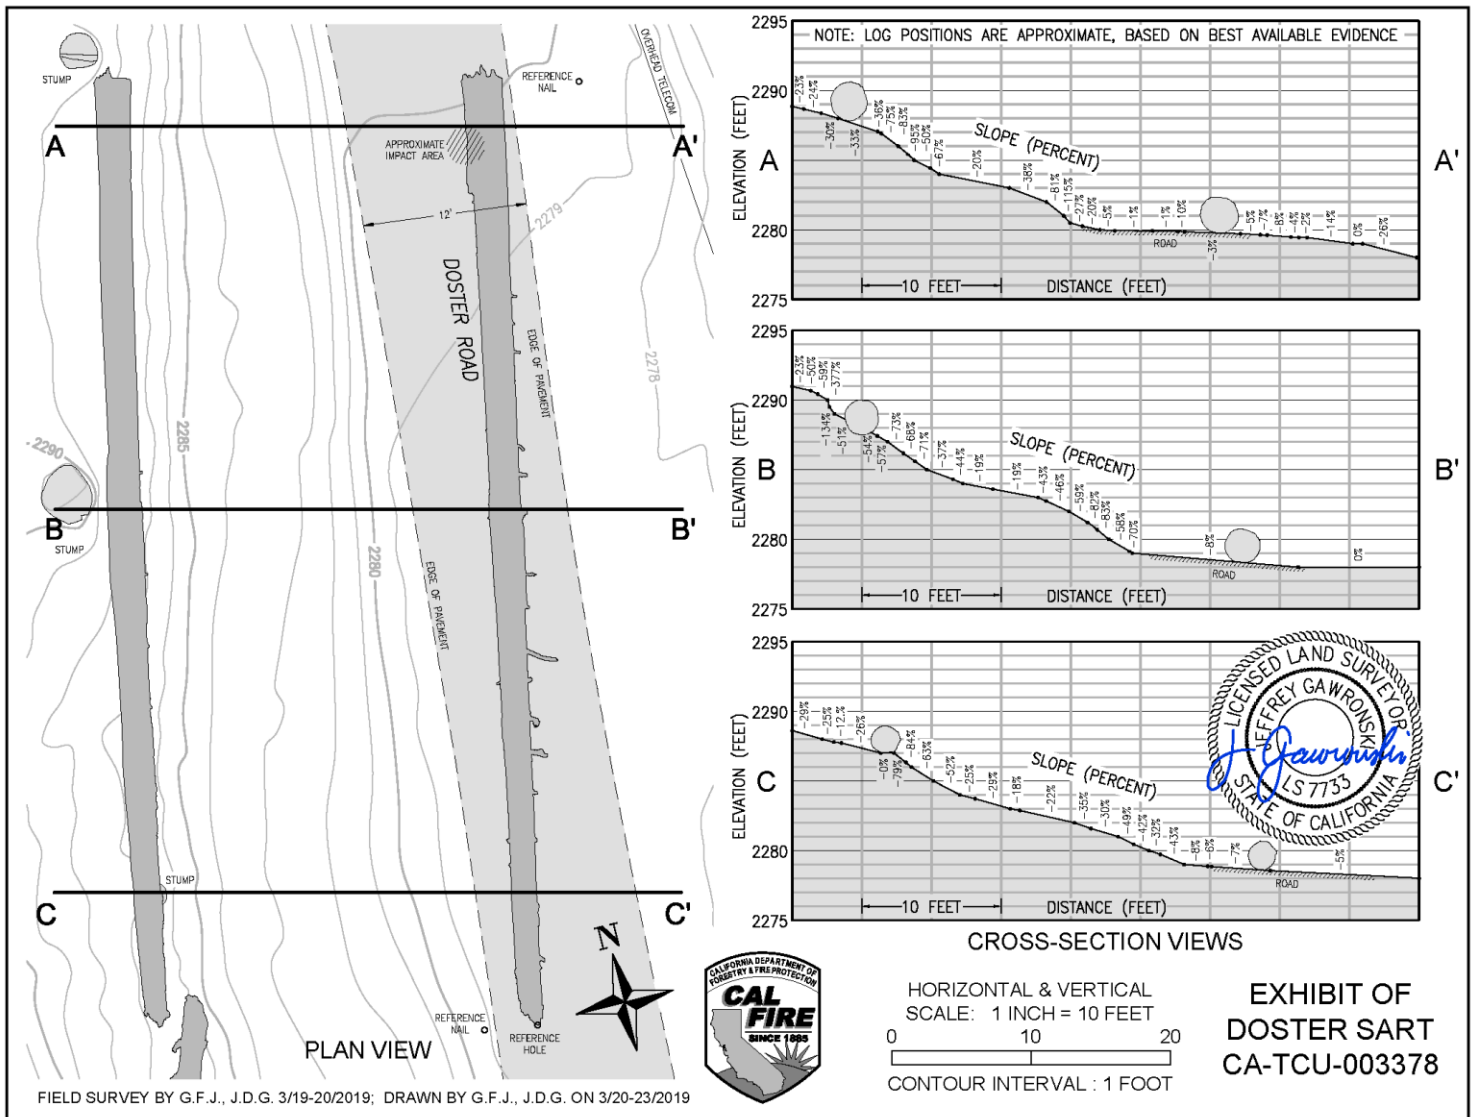
## LIDAR CROSS SECTIONAL VIEW OF ACCIDENT LOCATION

*(Cross-Section view shows approximate position of log on slope prior to rolling downhill as well as resting location of log on Doster Road)*

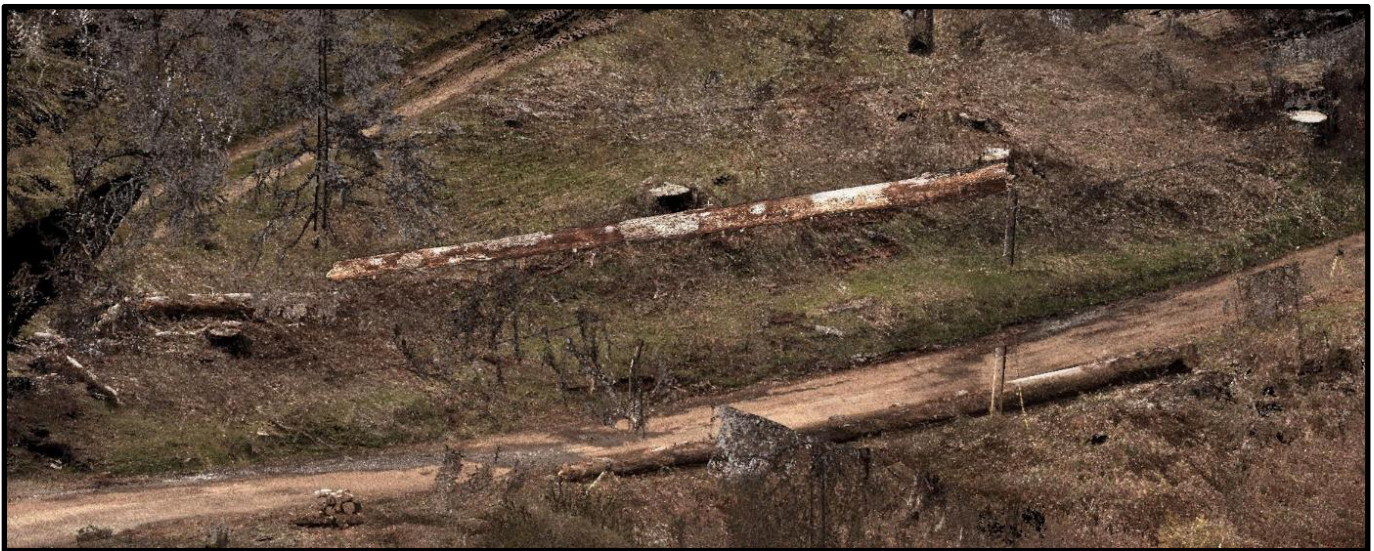
## **LiDAR DATA SCENE RECONSTRUCTION**

***(Approximate location of log on hill above Doster Road)***
