# **Redwood Engine 30 Vehicle Fire**

## **Non-Serious Accident Investigation**

### **Lessons Learned Review**

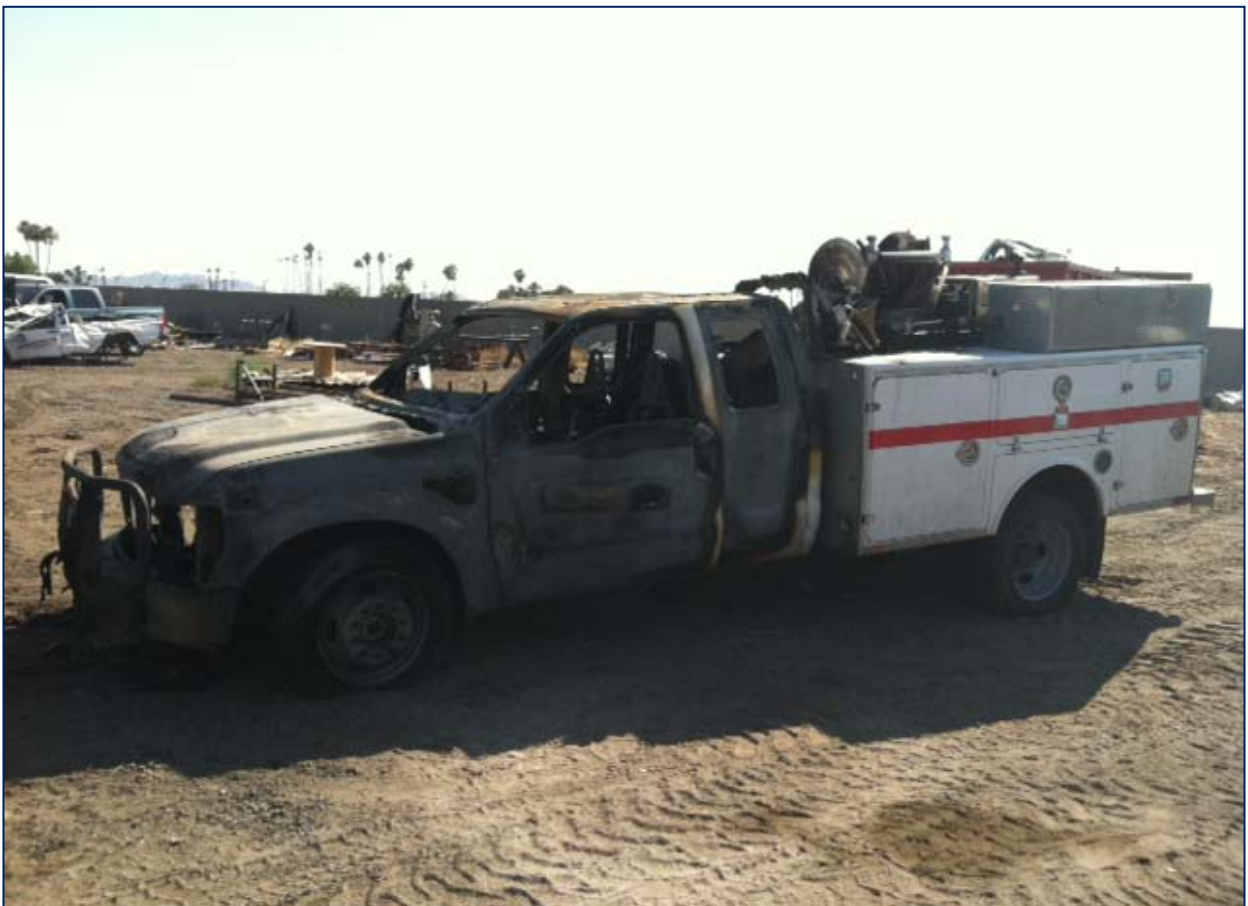
**Redwood Engine 30 after the vehicle fire incident.**

- All of cab—including wiring and electrical—was completely destroyed by fire.
- Front right tire was destroyed. All other tires remain intact (although the right rear outside dual was off the rim).
- Exhaust system—including Diesel Particulate Filter—remains intact with little damage.
- First section of the rear drive shaft is entirely split and spread wide open.
- Rubber components of the idler bearing on the rear drive shaft are melted.
- Components to the rear of the transfer case appear to have suffered far less fire damage than the front and right half of the vehicle.
- Four-wheel drive was not utilized while the vehicle was on assignment.

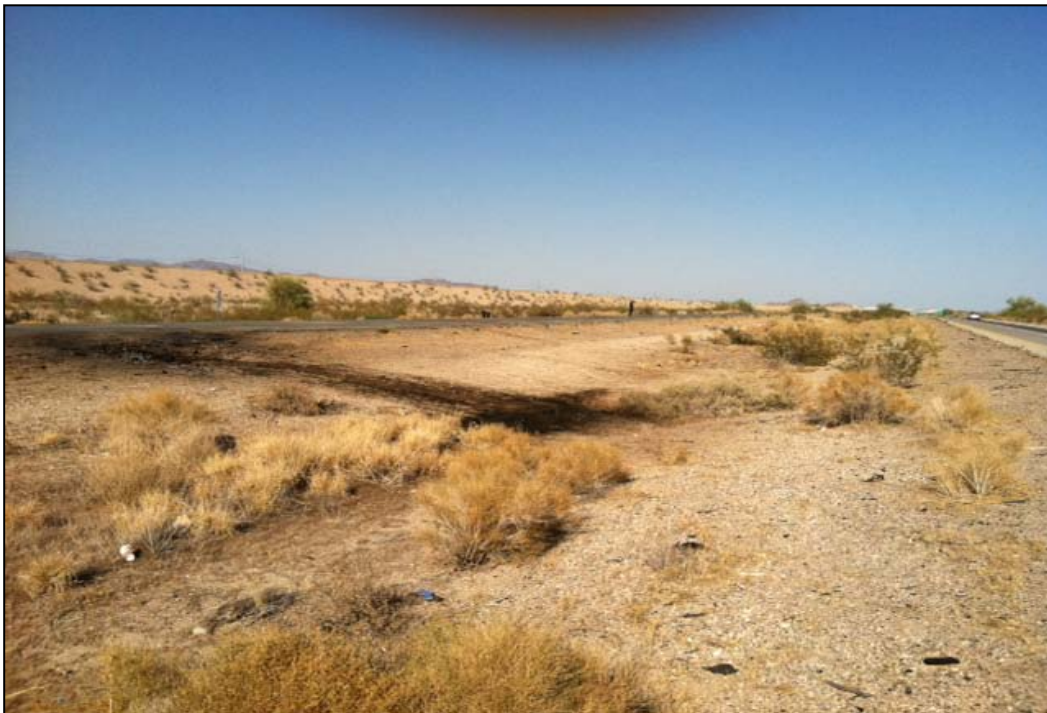
***Burn Scorch Area***  
*– The Interstate 10  
median space  
where Redwood  
Engine 30 burned.*

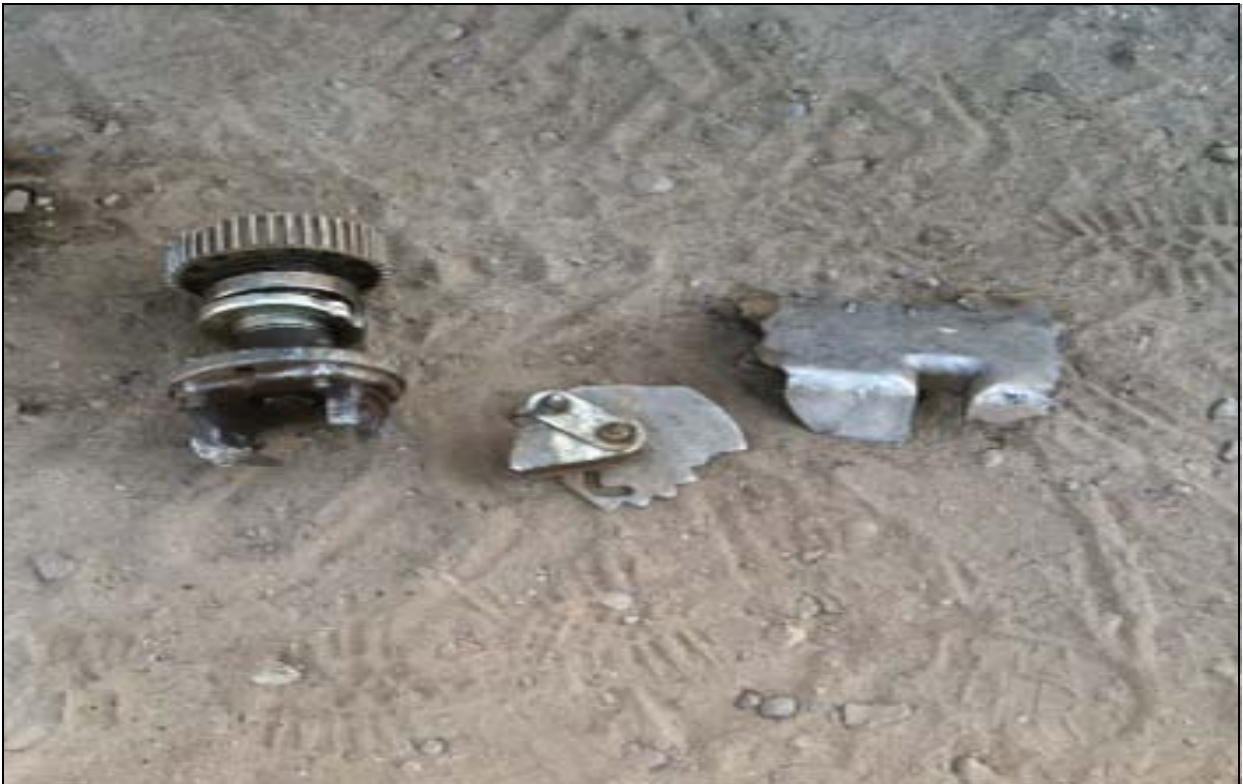
- After loud noise was heard, vehicle began to drive rough with mechanical parts falling to roadway from underneath vehicle.
- Drive train parts (specifically the transfer case) were found on roadway with no burn/charred marks.

- The transfer case was fully destroyed/disintegrated.

*Drive train parts found on the roadway.*

1. Ensure daily preventative maintenance checks occur. Include checking manual or combination auto/manual locking hubs to ensure that they are in the proper position.
2. Ensure preventative and maintenance checks are performed regularly and documented.
3. Visually inspect and determine the transfer case and front hub engagement methods.
4. Operation of vehicle should be in accordance with the owner's manual.
5. An understanding of the various types of accident investigations/reviews, their purpose, and who is responsible would streamline information gathering and timeliness of distribution of lessons learned.

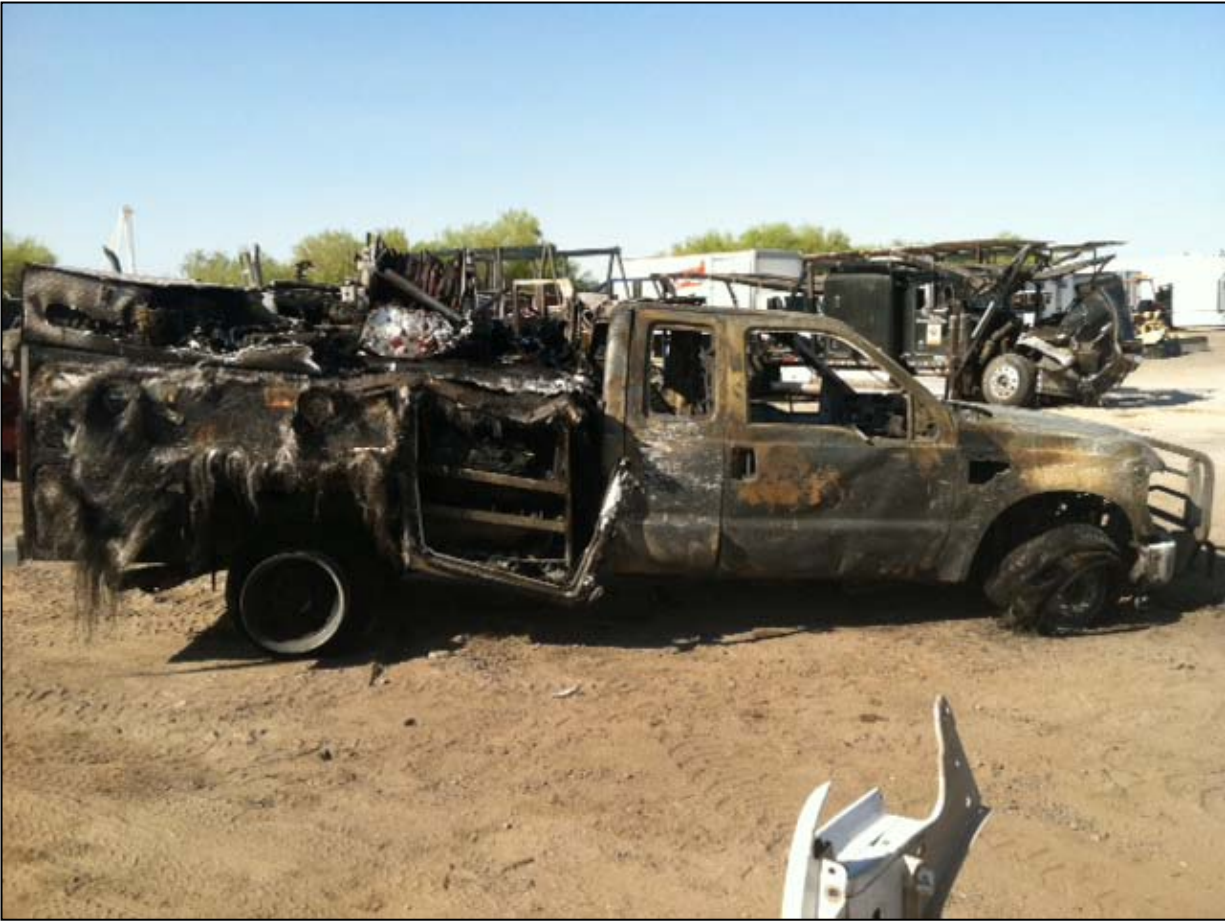
*Redwood Engine 30 at the Arizona tow yard.*

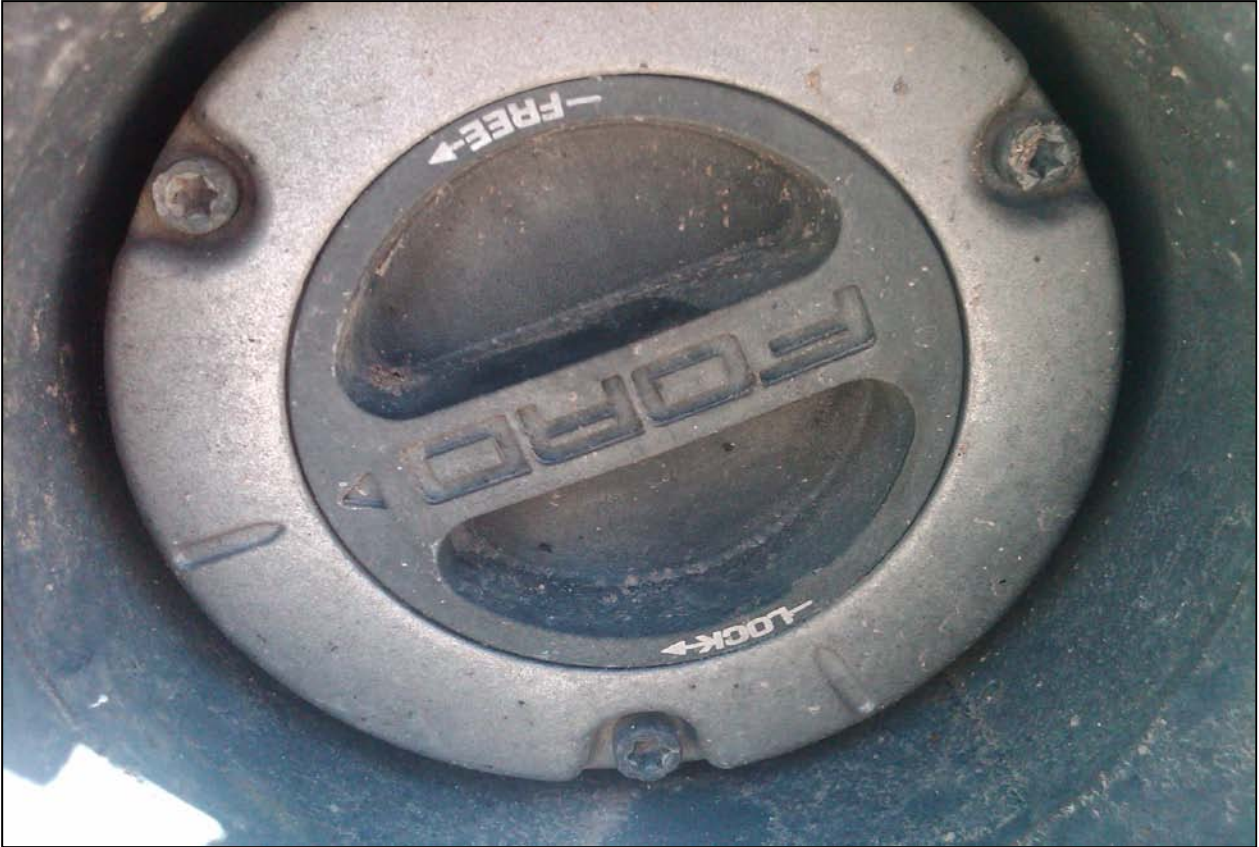
*Locked Hub*

- The left front hub was found in locked position.
- The right front hub was damaged in the fire. Therefore, its position could not be visually determined.

Four-wheel drive was not utilized over the course of the incident. However, the left front hub was found in the locked position.

When four-wheel drive is disengaged, power from the transmission is not applied to the front drive train components. However, if the front four-wheel drive is disengaged and the front hubs are locked, the front drive train will spin whenever the vehicle is in motion.

Allowing the front axles and driveshaft to spin unnecessarily decreases fuel efficiency, causes unnecessary wear and tear, effects handling, and decreases performance. This causes unnecessary dangers and can lead to severe damage—and possibly fatal injuries. It is therefore important to follow the manufacturer's recommendation and ensure that front hubs are not locked if four-wheel drive is not engaged.
