## **Accident Investigation Factual Report**

Snag Falling Accident  
Frank Church WFU – Missouri Ridge Fire  
Payette National Forest, Krassel Ranger District  
Intermountain Region  
McCall, Idaho

**Accident:** Frank Church WFU – Missouri Ridge Fire  
Snag Falling Accident

**Date of Accident:** September 6, 2005

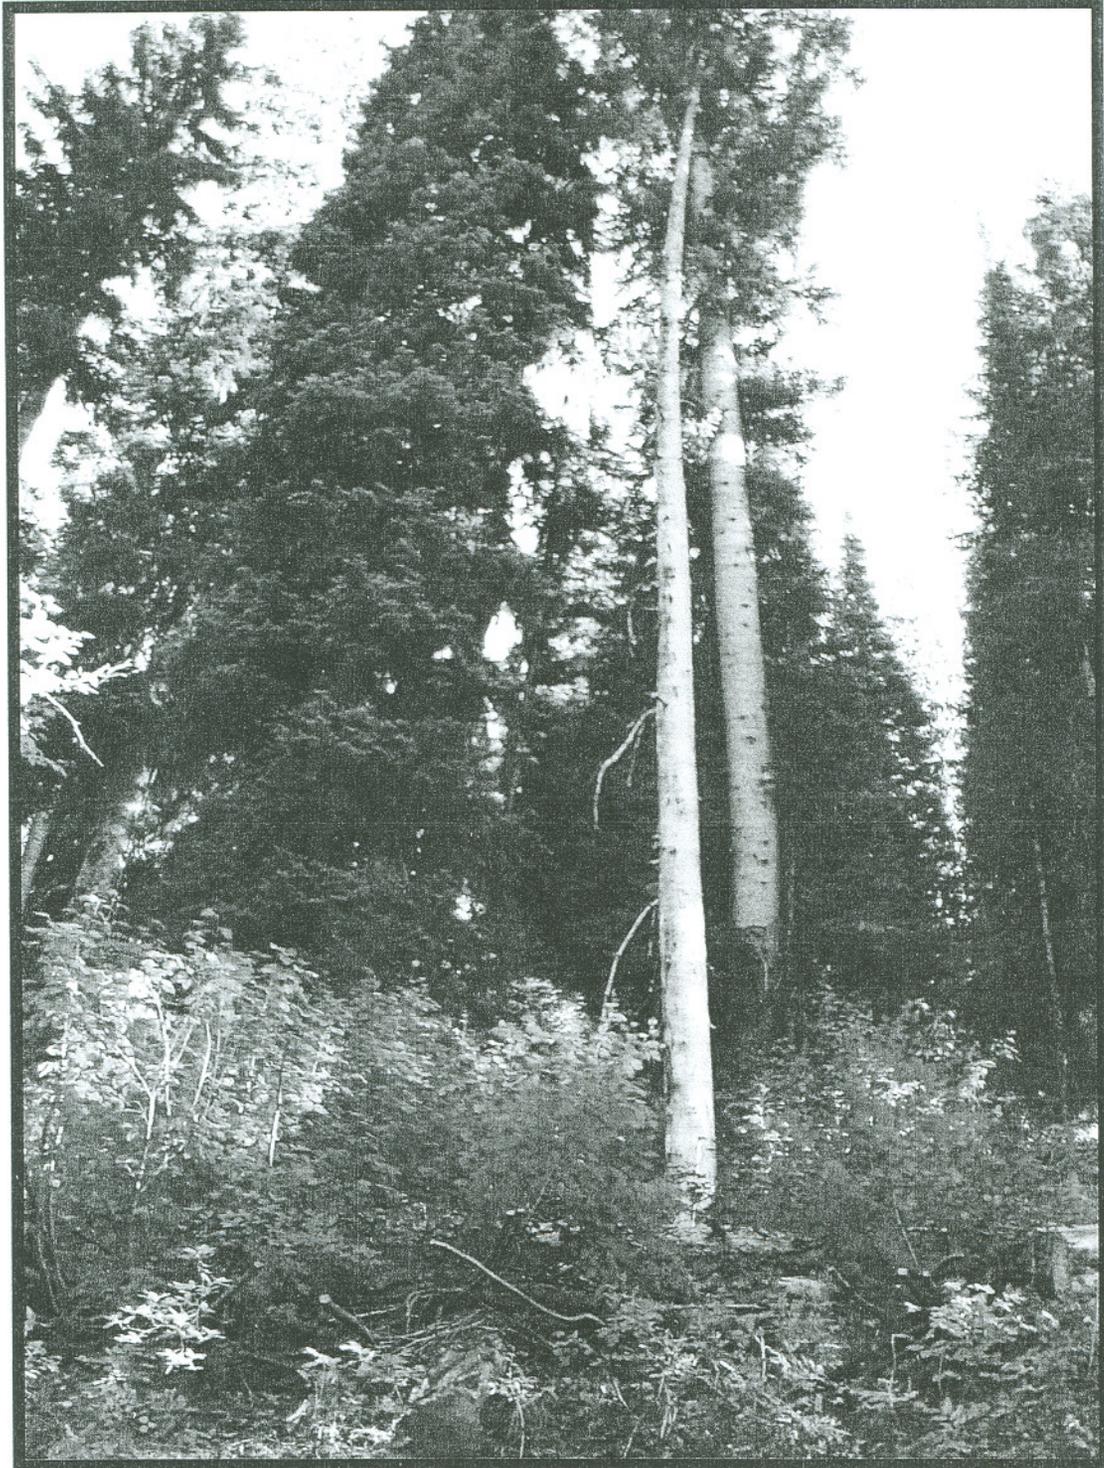
*Photograph 1*

Post accident photo of snag looking uphill.

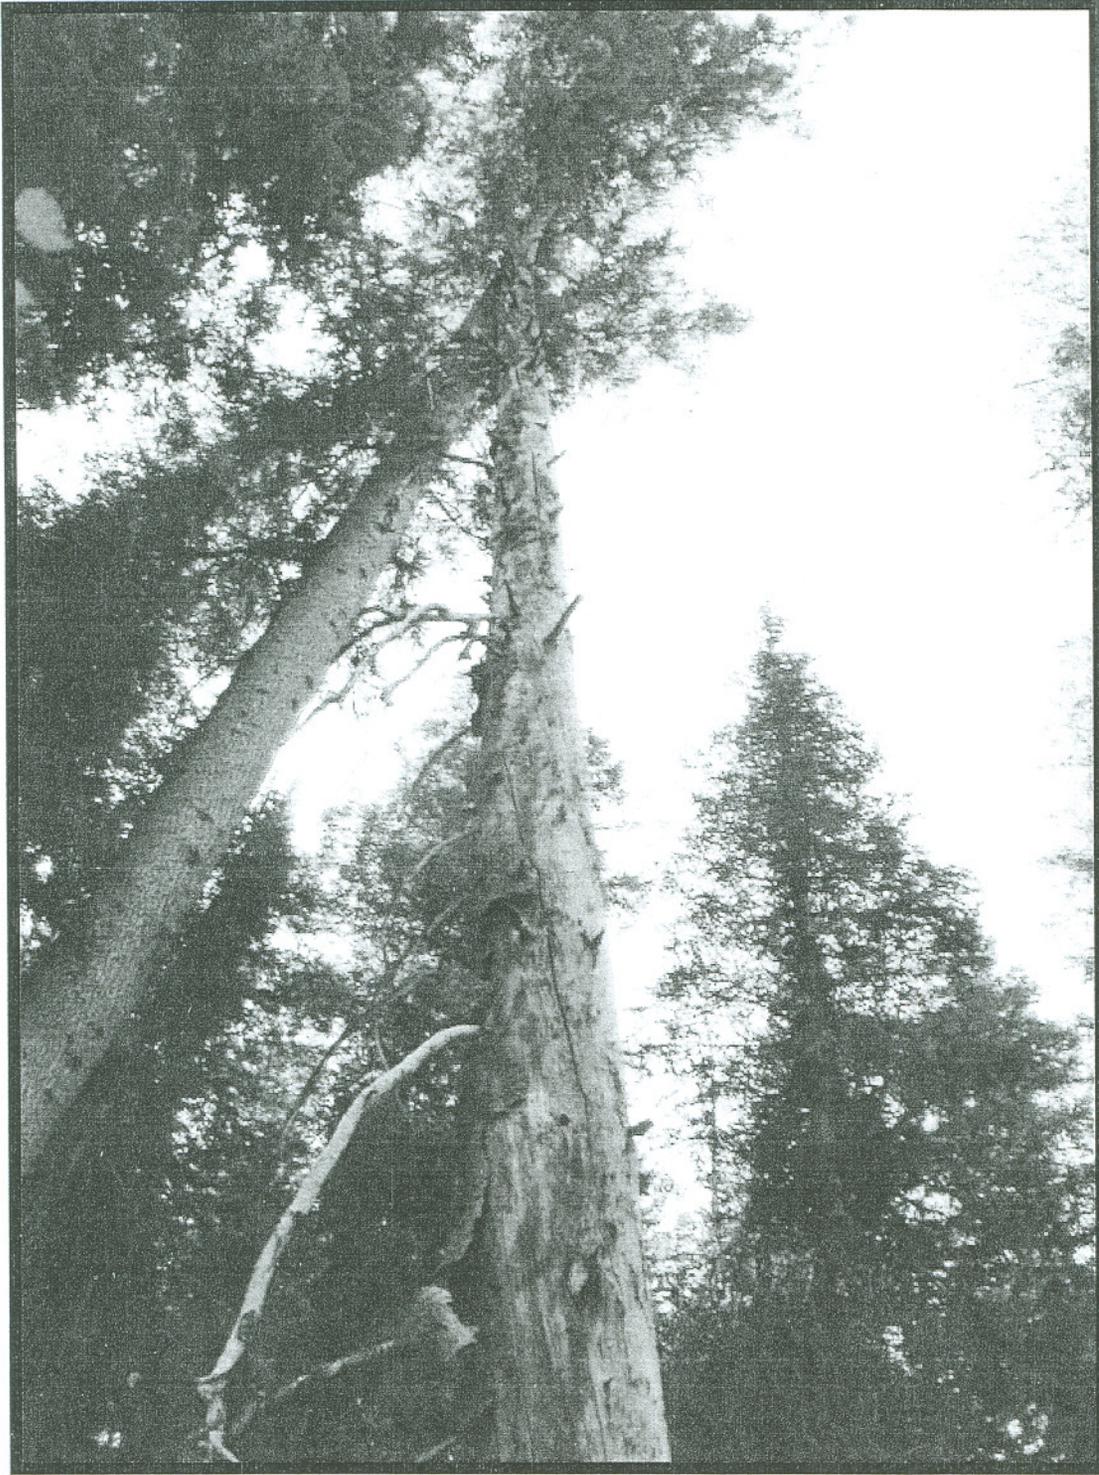
*Photograph 2*

**Post accident photo of snag showing limb and hung-up top.**

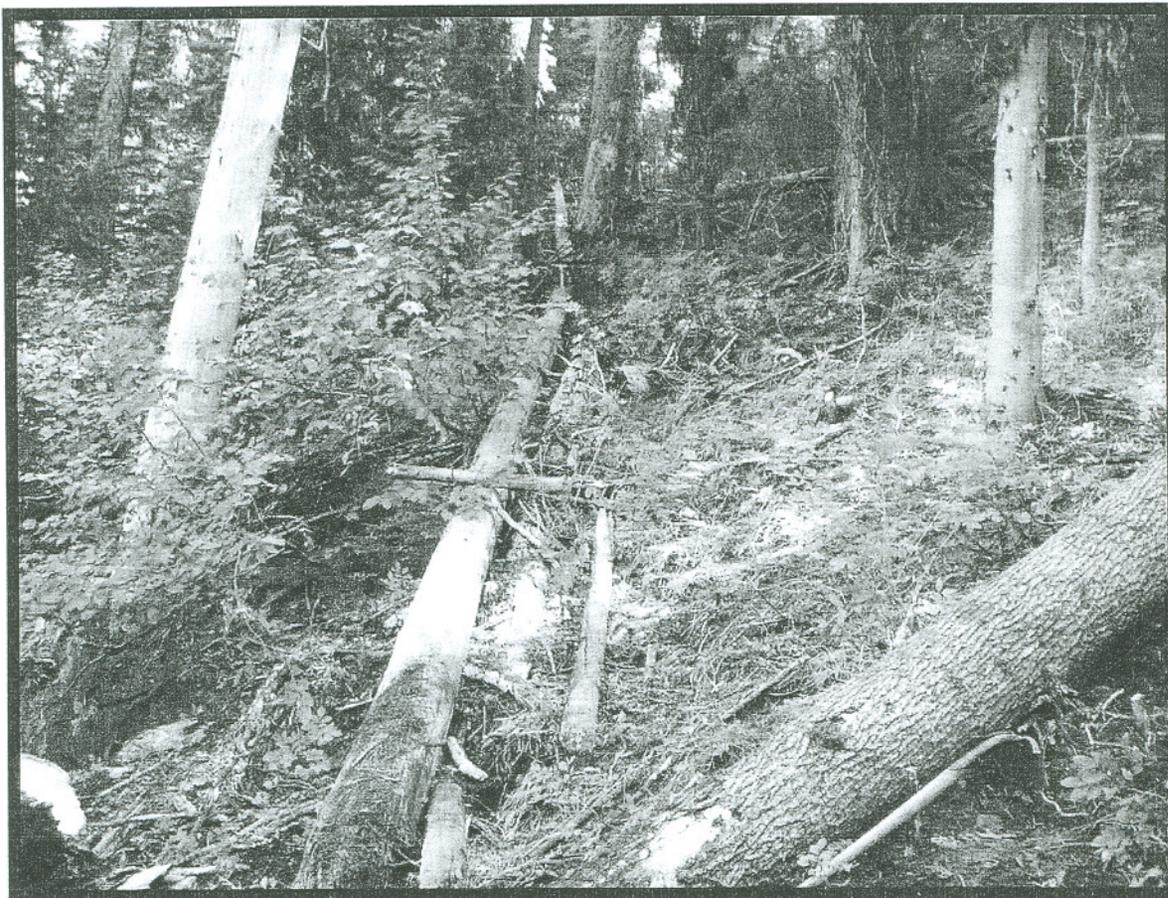
*Photograph 3*

**Accident site showing ground fuels, slope, and broken snag top.**

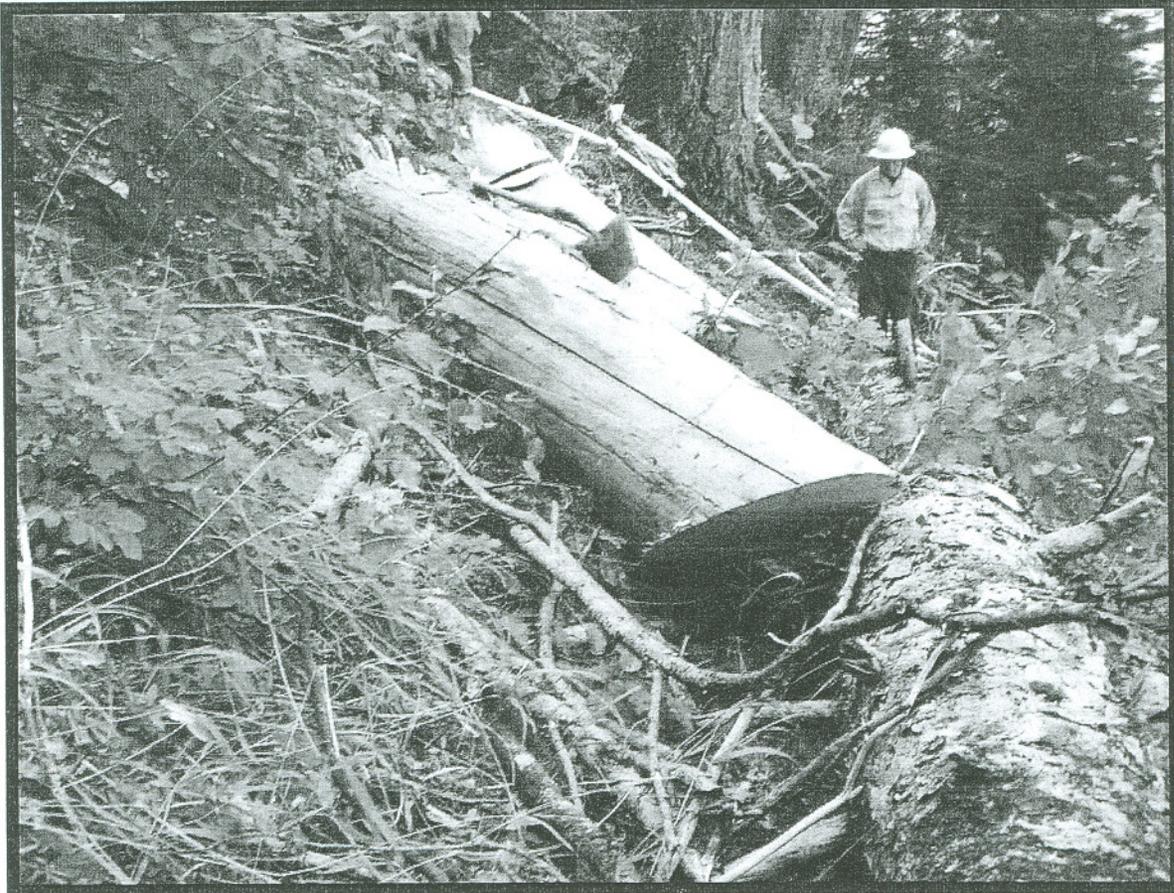
*Photograph 4*

**First and second sections cut from base of snag.**

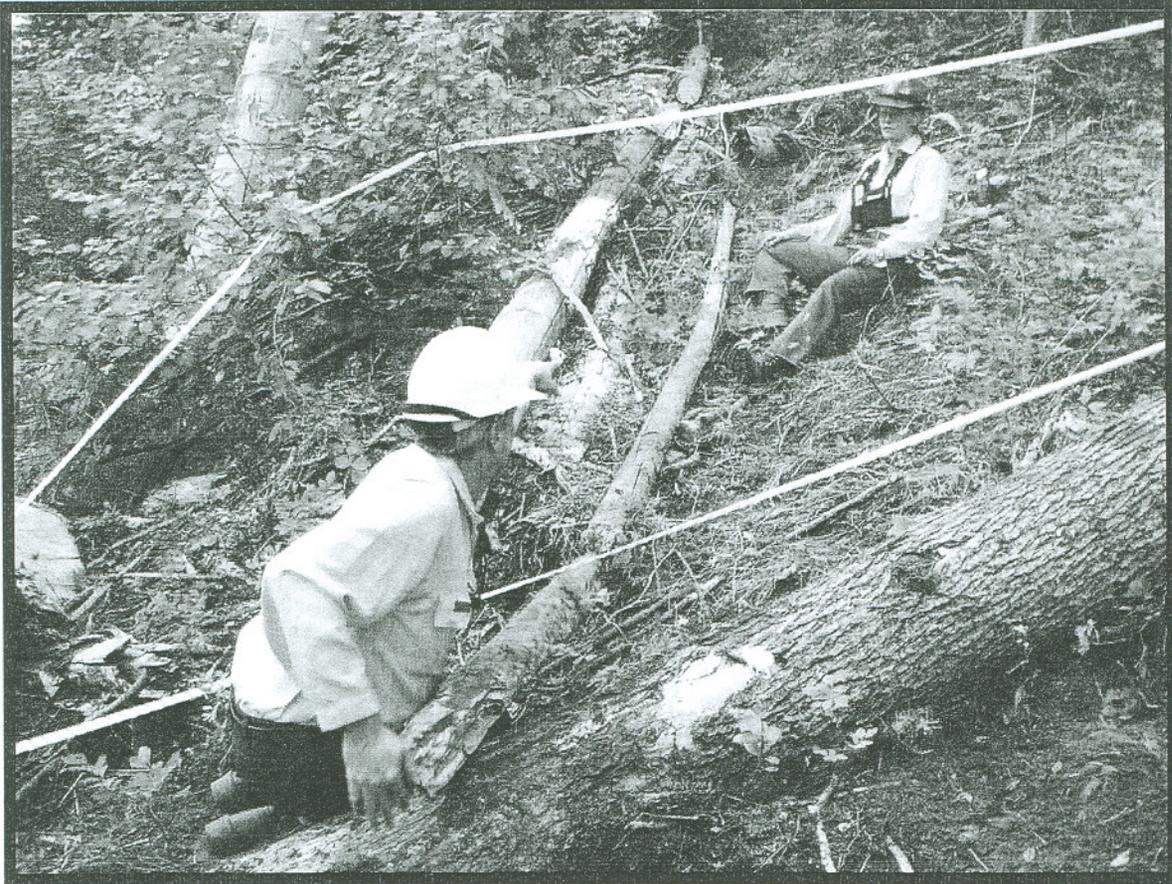
*Photograph 5*

**The 20-foot long broken top that struck the sawyer. Person in red hardhat in a sitting position is shown in the location where the sawyer was struck.**

3. The spruce snag that struck the sawyer was: predominately barkless with limited branches in the upper/upslope portion of tree; 21 inches in d.b.h. and 120 feet tall; mostly solid and sound and appeared to have been dead for a long time; had a rotten root system that naturally caused it to lean/fall/hang-up in an adjacent larger (34 d.b.h.) live/green Douglas-fir tree; leaning upslope (approximately 15-20 degree angle) into the larger/taller fir tree located approximately 28 feet directly above on the slope; defective at the top where it broke off; the size of the piece that struck him was 20 feet long, 6 inches in diameter at large end, and weighted 41 pounds. (RF-23)

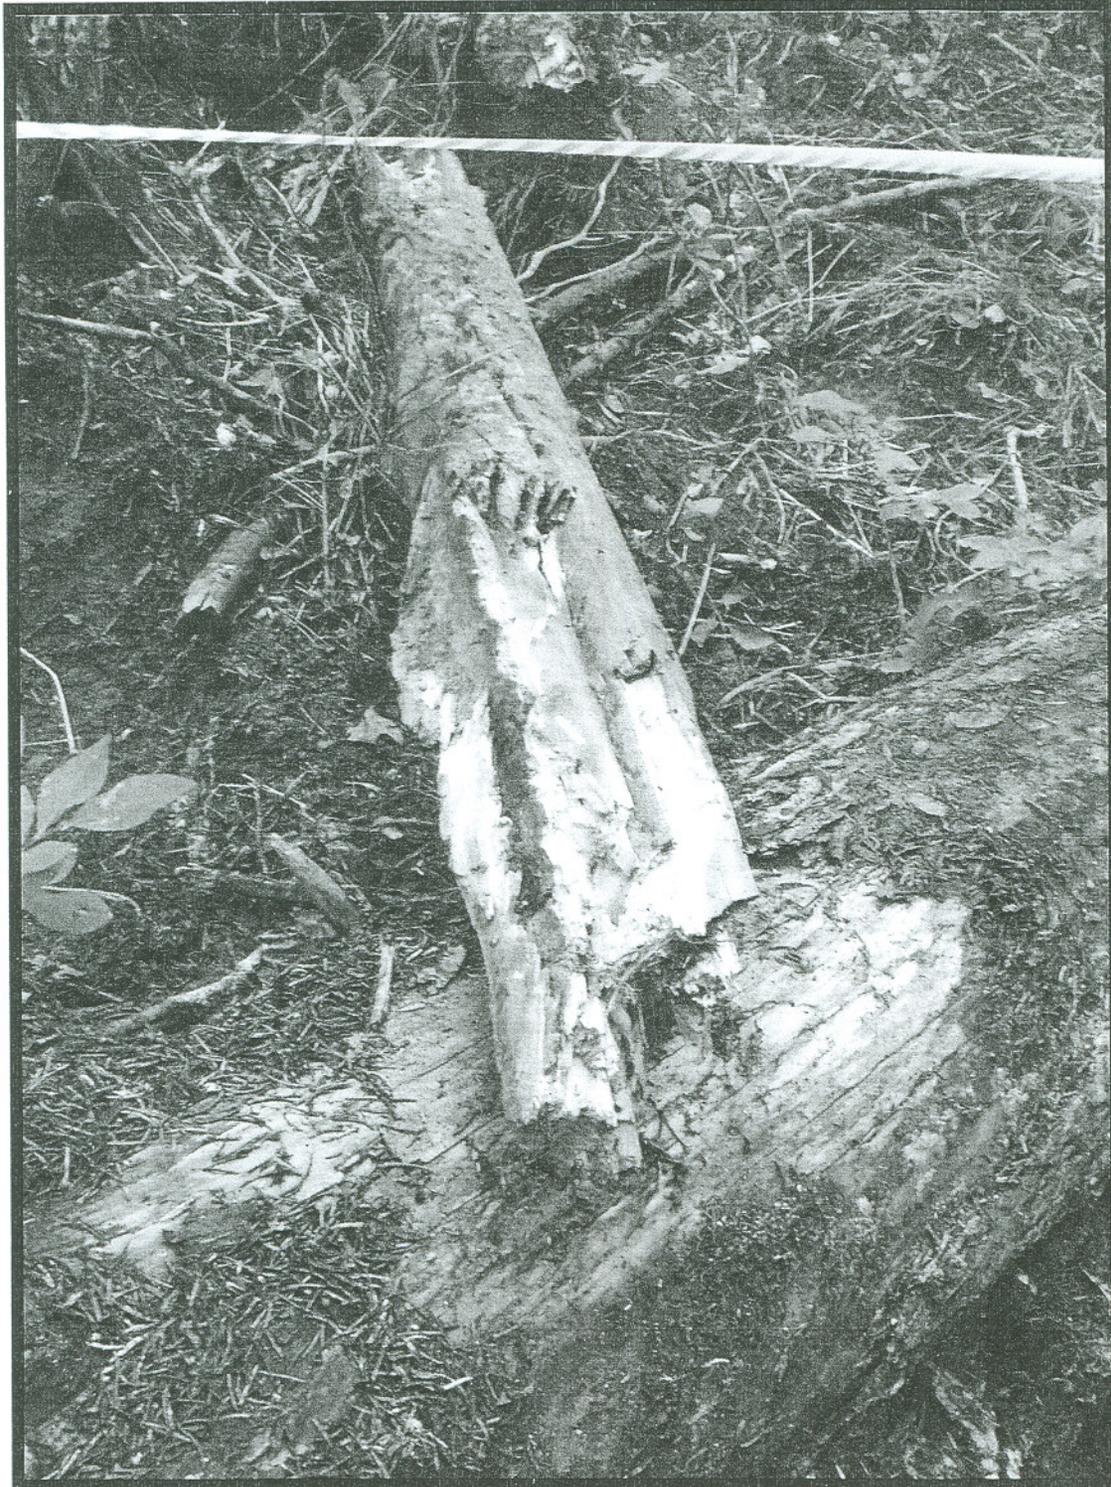
*Photograph 6*

The material from the base of the snag to upper portion was mostly solid and sound. The snag had a rotted root system which caused it to lean into an adjacent larger (34 d.b.h.), taller live green Douglas-fir tree. The snag was leaning upslope (approximately 15-20 degree angle) into the fir tree located 28 feet directly above on the slope. The material/wood at the location where the top broke off the snag was defective.

Close up of material defect in the top where it broke off the snag.

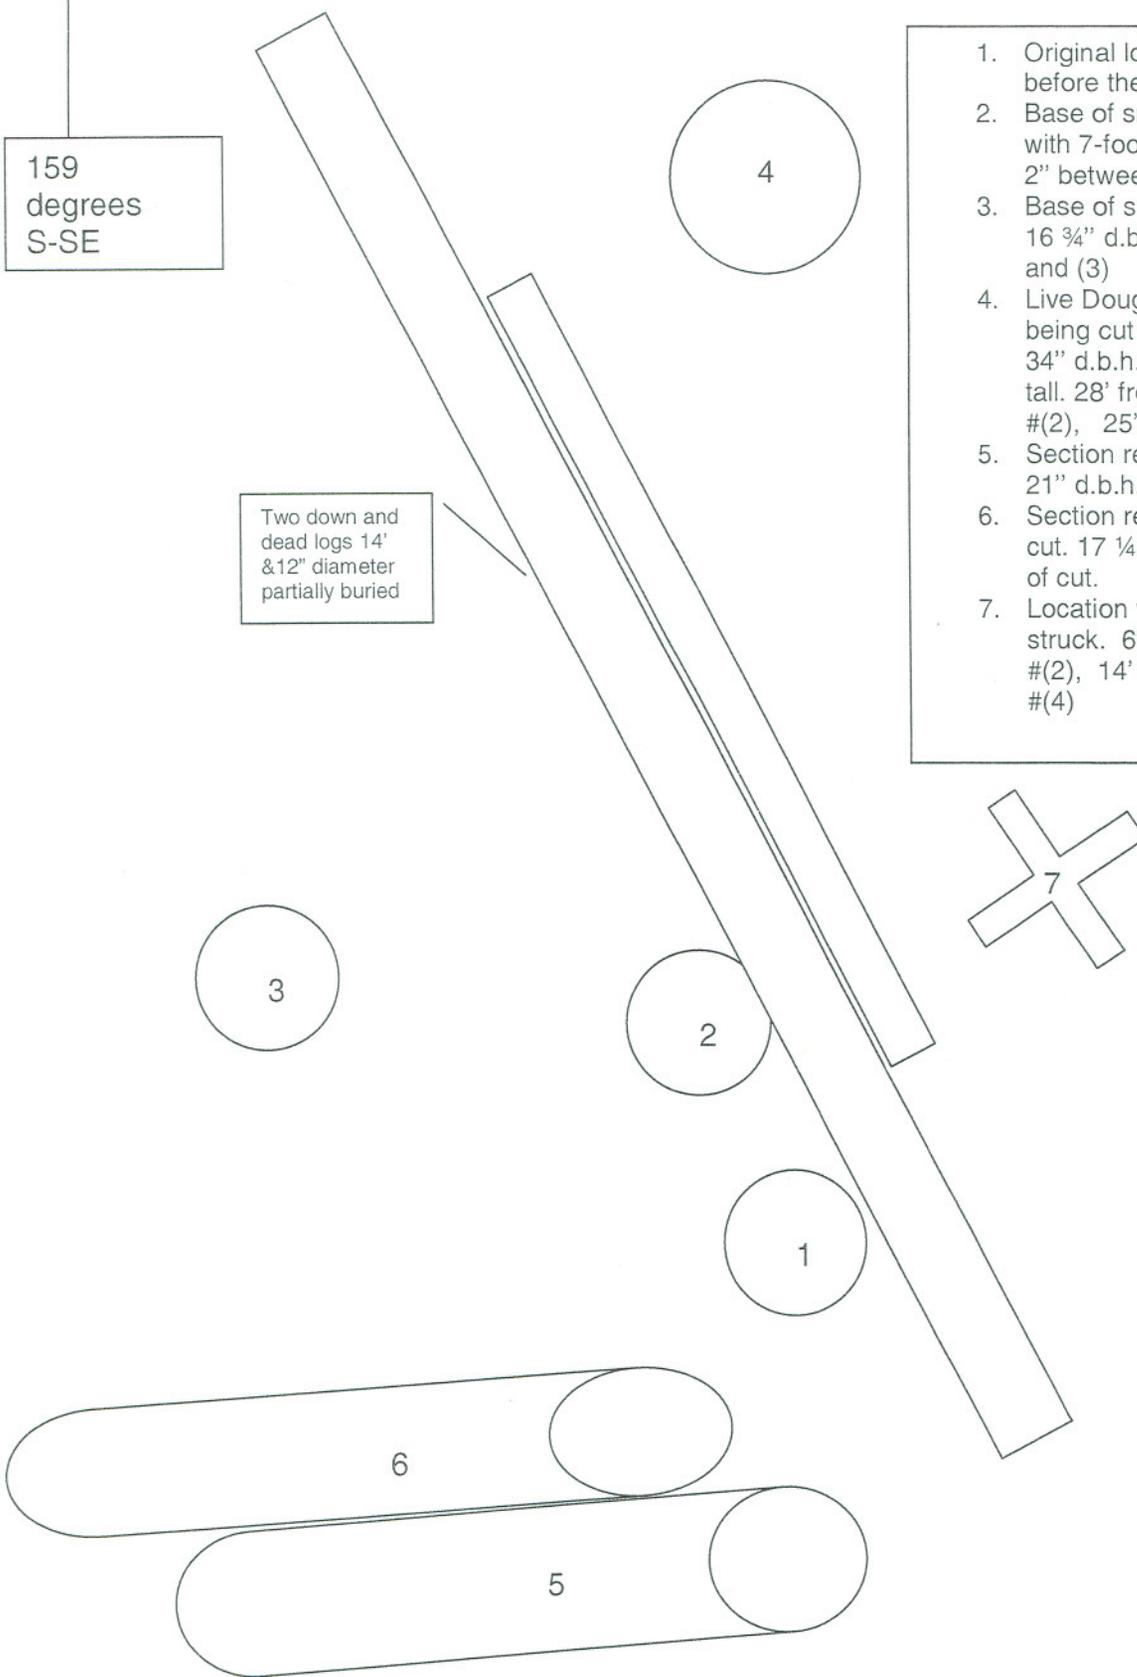
Sketch diagram of cutting sequence

1. Original location of snag base before the first cut
2. Base of snag after the first cut with 7-foot section removed. 4' 2" between (1) and (2)
3. Base of snag after second cut. 16 3/4" d.b.h., 7' between (2) and (3)
4. Live Douglas-fir that snag being cut was hung up in. 34" d.b.h. approximately 110' tall. 28' from #(1), 25'4" from #(2), 25' from #(7)
5. Section removed after first cut. 21" d.b.h., 7' long
6. Section removed after second cut. 17 1/4" diameter at height of cut.
7. Location where sawyer was struck. 6' from #(1), 5'6" from #(2), 14' from #(3), 25' from #(4)

31. The sawyer's second step-down cutting effort resulted in an 8-foot section going to the ground at the same time the top snapped back and fell. (RF-21 and 29)

32. The sawyer was struck approximately 6 feet from where the snag base was positioned when it was cut. (RF-21 and 29)
33. In the time it took the swamper to shout the sawyer's last name twice (about 3 seconds) the top fell and struck the sawyer who was not looking up and did not hear the warning. (RF-21)
