**Preliminary Summary Report of Serious or Near Serious CAL FIRE  
Injuries, Illnesses, Accidents**

# GREEN SHEET

## **MVU Fire Captain Injury**

**Grade Project**

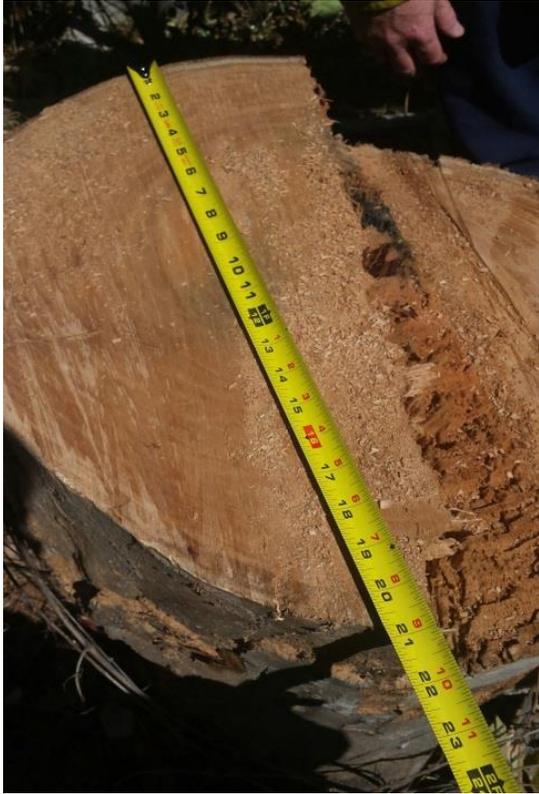
21" Stump

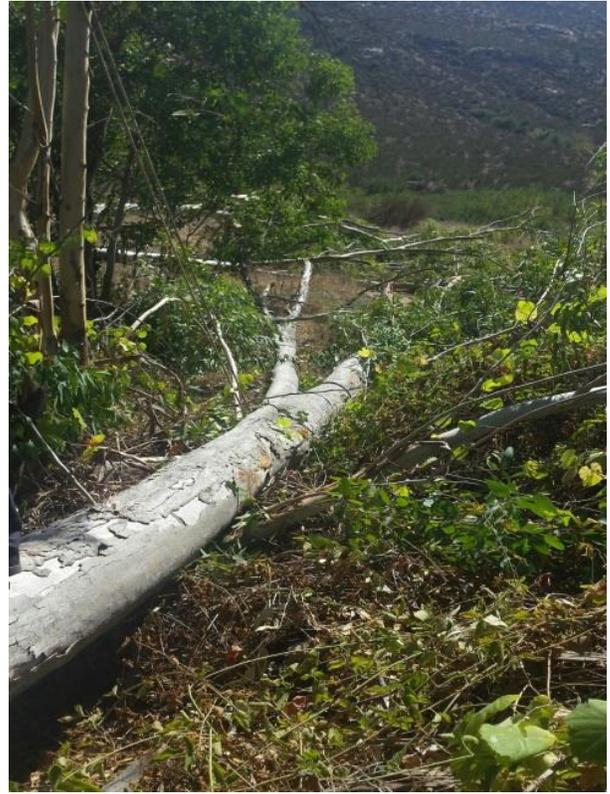
Fallers view

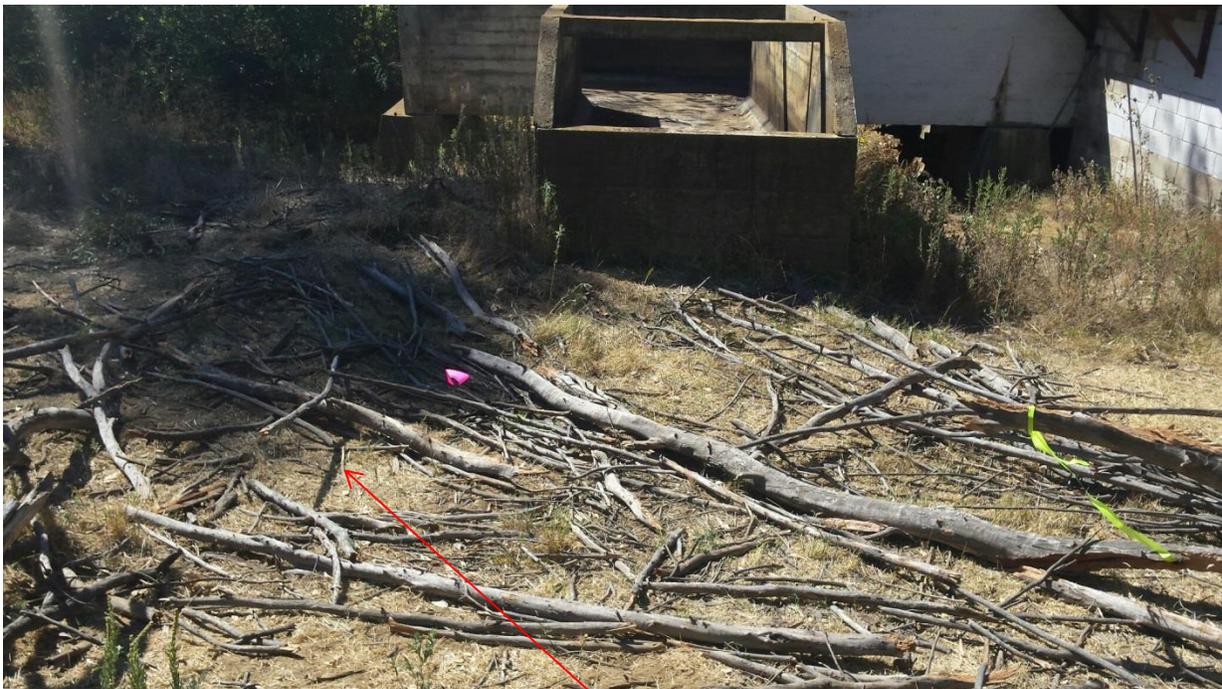
struck by the tree approximately 60' from the stump. FC 1 remained in the standing position after absorbing the impact, injuring his left arm and hand. Under assistance by the crew, FC 1 walked back to the ECT to be treated. FC 1 was transported by the project sponsor, with the crew, in the ECT back to the top of the El Capitan Truck Trail to an awaiting ALS ambulance and engine. FC 1 was transported to a local trauma center.

FC 1 general location within felled tree.
