**Green Monster Fire  
Engine 1932  
668 Super-heavy Tactical Engine (Tatra)  
BLM Elko, NV  
Non-Serious Accident Review  
September 2008**

**September 19, 2008**

**Executive Summary**

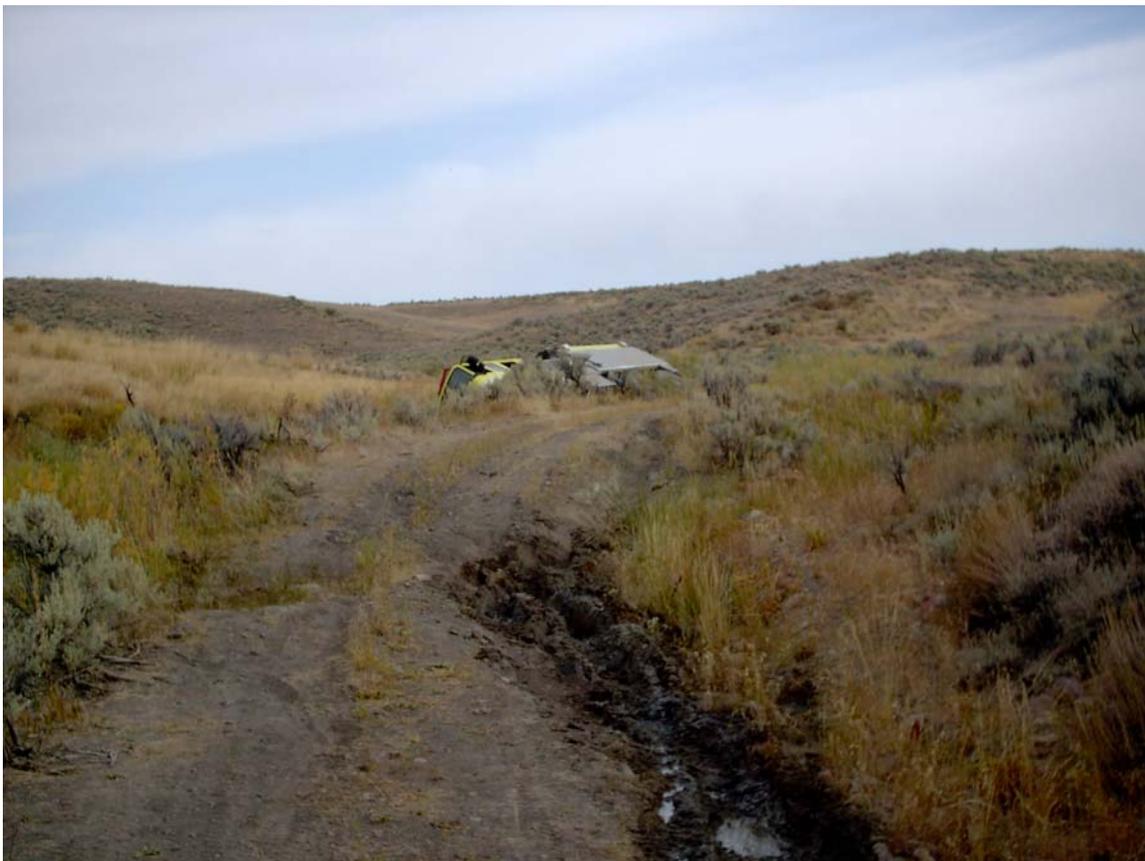
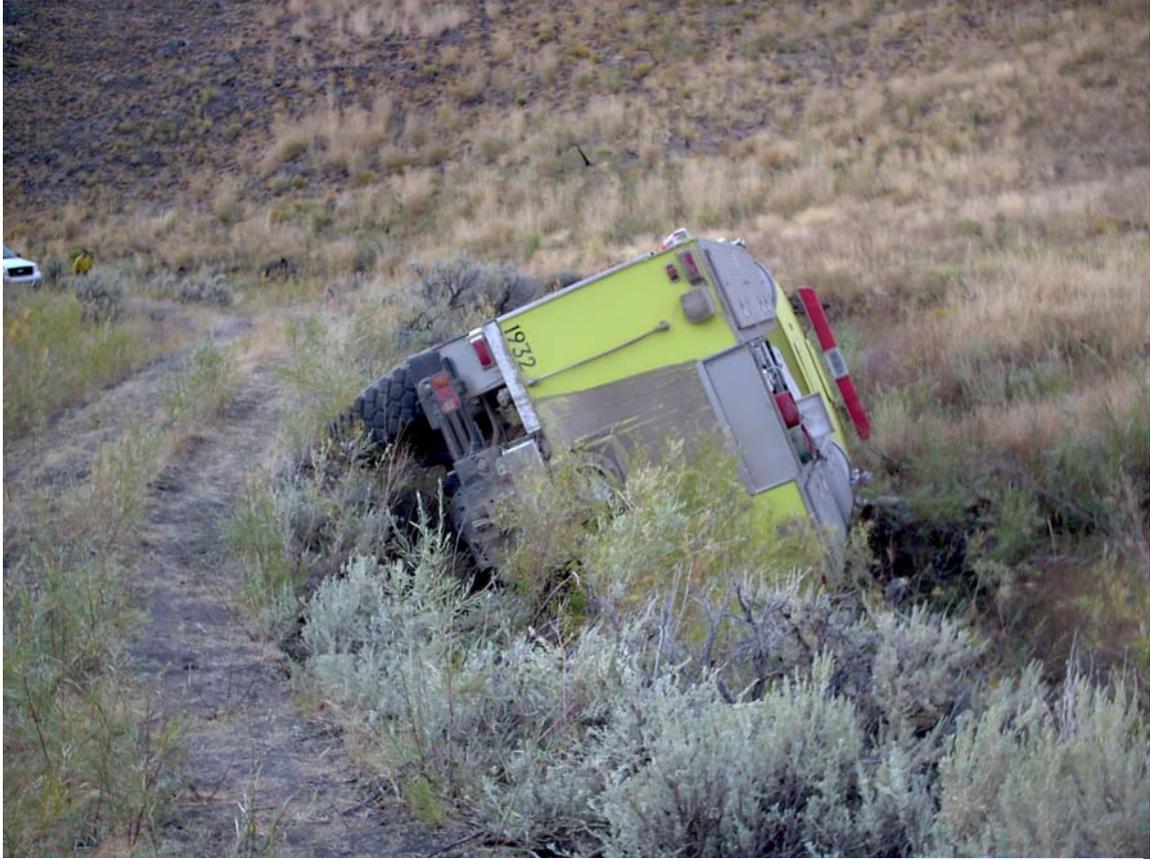
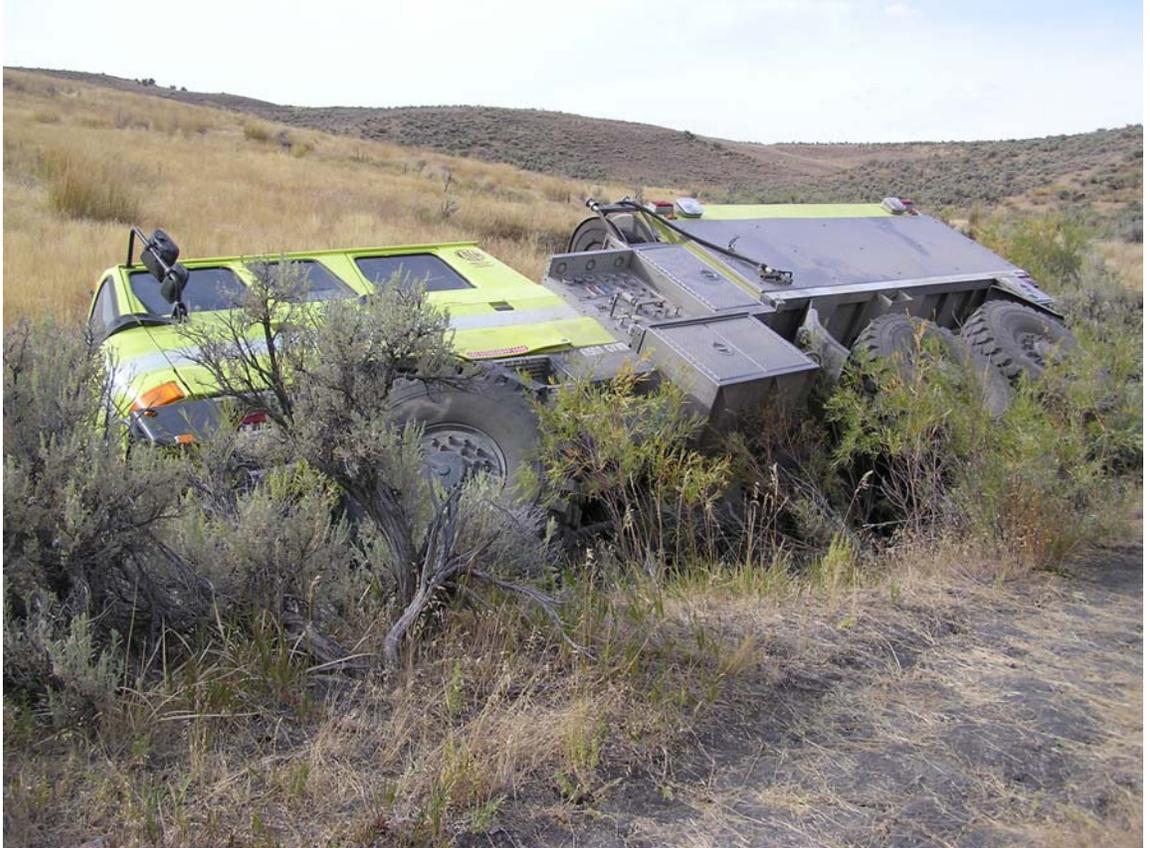
**Photos:**

At approximately 2000 hrs on September 16, 2008, an accident occurred on the Green Monster Fire, BLM Elko District, Nevada. While driving from the fire enroute to Midas station, Engine 1932 (Elko District engine) attempted to drive a narrow portion of a two-track road adjacent to a ditch, slid into the ditch and tipped-over onto its side. The four person crew, engine captain, engine operator, engine operator (T) and crewmember, were not injured during the accident and did not require first aid treatment. All personnel were picked up by vehicle at the scene and transported to Midas Station.

The crew of Engine 1932 was conducting routine operations on an Initial Attack fire and was within policy requirements for work/rest and driving duty day limitations. They unexpectedly encountered a narrow portion of road at night and slipped into a ditch,

tipping over onto the right side of the engine. All passengers were wearing their seatbelts at the time of the accident. One passenger undid his seatbelt and exited vehicle during the tip-over. While the outcome was positive, potential serious injury could have occurred. This passenger should have remained in his seat with the seatbelt fastened. The review team believes that the training offered by the BLM is more than sufficient for Bureau employees and this type of vehicle. Driving, and especially night driving, remains one of the highest risk activities firefighters undertake in the accomplishment of their jobs. This incident should serve as an important lesson learned to all personnel engaged in driving activities.
