# Green Rock Fire Accident Investigation

## Summary of Investigation Findings

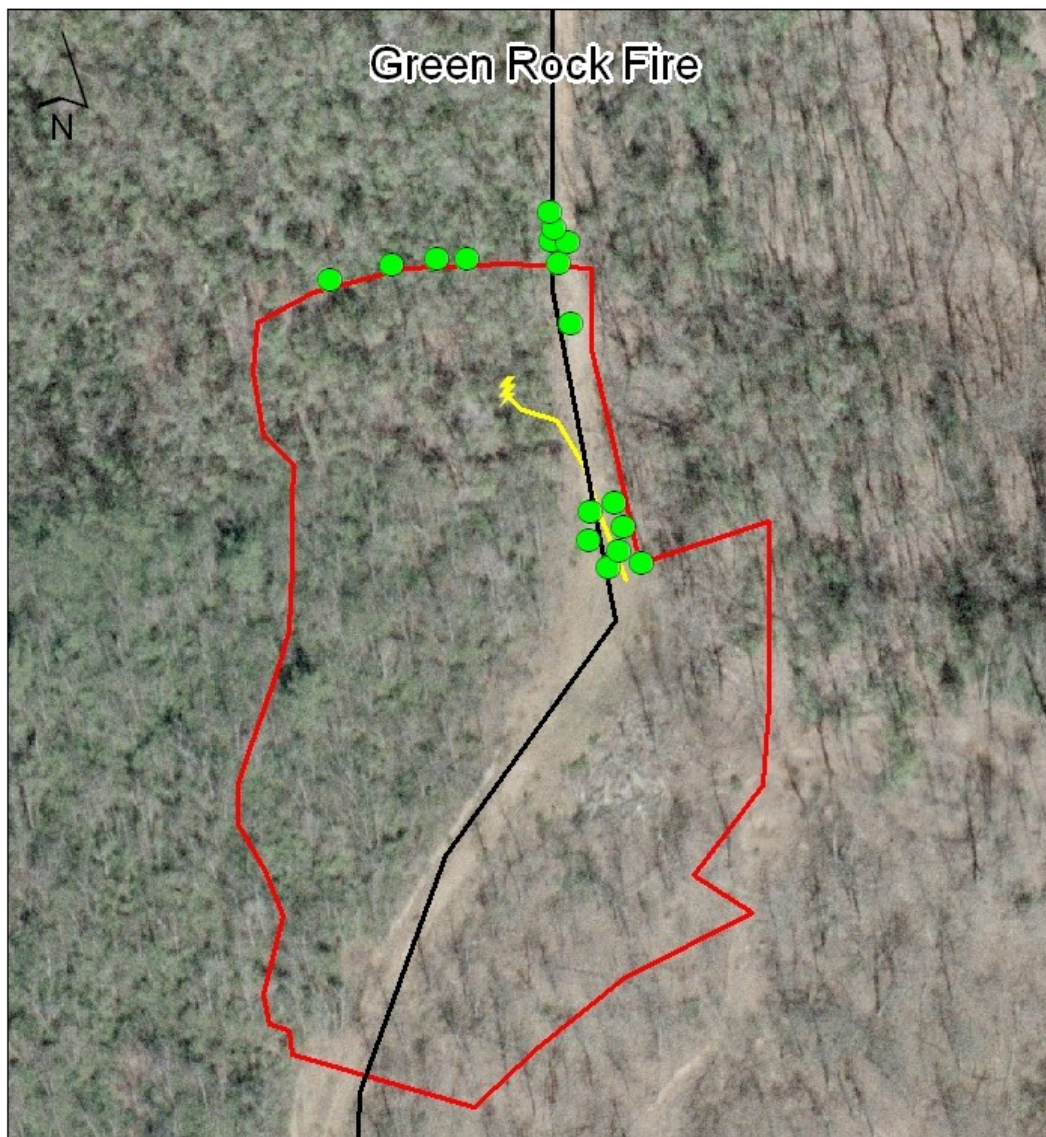
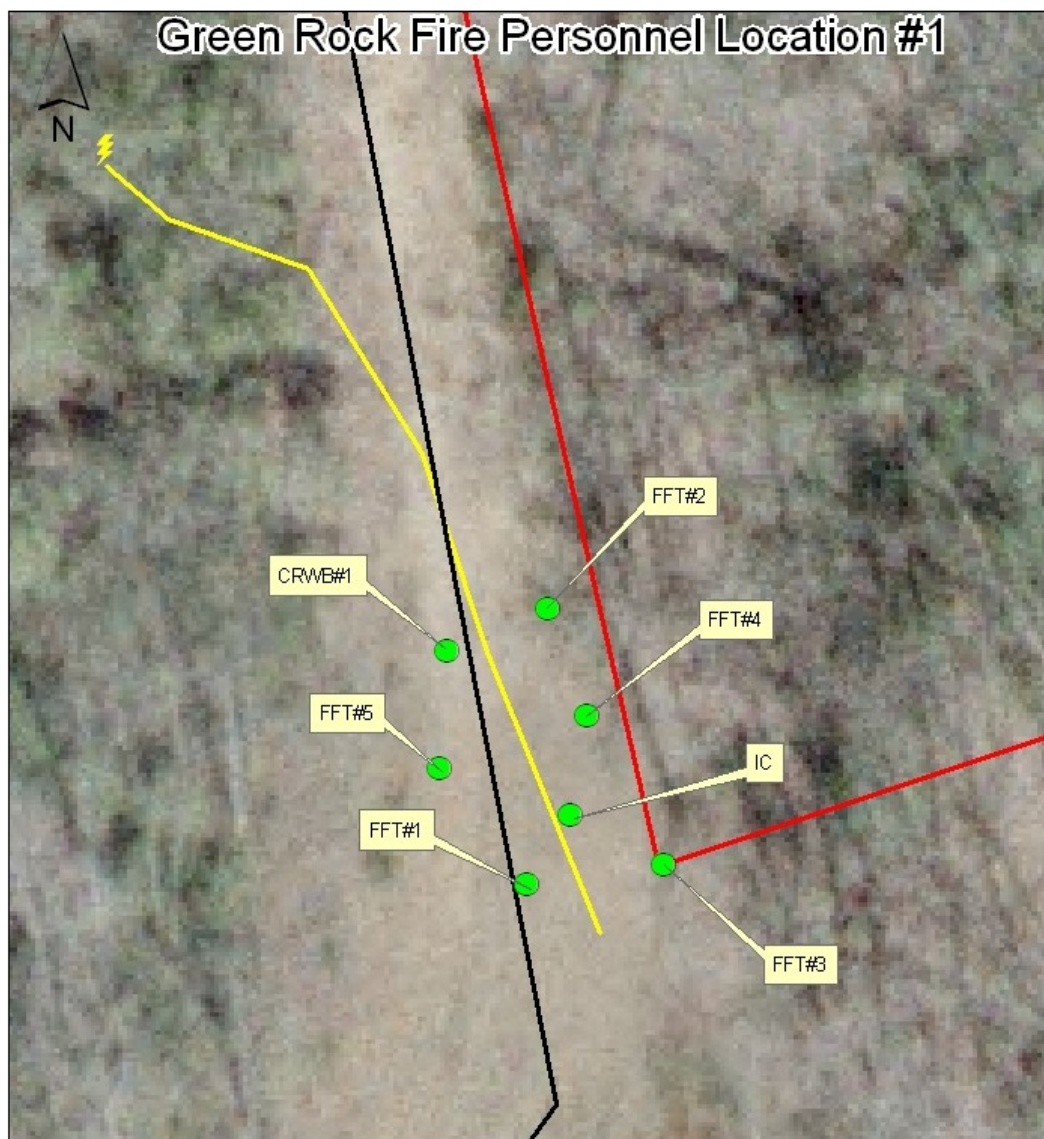
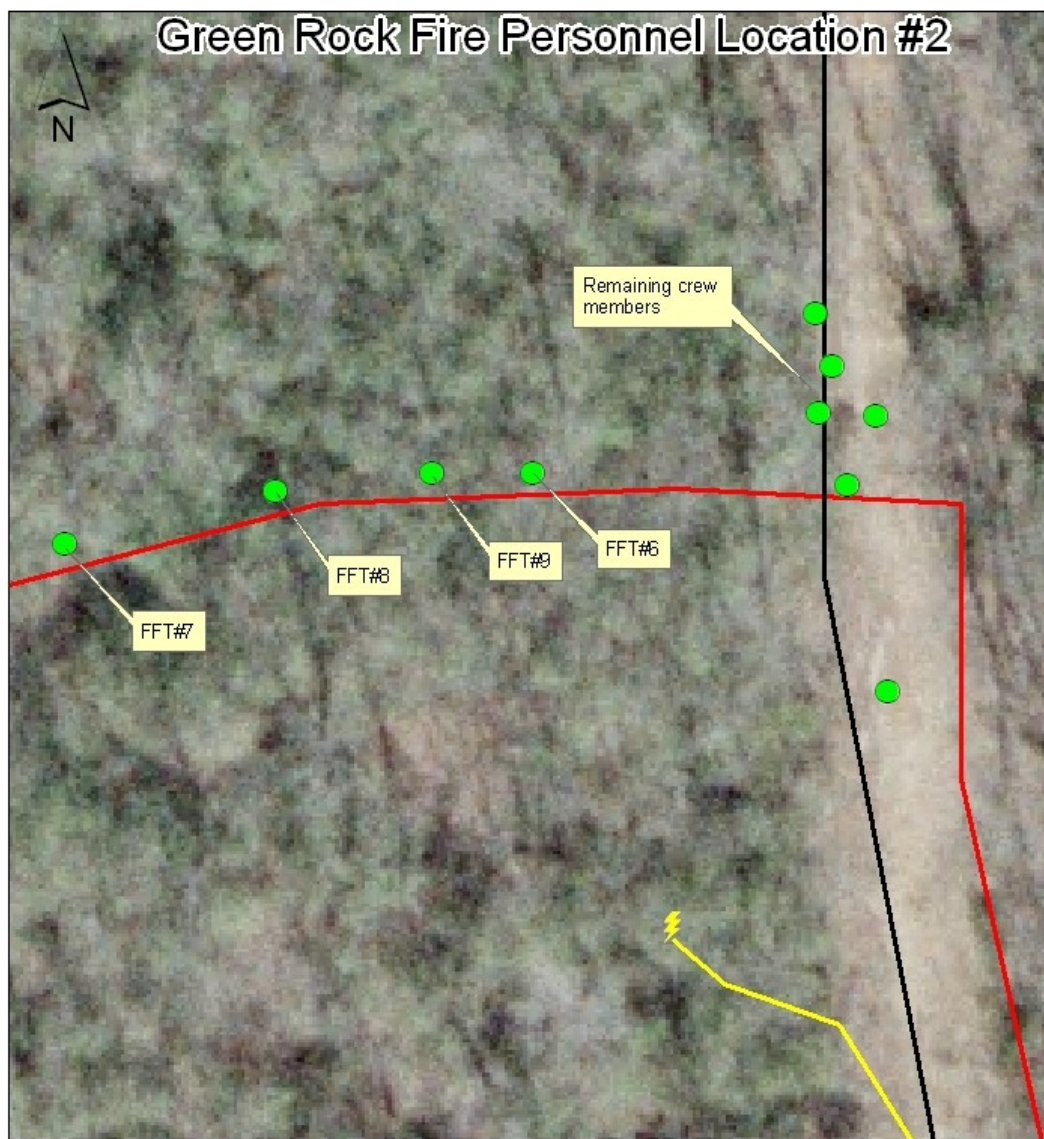
employee was walking the line on the south side of the fire. According to BLM Lightning Data, a negative polarity strike occurred at 16:37 hours on June 28, 2008. Based on evidence from the scene, it appears a dead snag just off of the fireline was struck and lightning ran along a path in the ground passing directly under or adjacent to several groups of firefighters.

As depicted on the attached Personnel Location Map(s), the closest to the strike was BRIDGE CRWB1 who was standing next to a RTV and indications are, the lightning passed near or directly under him. The path of the lightning traveled south toward another group of firefighters to include: five crewmen and the IC/OSC. Four additional BRIDGE crew members on the fireline on the NW perimeter were struck. Two BRIDGE CRWBs were sitting in the Kubota RTV and were not injured. Nine additional firefighters were not injured by the lightning strike.
