# GREEN SHEET

## **Informational Summary Report of Serious CAL FIRE Injuries, Illnesses, Accidents and Near Serious Accidents**

**Tree Felling Accident**

**15-CA-HUU-005606**

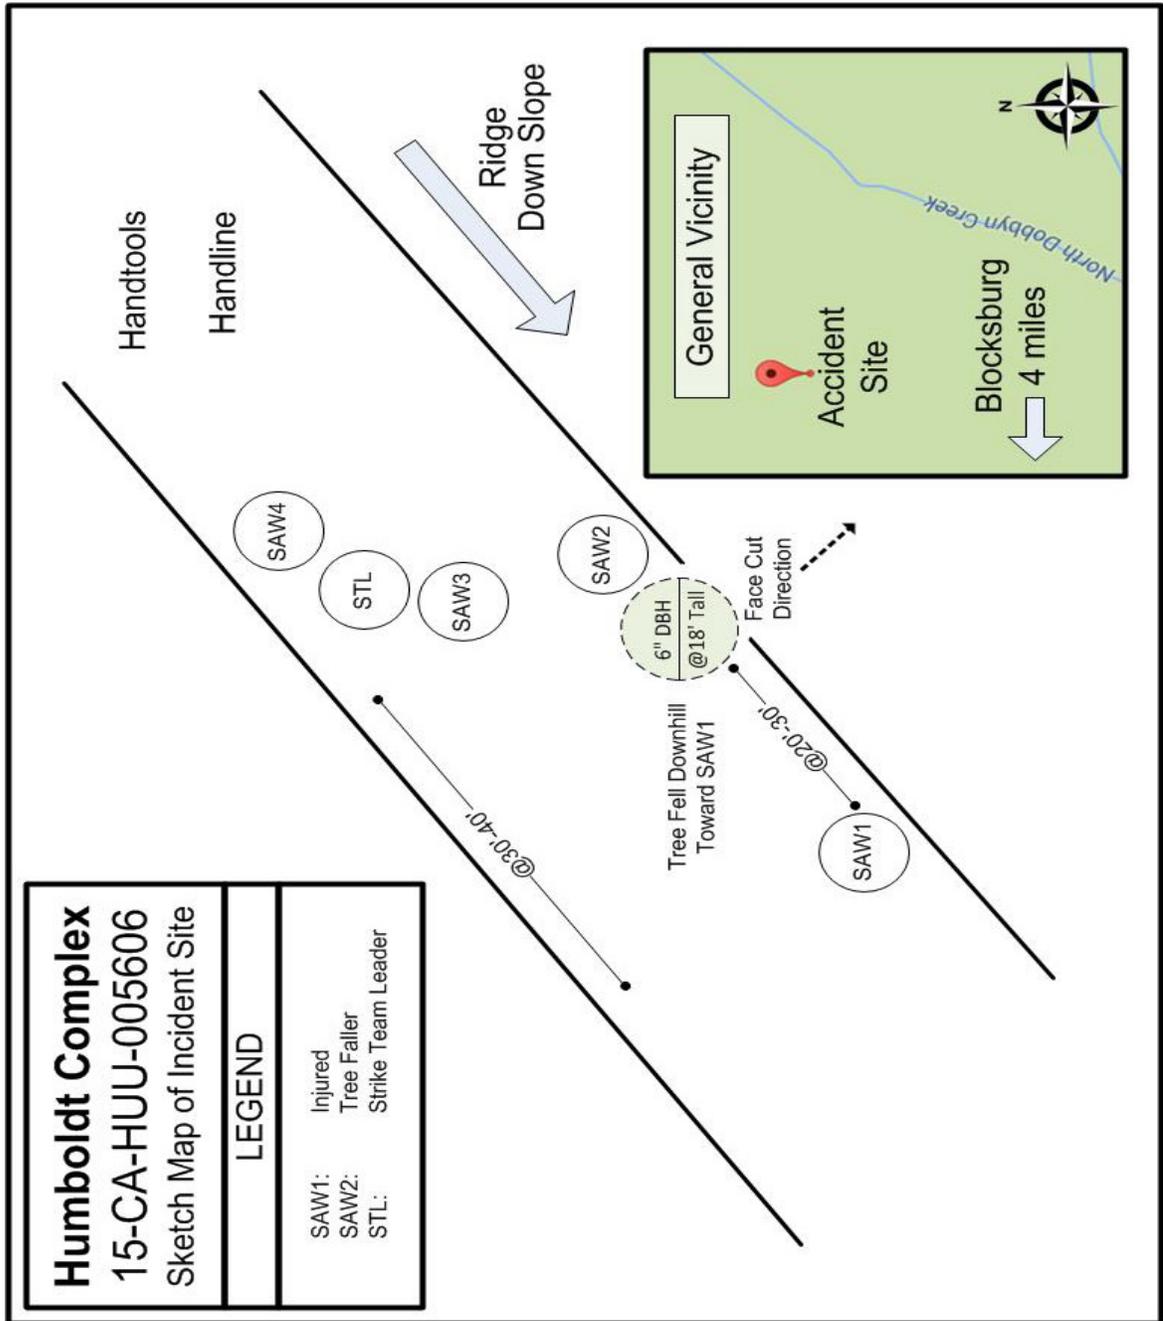
Figure 1. Sketch of accident scene.

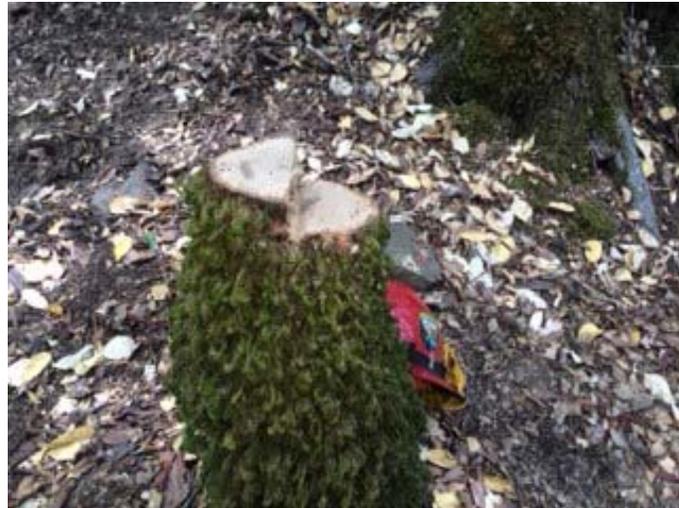
Figure 3. Side view of the stump (no holding wood)

- SAW1 was wearing full wildland PPE
- Establish cutting area controls and ensure all personnel are outside the two and one-half times the height of the tree being felled.
- Ensure all trees being felled are analyzed for lean and lay. When the holding wood is cut, the tree will follow the lean.
- Use proper felling cuts, even on small trees
- Remember to shout out, “Back Cut,” and communicate the direction of intended fall

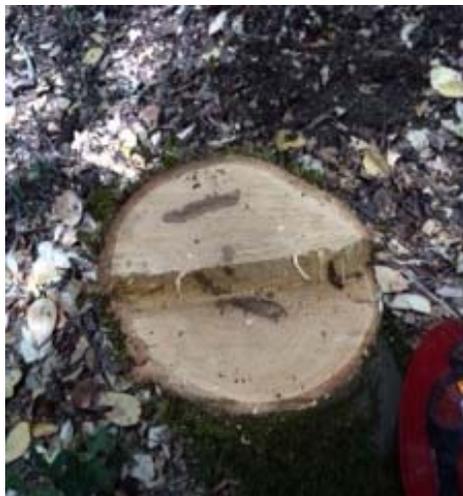
Figure 4. Top view of the stump (no holding wood)
