After Action Review of Chainsaw Personal Injury

From February 26, 2015

Kisatchie NF

February 29, 2015

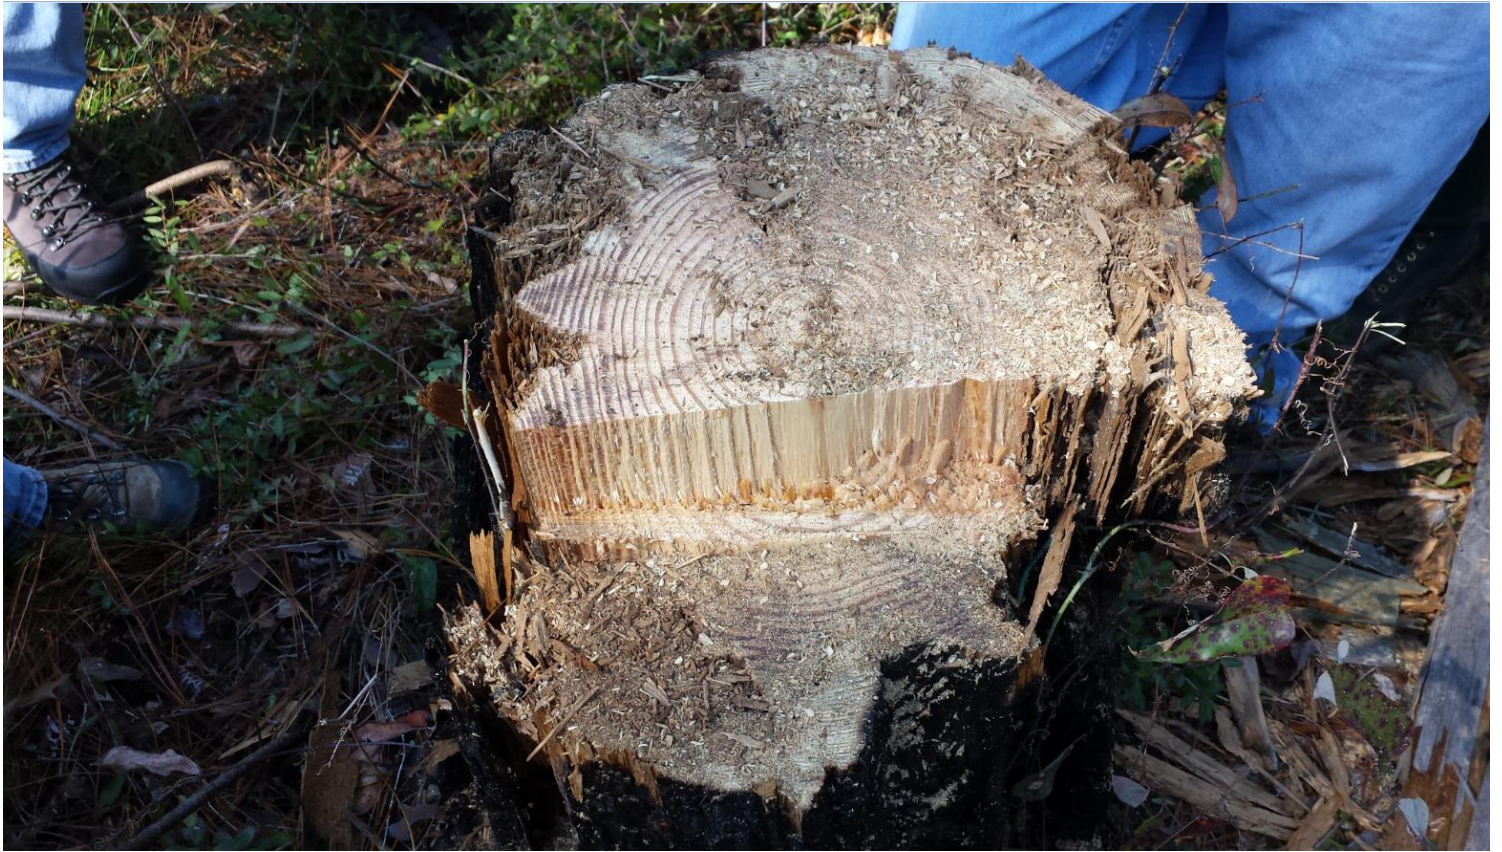
According to the Forest Chainsaw Coordinator, the facecut, holding wood, and backcut were appropriate.

Photo 1: Close-up of the stump.

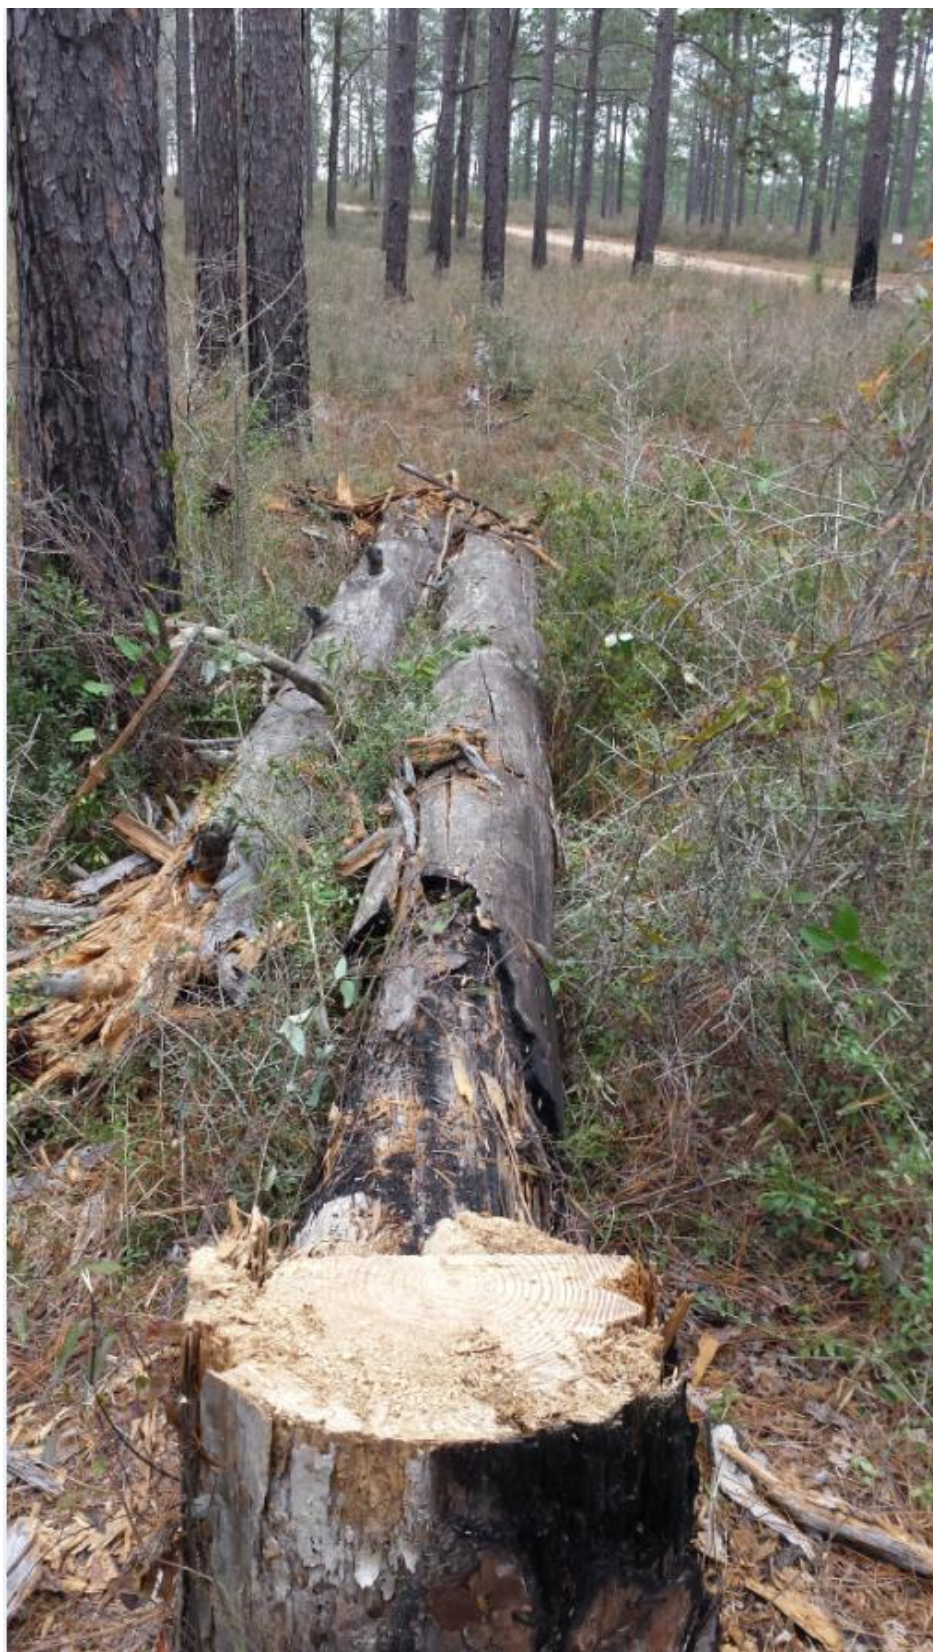
There was room to the right of direction of fall. The selected direction of fall crowded the two green trees.

Photo 2: View sighting across the stump and down the direction of fall.

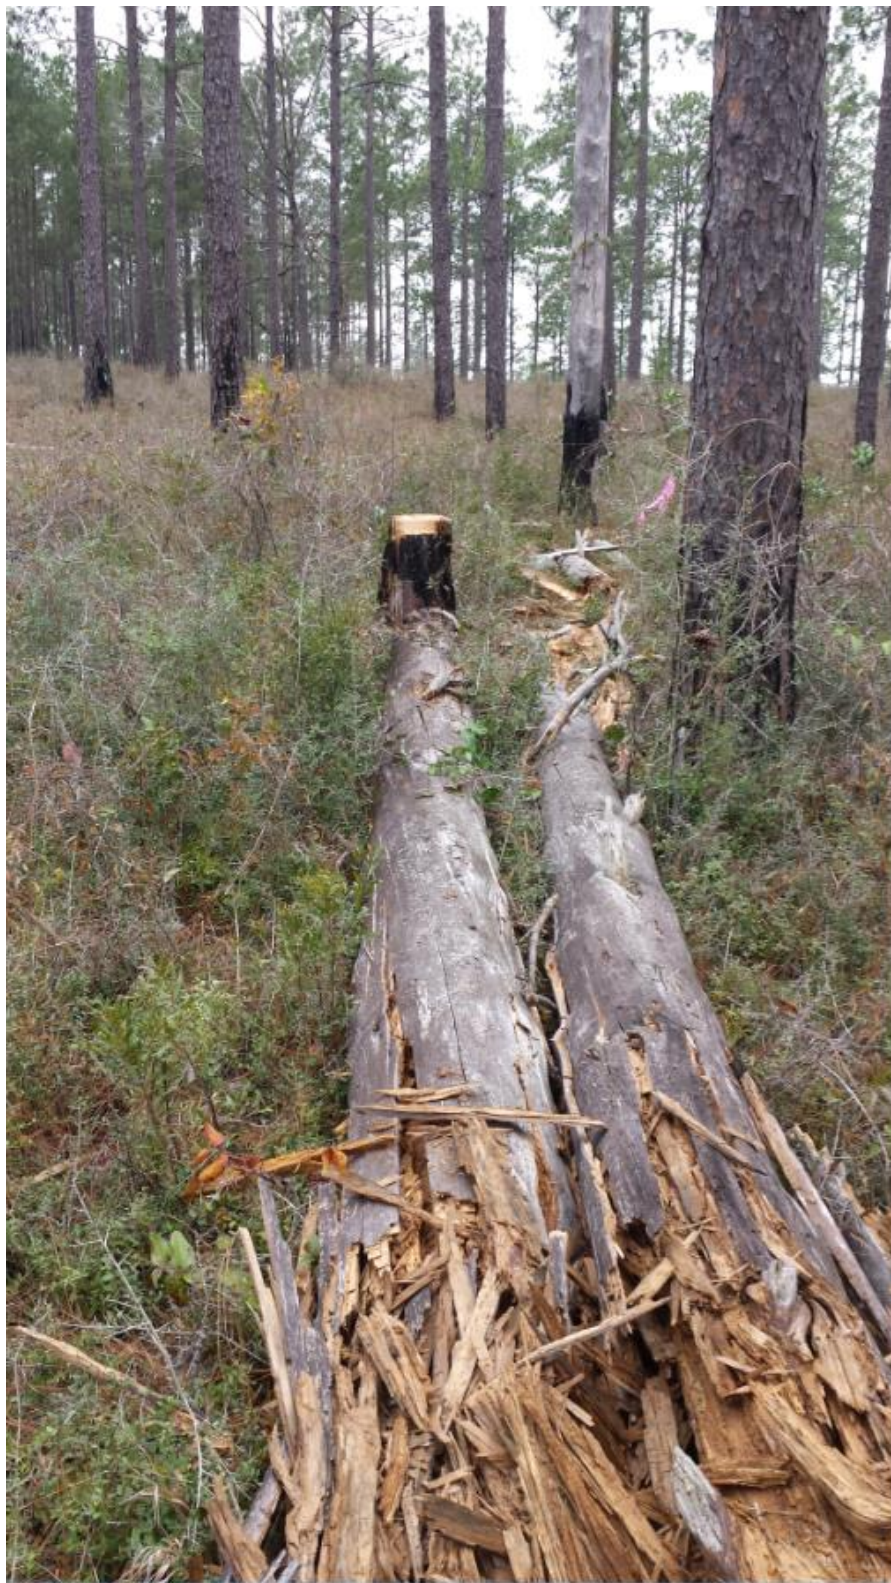
Once the backcut was started, the Smokejumper used a wedge to push the snag over. The top of the snag cleared the closest green tree but encountered the branches from the second green tree. The snag broke approximately 25 feet above the stump. The top portion of the snag slingshot back towards the stump. The Smokejumper, after wedging the snag over, moved nearly straight back from the stump and watched the snag. As the snag broke and the top came back at the Smokejumper, he moved further away and roughly 45 degrees from the stump. The Smokejumper was struck by the top of the snag. The site of impact was approximately 12-15 feet from the stump and approximately 45 degrees from the angle of fall. The snag inflicted a glancing blow sliding down the right side of the Smokejumper's head, knocking off his hard hat and glasses. Smokejumper stated that as he watched the snag break, he didn't think it could come back that far and that he was surprised at the speed the top came back.

Photo 3: View standing at the break mid-bole looking back at stump. There are pink flags marking the site of impact barely visible behind and to the right of the stump.

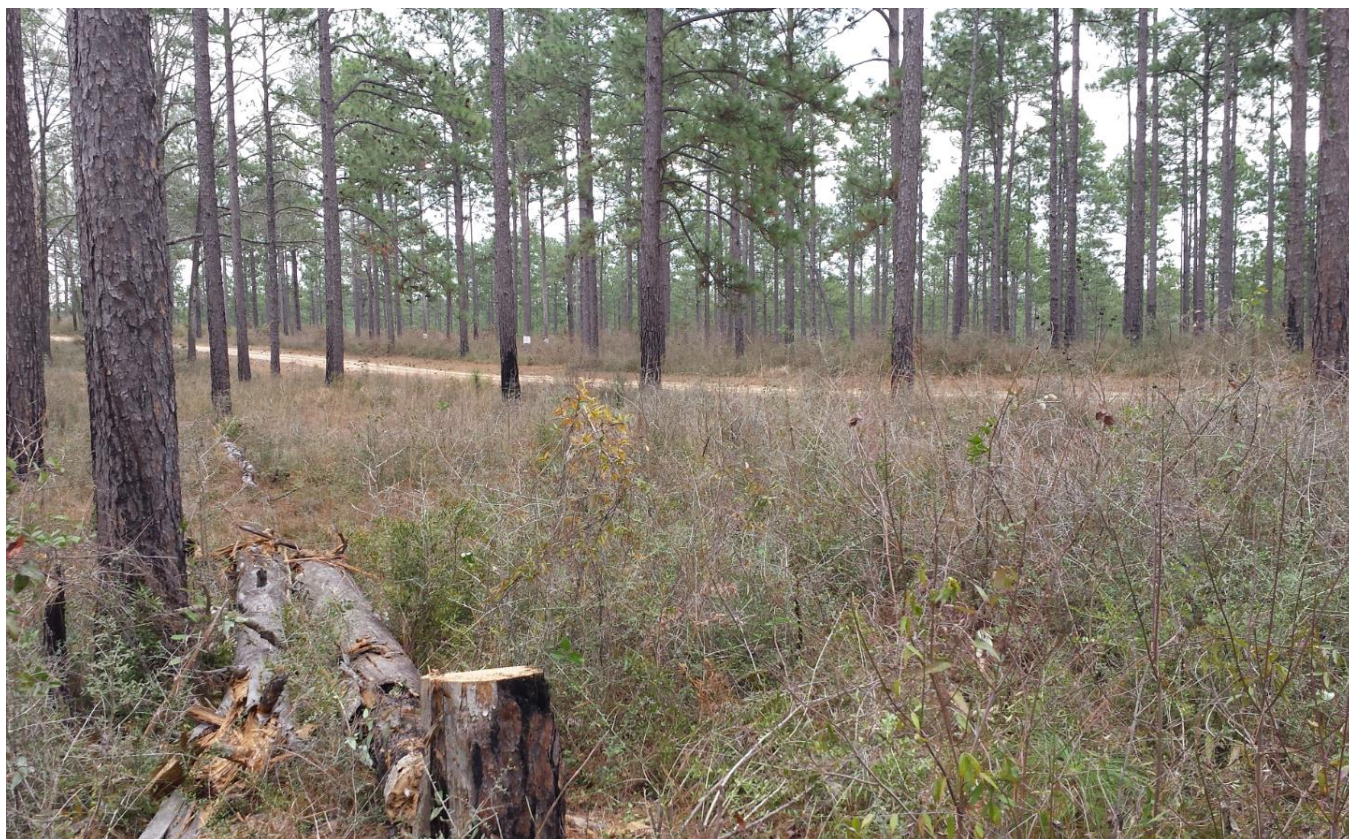
Photo 4: View showing space available to the right side of the direction of fall.
