LESSONS LEARNED - Driving Incident (Rollover)

Date/Time: August 22, 2009 @ 09:00 Hours **Location:** Highway 99, Los Molinos, CA
Employee Title: Klamath Interagency Hotshot Crew **Purpose:** Returning to Home Unit

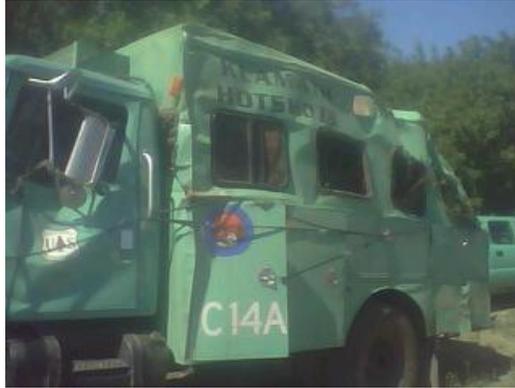
Eight personnel from the Klamath Hotshots, Klamath National Forest, were involved in a vehicle accident on Highway 99 near Los Molinos, CA. The crew was returning to their home unit from a fire assignment on the Plumas National Forest and was in the northbound lane when a semi-truck traveling south crossed over into the northbound lane and struck the crew vehicle with a side mirror. This pushed the crew carrier into a sideways skid, crossing oncoming traffic and leaving the roadway, where it experienced a $\frac{3}{4}$ roll landing on the driver's side of the vehicle.

Be aware that exits/emergency exits may not function after vehicle damage. The crew carrier roll-over damaged the frame of the box (crew passenger area) to the point that the rear door and the emergency exit (side window) would not open. Crew members from the other vehicles tore the emergency exit window (frame and all) from the vehicle to extricate injured personnel. Other occupants crawled through the pass through window between the cab and the box and exited out the broken windshield area.
