# Informational Summary Report of Serious or Near Serious DFFM Injuries, Illnesses and Accidents

# GREEN SHEET

## Burn Injuries

Laguna Fire

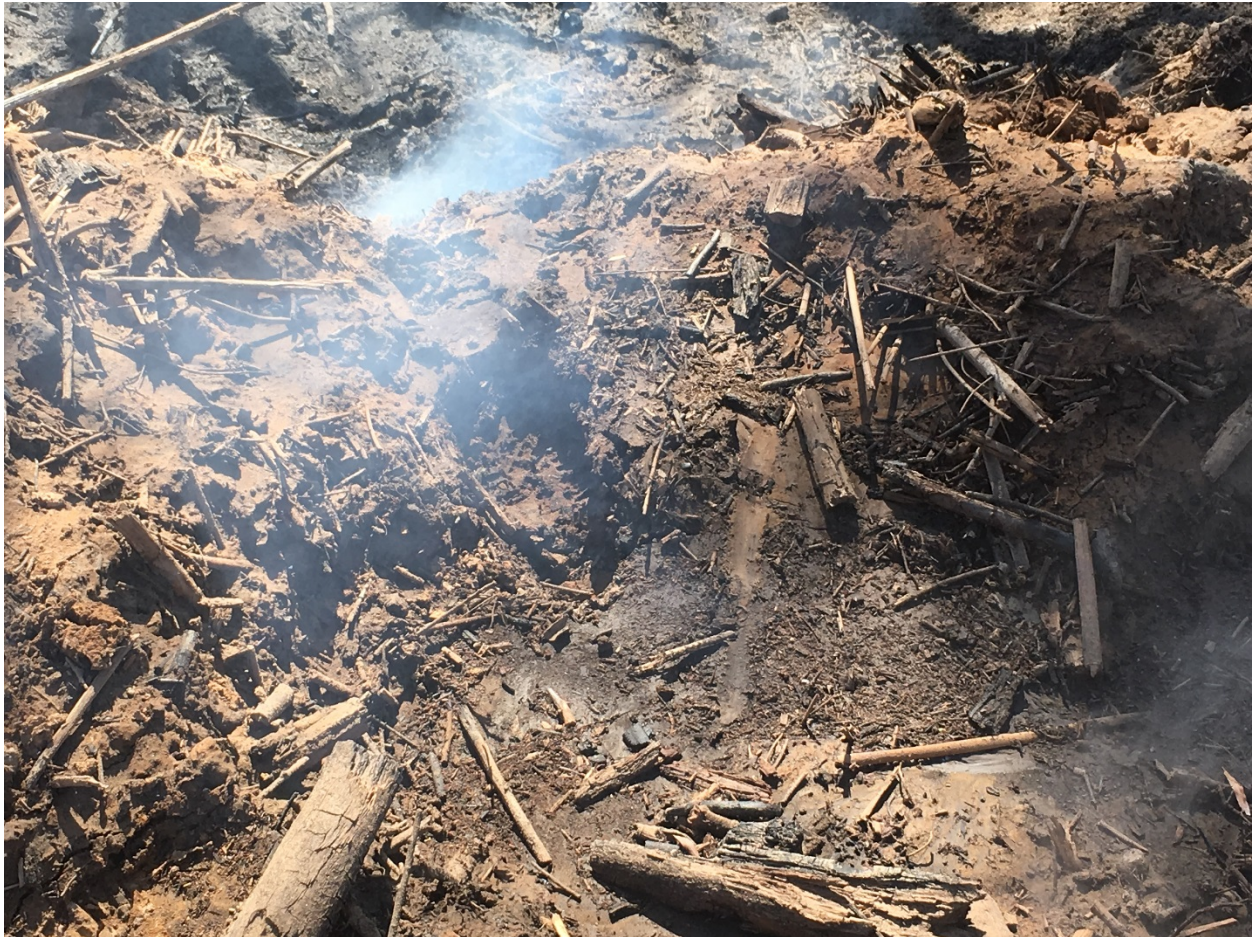
Fuel Type: Salt Cedar with berms of organic material and dirt (Photo 1)

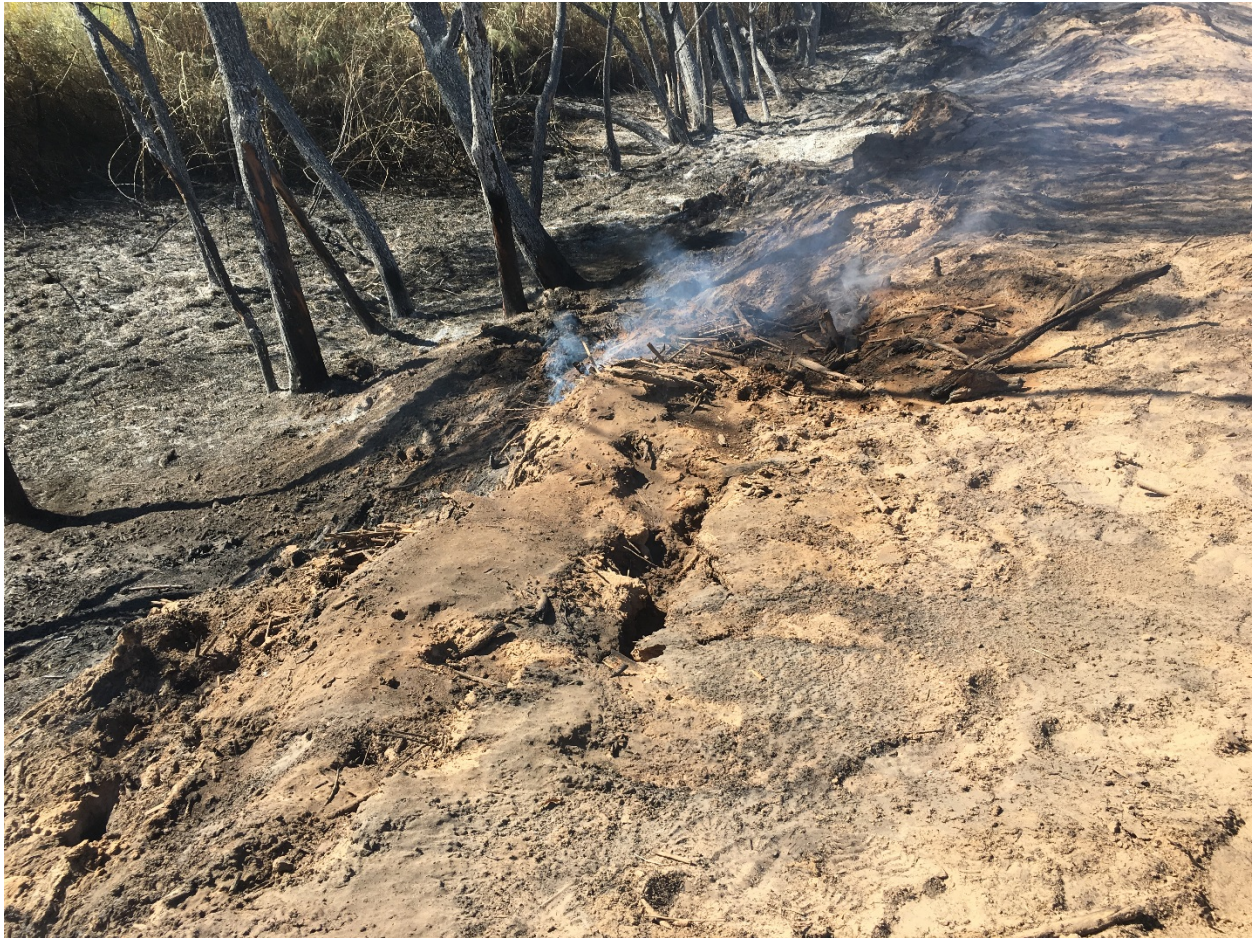
At approximately 1010 a crew member from the type II crew fell into an ash pit, after ground gave way on a mechanically constructed berm the crewmember was mopping up with a branch line (photo 2). The crewmember advanced a hose line up the berm and upon reaching the top the employee stepped toward the downhill side facing the Colorado river and berm gave way (photo 3). The employee went down to approximately the knee level in a void space created by burning material being consumed under the crust of the berm. The employee fell forward towards the downhill side adjacent the Colorado River (photo 4). The employee had forward inertia and momentum which continued him downhill with a section of ash and dirt. The section was approximately 38 inches wide and 18 inches long. The employee extended their hands and arms to provide protection while falling forward. The employee because of body weight and that inertia sunk into the hot ash pit and displaced debris sunk up to approximately the armpit and shoulder, additional hot rolling material followed the employee downslope encompassing lower extremities and upper torso. As the employee was falling and adjacent crewmember heard the employees screaming. The witness employee was approximately 6 feet to the south

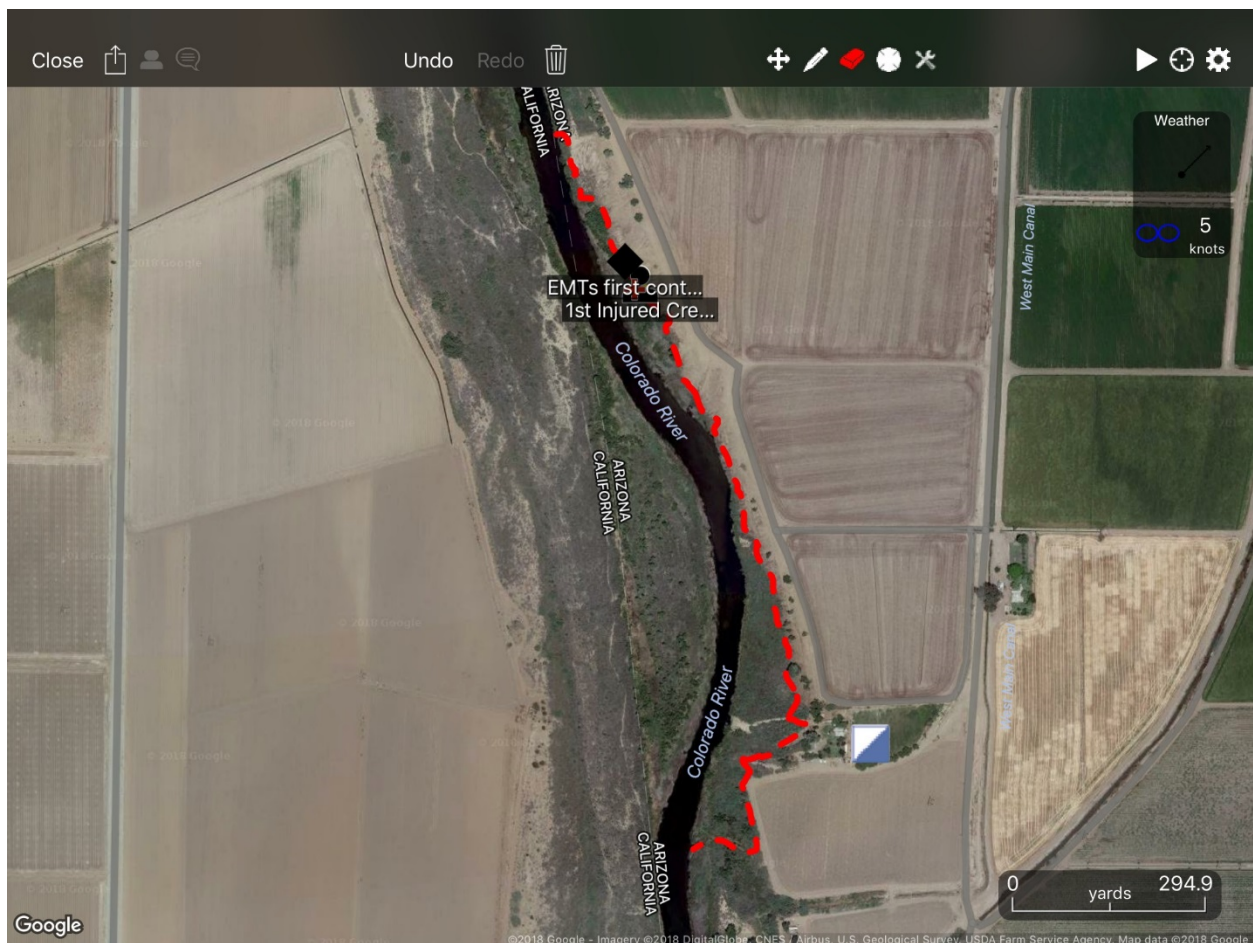
At approximately 1027 an update on the employee's medical condition was given via radio to the incident commander. The incident commander notified Arizona dispatch, requesting an ambulance to transport the employee and start the notification process to the fire staff. The crewmember was ambulatory and communicating. The decision was made to walk the injured employee to a waiting crew agency vehicle to be driven and rendezvous with the ambulance at the ICP (photo 6).

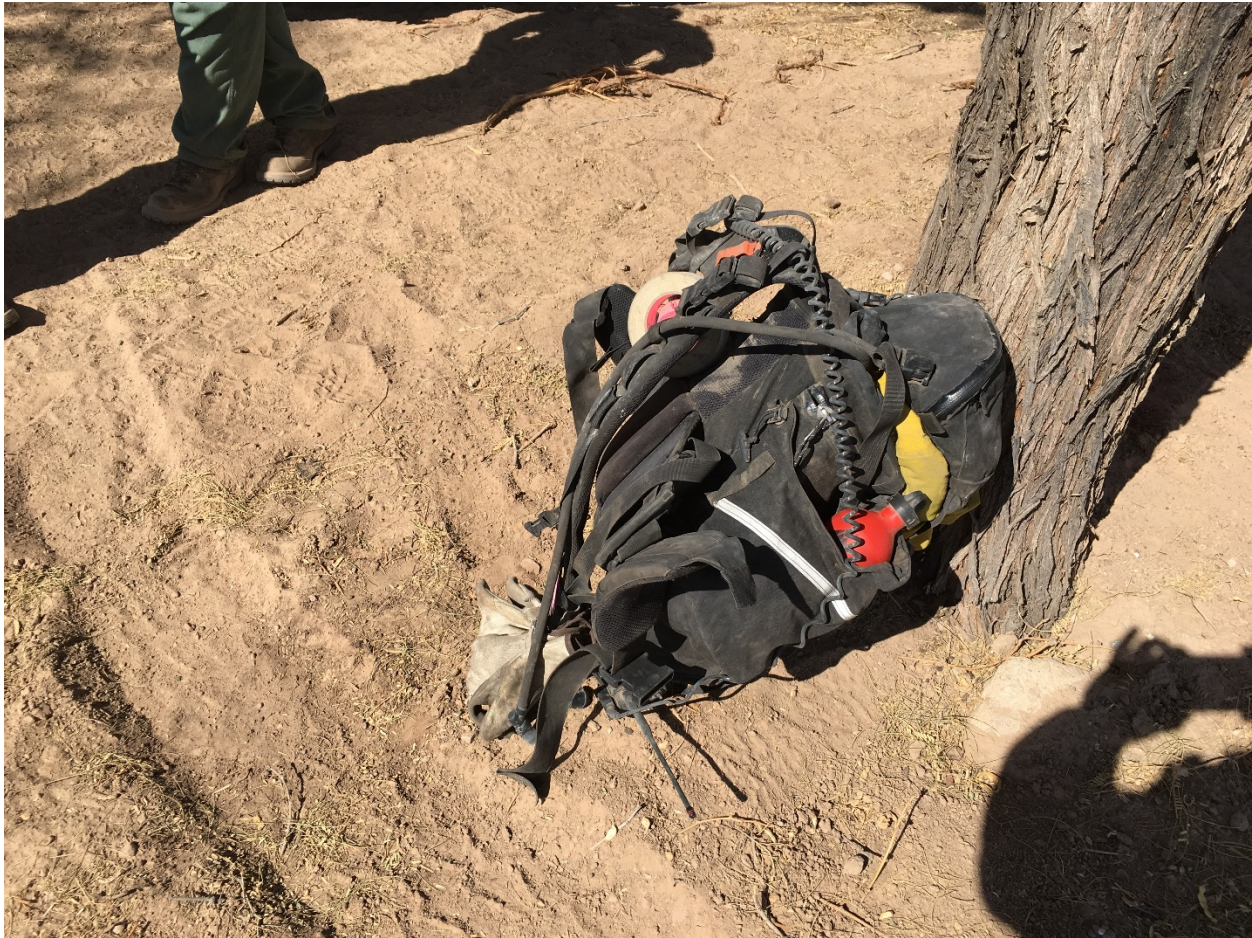
- Based on the nature of the injury, statements of witness employees, and the injured employees' gloves hanging on a D ring on the employees' pack. At the time of this report it appears the injured employee was not wearing gloves during the incident (photo 7).
- The Situational Awareness of the employee regarding ash pits, the employees' understanding of the leader's intent for the operational task assigned.

- Situational Awareness including understanding of special hazards such as berms built mechanically with agricultural tilled soil as a base verse a naturally developed berm. <https://www.wildfirelessons.net/search?executeSearch=true&SearchTerm=ash+pits&l=1>
- The IC communicating with Agency Administrator/Duty Officer regarding Objectives, Strategy, and Tactics being utilized for an Incident.
- Assuring instructions are heard and understood by all employees with clear leader's intent (Task, Purpose, and End State).
- Wearing of proper PPE for tasks assigned
