United States Department of Agriculture
Forest Service

Little Fire Shelter Use San Bernardino National Forest Facilitated Learning Analysis

Little Fire—Personal Protective Equipment Procedures and Analysis Report

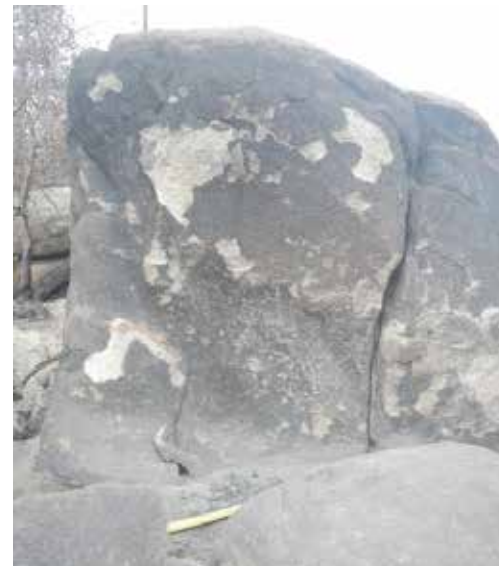
Figure 2: Barrier rock.

At Barrier Rock they lose water pressure presumably because the hose has burned. They are still experiencing a lot of heat from the ash and are trying to stand on rocks to keep from standing in the hot ash. Div-A cannot see the main fire because both Barrier Rock and smoke impedes his vision. Visibility through the smoke is about 20 feet at best. He can hear the fire behavior but cannot see it so he reluctantly decides to have his personnel pull their fire shelters from their fire packs, as a precautionary measure. At this time, two individuals pull the red rings on the poly vinyl chloride (PVC) bags, removing the shelters. They stay at Barrier Rock for a couple of minutes. Div-A spots a large boulder (referred to in this document as Big Rock) when the wind shifts and leads his personnel there hoping to find a more comfortable location from the heat and smoke.

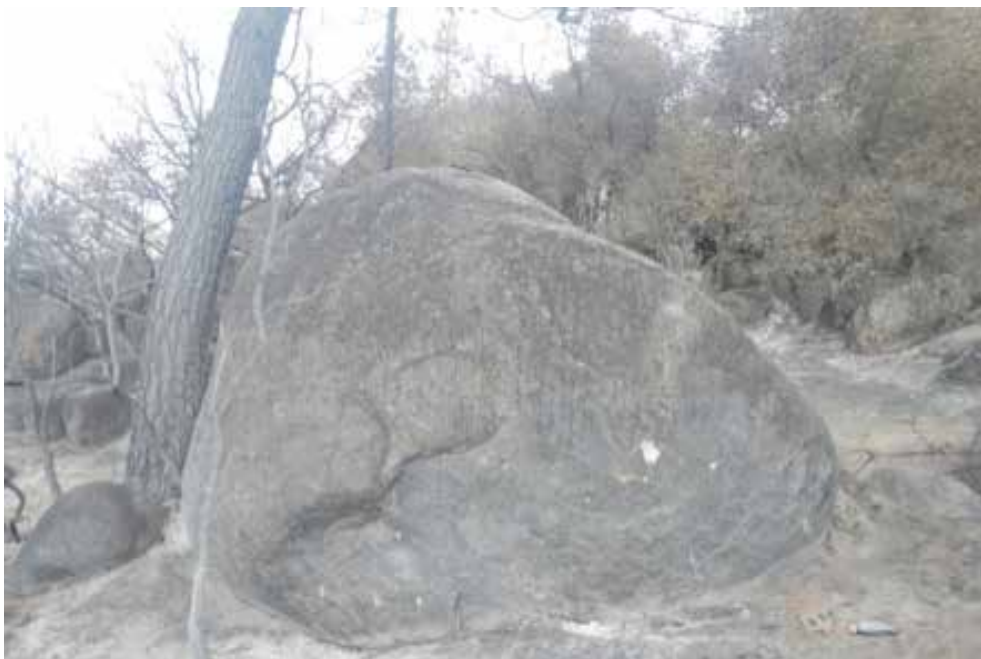
Figure 3: Big Rock.

When they arrive at Big Rock (figure 3) there is room for all four of them atop it. Div-A remains standing and the firefighters sit down. The fire's edge is approximately 75 feet to the east of this

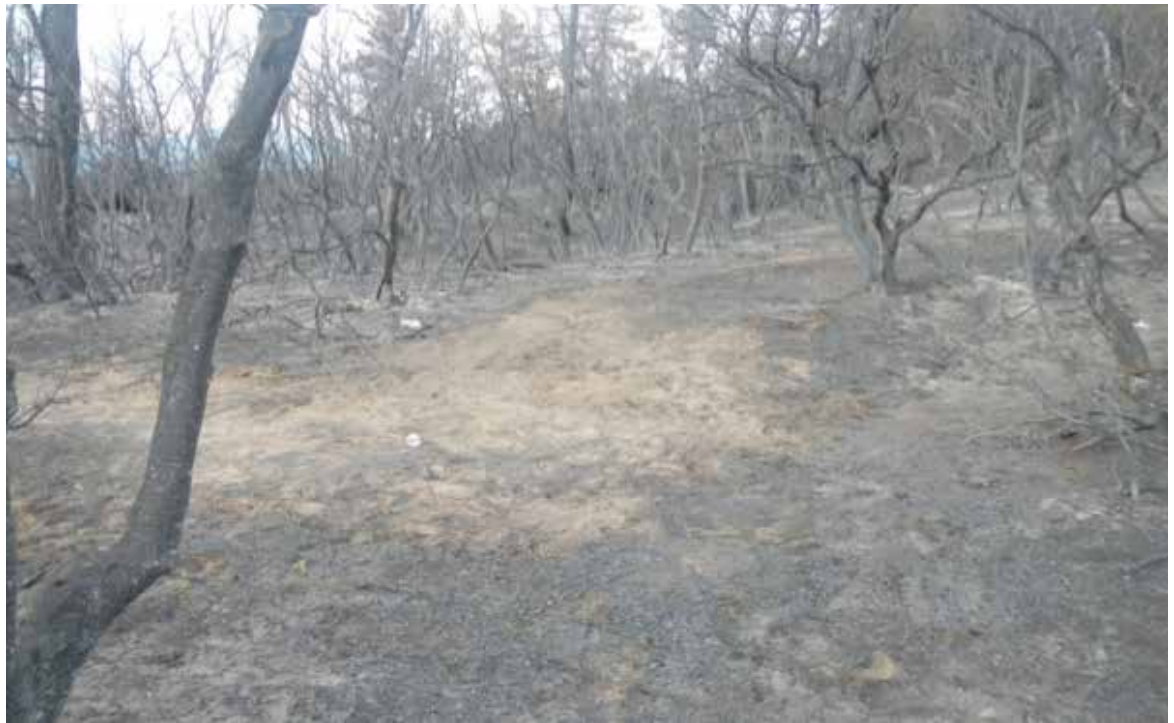
At the new location (the Sandy Spot [figure 4]), Div-A continues to try and get water drops and the hoselay to their location. Although the conditions are more desirable, there is still a lot of ground heat in the area. They make several attempts to get a latitude and longitude reading for their position sbut again have no satellite signal. They ignite some fusees in hopes that the helicopter is able to see it through the smoke but, again, haven't any luck. While at Sandy Spot, Div-A is contacted by BC-2, who arrives at the staging area to check on them. Div-A radio's in to report their current status and also advises BC-2 that they are using their shelters and, specifically, why they are using them so there isn't any confusion about the intended use of the shelters. After about another half hour they hear an engine crew bringing the hoselay through the black. When they are able to see them they walk up to them and out to the engines that remain in the staging area.

Figure 4: Sandy Spot

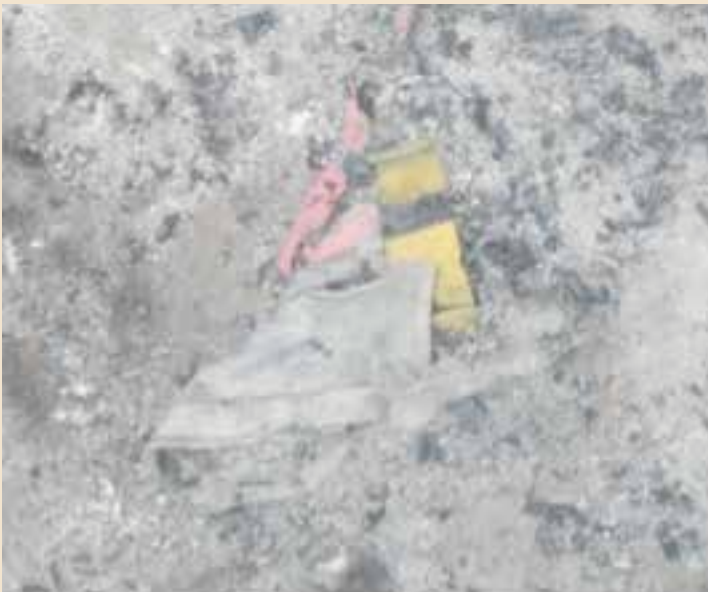
Fire Shelter #3	<ul style="list-style-type: none">• Outside layer–No damage• Inside–No damage• Floor–No damage	Manufacture Date–Not legible
Fire Shelter # 4	<ul style="list-style-type: none">• Outside layer–Aluminum foil worn away and cracked along some fold lines.• Inside layer–No damage• Floor–No damage	Manufacture Date–January 2004. Fire shelter was not deployed.
Fire Shelter PVC Bags	<ul style="list-style-type: none">• The recovered bags were partially melted and burned. Two bags were 30-40% consumed by fire; one bag was 80% consumed by fire.	Three fire shelter PVC bags were recovered from the site. One PVC bag was not recovered; it was most likely consumed by fire.

Figure 5: Shelter PVC bag–280-945 °F.

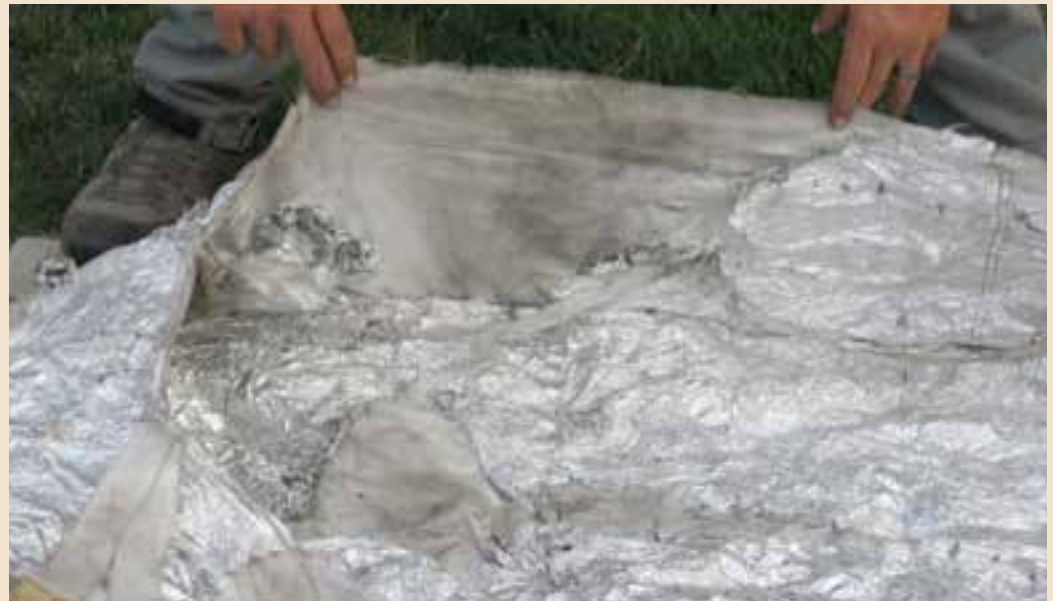
Figure 6: Shelter floor delamination–500 °F.

Heat and physical damage to fire shelters–The site contained areas of smoldering duff with enough heat to melt and ignite the shelter PVC bags. This surface and ground-based heat source made contact with the shelter floor material at some point. After shelters were deployed at Big Rock they were moved to Sandy Spot. Heat contact combined with physical abrasion most likely resulted in delamination of the floor material.

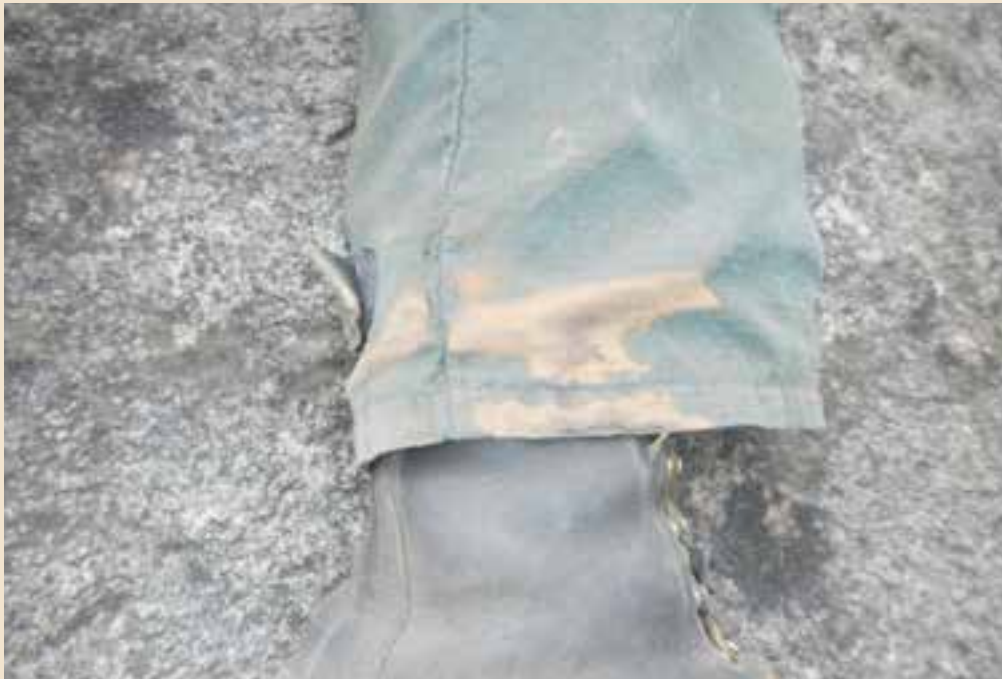
PPE	Condition	Remarks
FR Pants	Dye sublimation marks on three leg cuffs; approximately 3 square inches. See figure 7.	All four firefighters were wearing pants certified to NFPA-1977 Standard on Protective Clothing and Equipment for Wildland Firefighting-2011 Edition.
FR Shirts	No visual indication of exposure to high temperatures.	All four firefighters were wearing shirts certified to NFPA-1977 Standard on Protective Clothing and Equipment for Wildland Firefighting-2011 Edition.
Gloves	No visual indication of exposure to high temperatures.	All four firefighters were wearing gloves certified to NFPA-1977 Standard on Protective Clothing and Equipment for Wildland Firefighting-2011 Edition.
Helmet	No visual indication of exposure to high temperatures.	All four firefighters were wearing helmets certified to NFPA-1977 Standard on Protective Clothing and Equipment for Wildland Firefighting-2011 Edition.

Figure 7: Flame resistant Nomex dye sublimation (color change) 400 °F.
