BUREAU OF INDIAN AFFAIRS

Facilitated Learning Analysis

Martinez 3 Fire – October 21, 2019

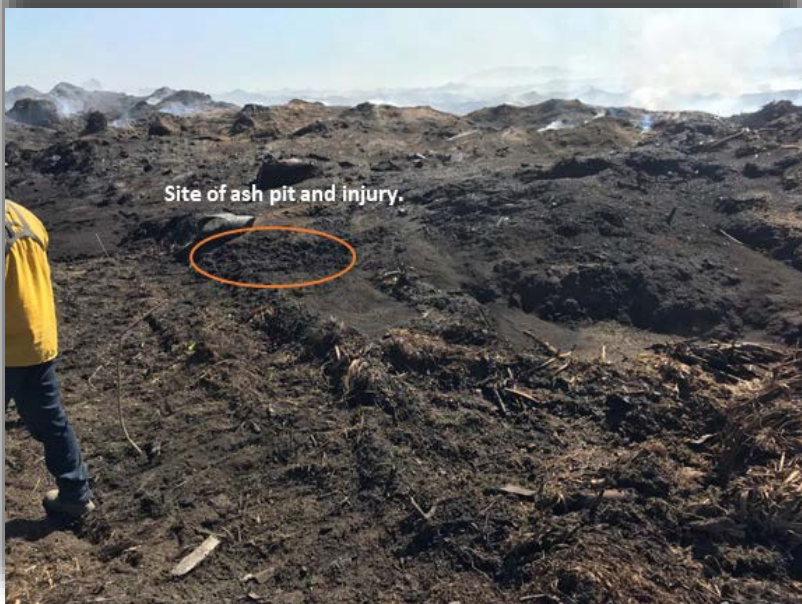
On October 21, 2019, at approximately 11:50 a.m., a firefighter assigned to the Martinez 3 Fire received 2nd and 3rd degree burn injuries below both knees. The firefighter, assigned to a type 3 engine on the incident, was performing suppression duties in an area of deep vegetation (duff) material, when he stepped into an ash pit, sunk to his waist, and received injuries.

1. A written Incident Action Plan should be made available to all resources as soon as possible, during extended attack operations.
2. Med-evacuation sites and landing zones should be identified and communicated to all resources as soon as possible.
3. To reduce firefighter exposure, use thermal detectors to identify hot spots during mop-up operations and when working in areas of widespread vegetative material (duff).
