Montezuma Fire

June 8, 2012

Serious Accident Investigation Report

Location:
Bureau of Indian Affairs - Papago Agency
Tohono O'odham Tribe
Sells, Arizona

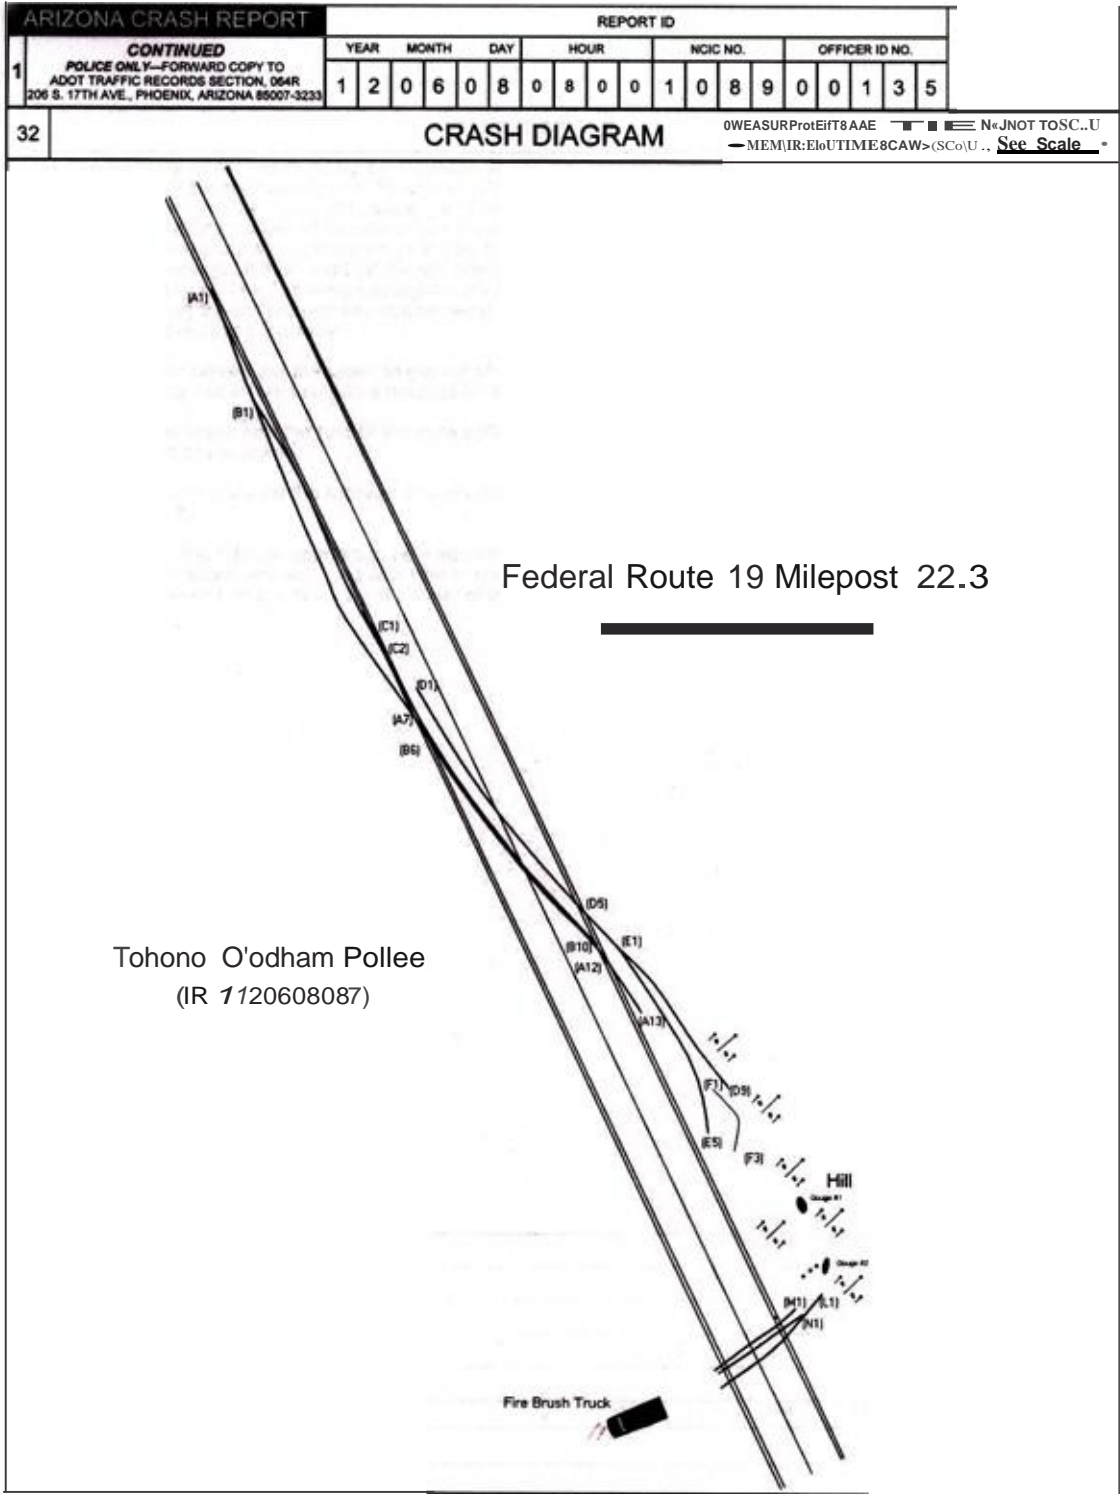
Crash diagram prepared by Tohono O'odham Police

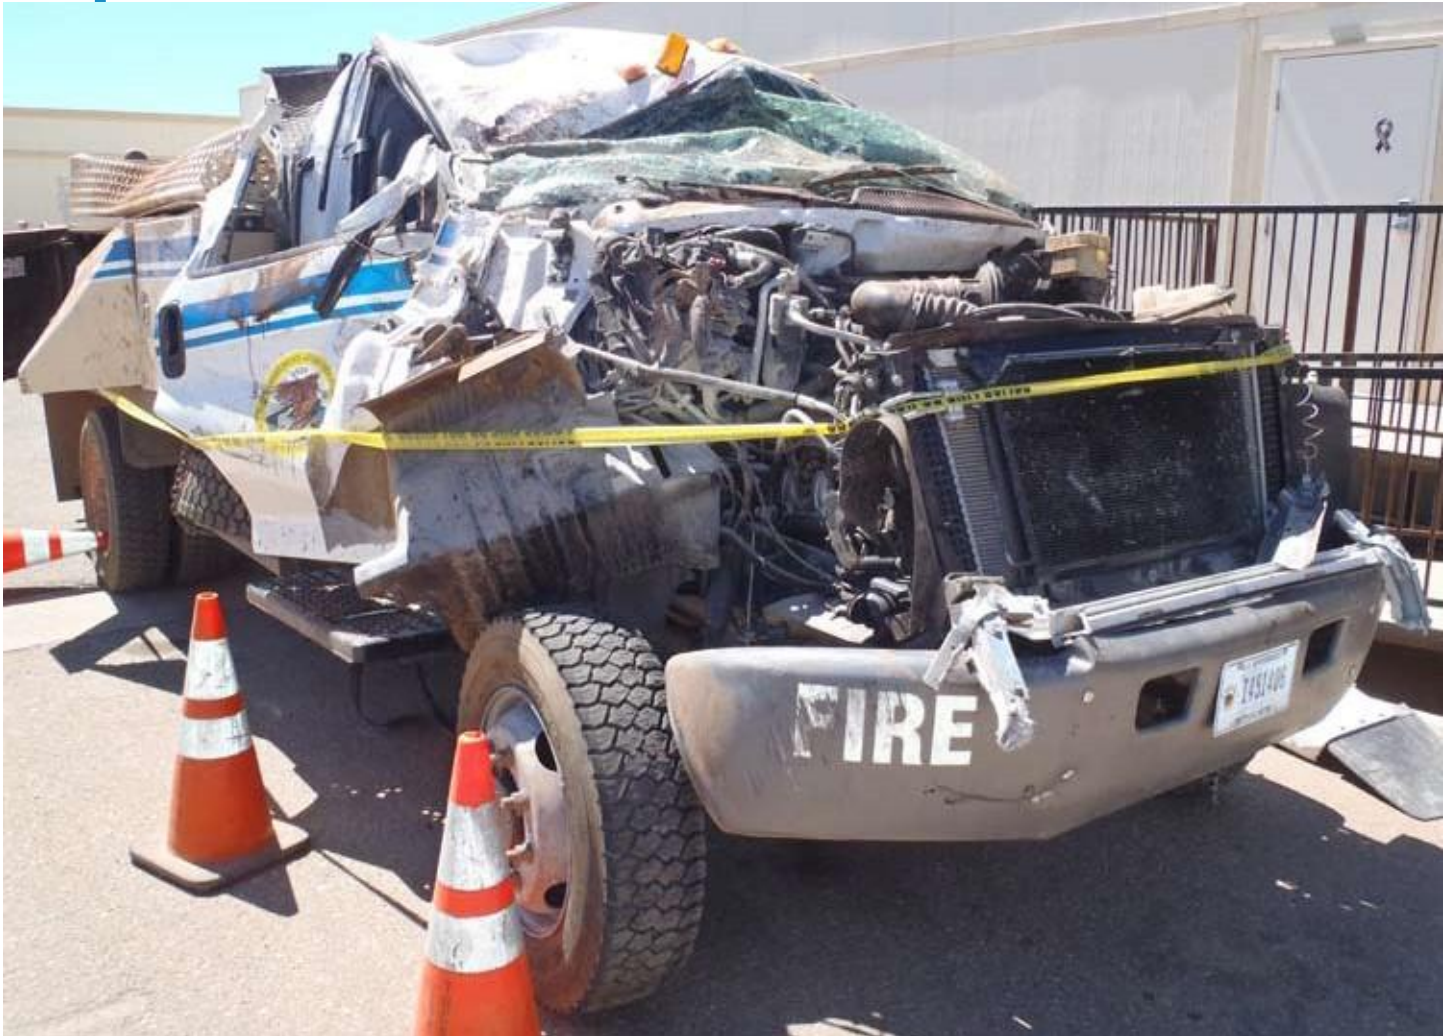
- b. The wear on the inside of the front passenger's side tire was consistent with the vehicle leaving the paved surface and rubbing on the pavement edge during the driver's attempt to return to the road surface.

Vehicle passenger side - The fatally injured employee was riding as the passenger.

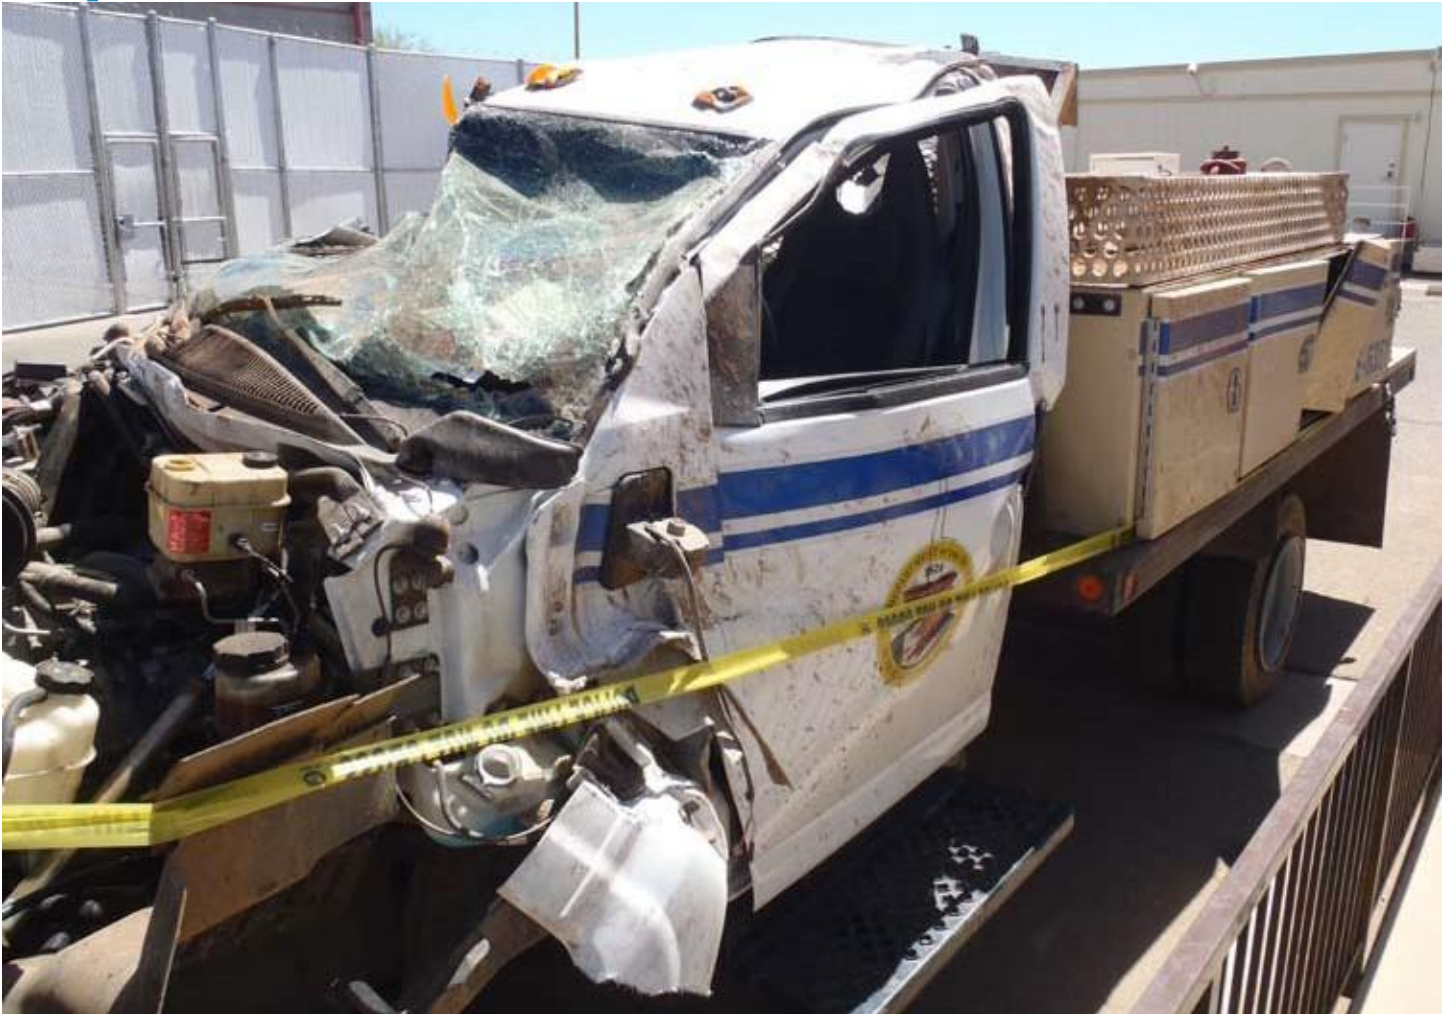
- c. Both the front and back outside dual, drivers' side tires, were off the rim due to the impact with the embankment which broke the seals of the tires. Tohono O'odham Nation Vehicle Accident Investigator, Marty Fuentes stated this action was normal in this type of accident.

Vehicle driver side - Crewmember 1 (middle passenger) and Crewmember 2 (driver) successfully exited the vehicle through the driver side window following the accident.
