## Pacific Southwest Region – Lessons Learned

Main Rotor-Blade Strike, North Pass Fire, Mendocino National Forest

September 1<sup>st</sup>, 2012

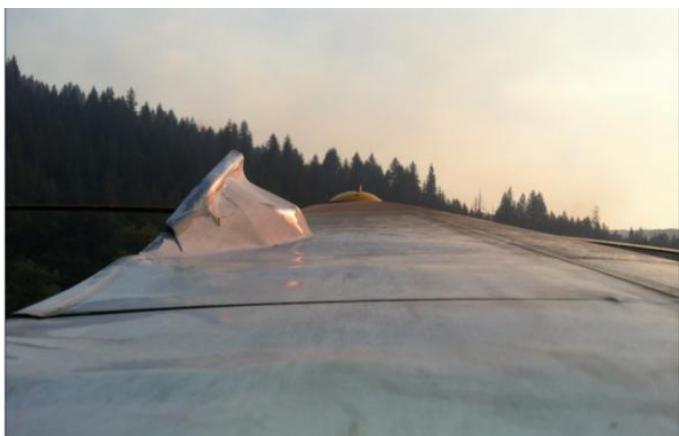
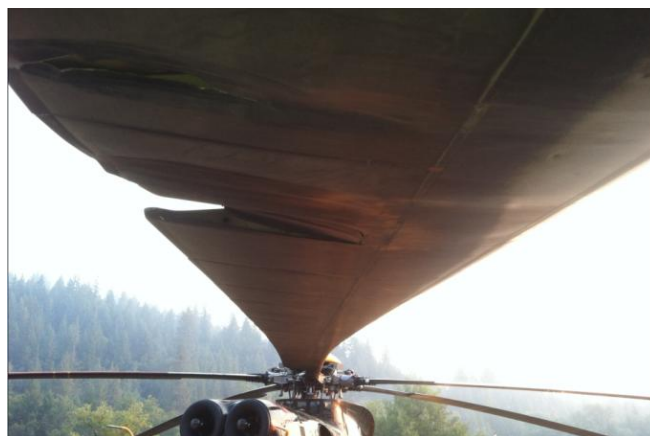
After shut down was complete, the pilots inspected the main rotor-blade damage and noted that all 5 main blades incurred damage to the trailing edge about 18" inboard from the tip.

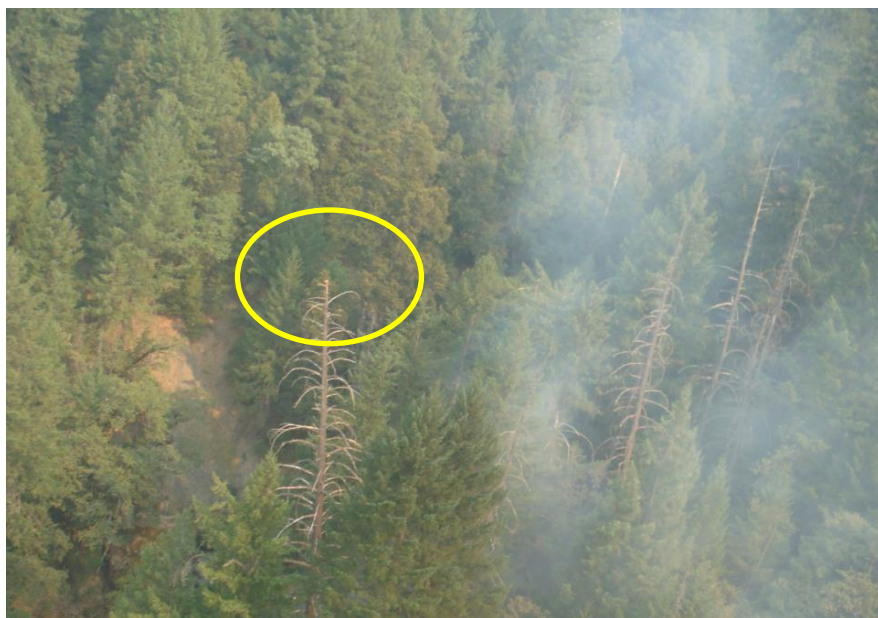
The HLCO platform landed to retrieve the pilots and fly them back to the Airport/Helibase. Enroute to the Airport/Helibase, they flew by the area where the strike had occurred and located a “buckskin” snag about 30 ft higher than the other trees. The snag was missing its top, and was estimated to be about 4-5” in diameter at the point where it had broken off.
