Nut Hill Fire Facilitated Learning Analysis (FLA)

July 19, 2013

Nez Perce-Clearwater National Forest

Red River Ranger District

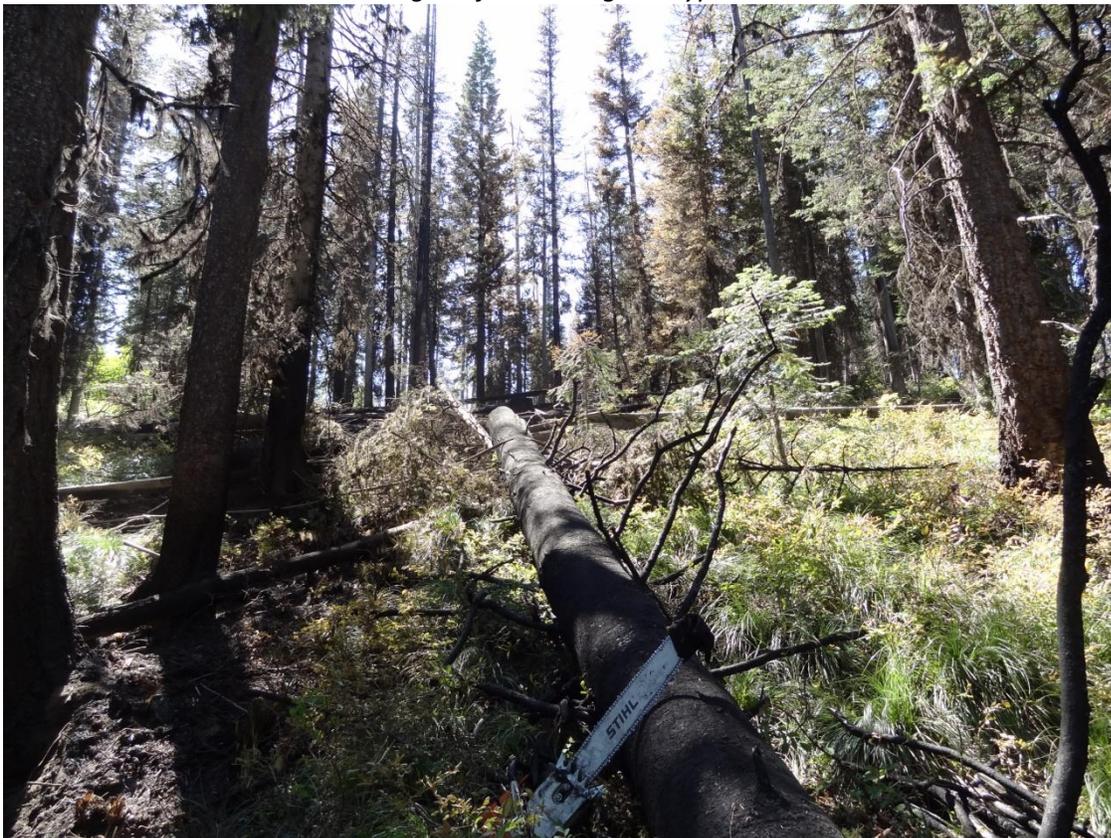
The Nut Hill Fire, spotted on July 19, 2013 at 1512 by the Oregon Butte Lookout, was located on the Red River Ranger District approximately 20 miles south of Elk City, Idaho, and 2.5 miles west of Dixie, Idaho. Started by lightning, it was burning in subalpine fir and lodge pole pine with numerous snags, and was burning mid-slope up to the ridge-top on an east facing aspect. The understory was bear grass and grouse whortle berry with enough large diameter woody debris to put the area into a Fuel Model 10 or TU5 (Timber Understory 5) (**Photo 1**).

Photo 1 – Looking upslope along the southern end of the fire showing the fuel loading and type in the Fire area.

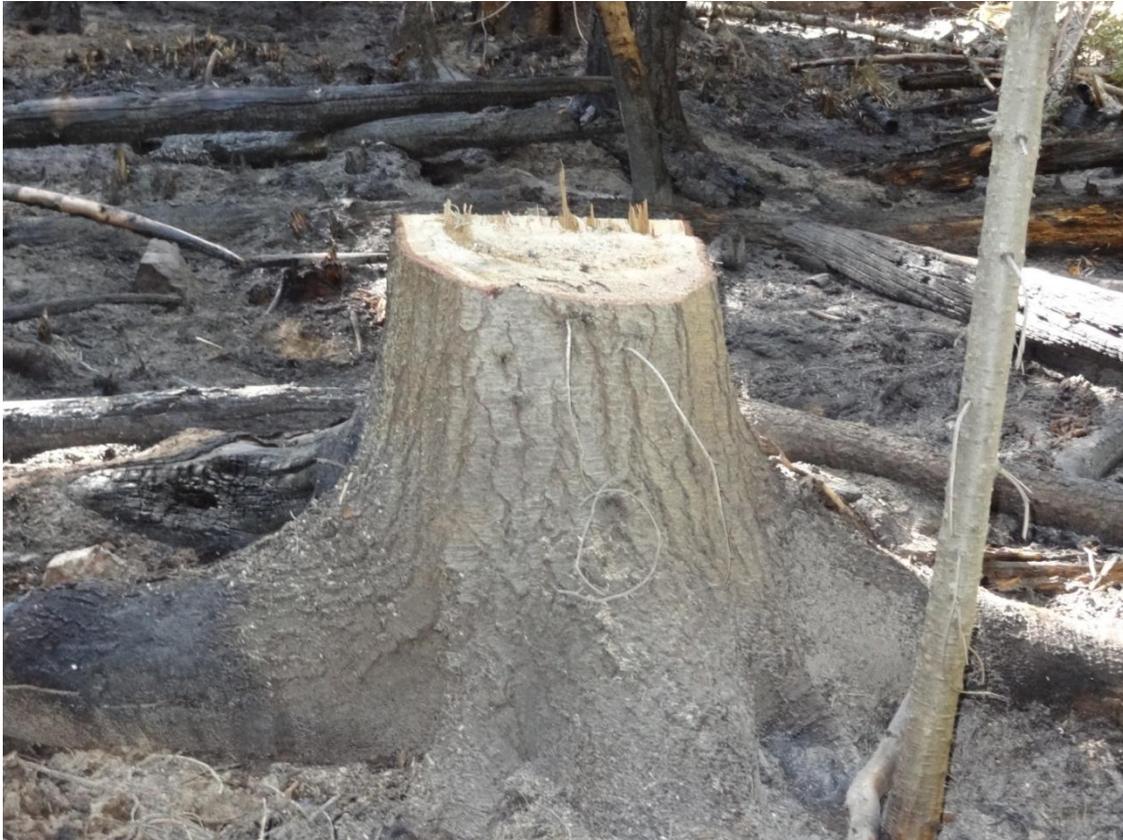
There was less than a chain of handline left to construct to tie into the smokejumpers line as it began to get dark. The IA module was working to complete that portion of the line prior to bedding down for the night. As the IA Module continued to construct handline and it became darker, they lost track of their proximity to a 60 foot sub alpine fir snag that had previously been identified as a hazard tree when they

witnessed it burning in its split top. They were constructing fireline within 4 feet of the base of the hazard tree.

It was around 22:00 when one of the forks at the top of the snag broke and fell approximately 45 feet striking a firefighter in the head, shoulder and back, knocking the firefighter to the ground (**Photos 2, 3, and 4**).

Photo 2 – This is the stump of the snag that dropped its top on the firefighter. The base had a small scorch on the upslope side, which may have occurred after the incident.

- If overhead hazards are identified, even if the snags are lower priority to fall, make sure resources know they need to mitigate the risk posed by these hazards. This could be done in many ways, such as moving line placement or working in other areas until the overhead hazard can be effectively dealt with.

- Mark all hazard trees in proximity to the fire line to ensure the hazards are recognized and mitigated.
- Firefighters need to continually evaluate the risk to themselves and co-workers and determine whether the risk is commensurate with meeting the objectives of the mission.

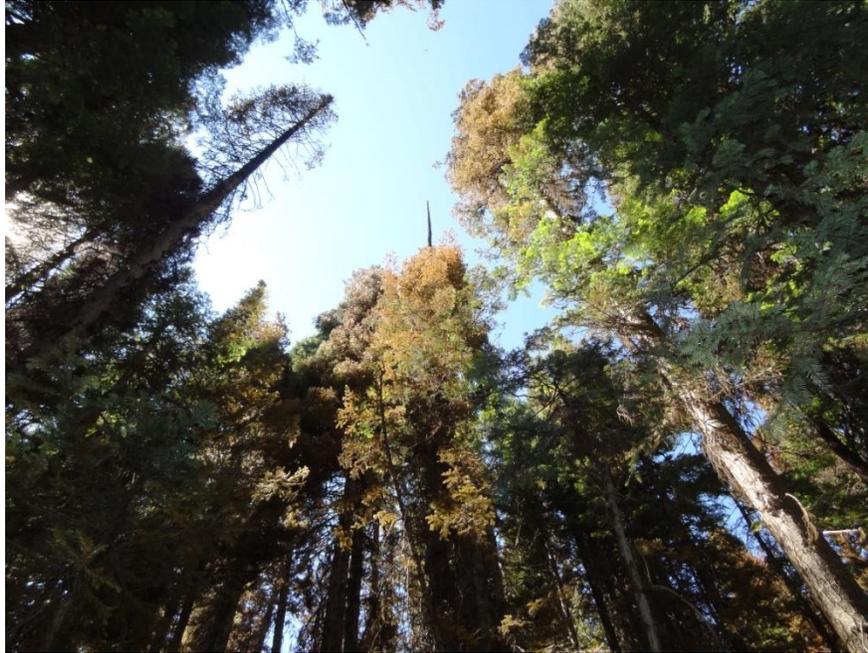
Photo 3 – This is looking upslope into the canopy standing right below where the snag was located. The only other snag in this area, which happened to be sound, is in the center of this photo well into the interior of the fire.

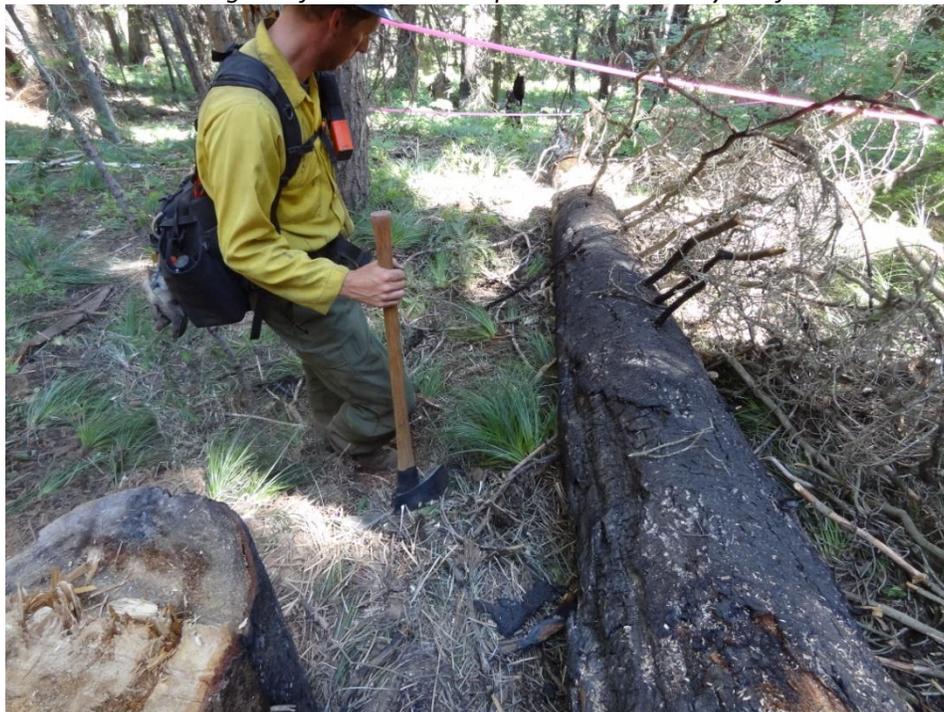
Photo 4 – This is looking down hill at the snag that dropped its top on the firefighter. The snag was felled and the top was consumed by the fire.

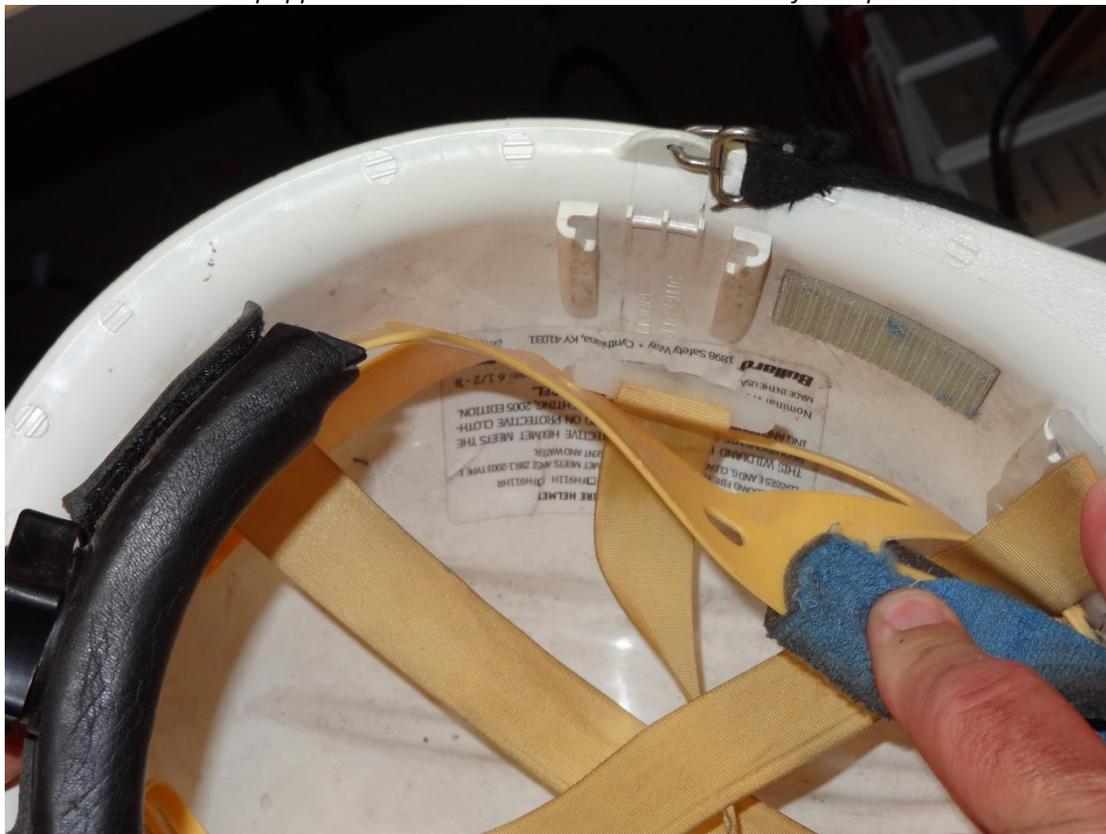
worried about” (The snag was in fact, the one the firefighter was worried about). It appeared that the firefighter’s helmet and pack took the brunt of the impact from the falling top (**Photo 5**).

Photo 5 – Looking at the inside of the firefighter’s helmet, the only visual damage is the suspension bracket popped loose. The helmet was sent to MTDC for inspection.

- The injured firefighter was wearing all required personal protective equipment (PPE) including a helmet that was less than 5 years old. The helmet performed as it was supposed to by protecting the firefighter from head injuries.

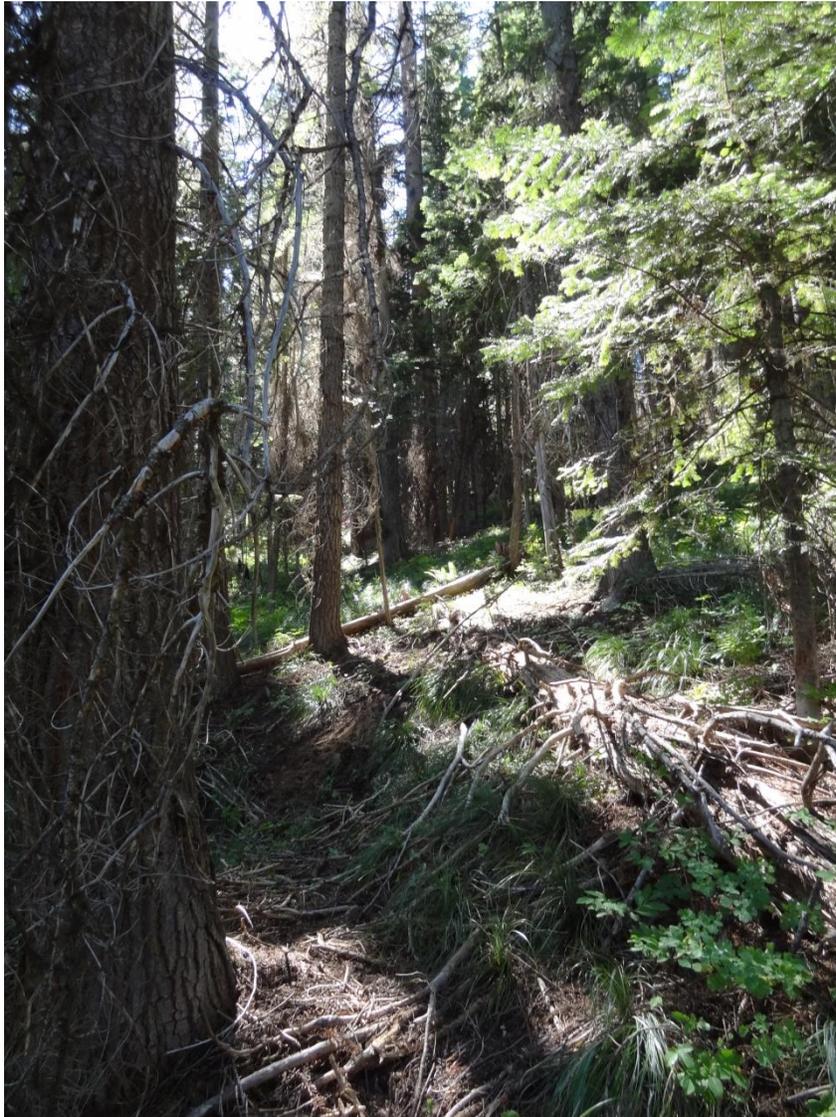
After the initial assessment it was decided by the EMT that they should move the injured firefighter out of proximity of the snag. The injured firefighter was carried to the nearest road by following the hose lay down the hillside. Even though they attempted to clear a pathway, there were numerous downed logs and branches, as well as slick bear grass (**Photo 6**).

Photo 6 – A view looking upslope along the route they carried the injured firefighter.

- Following the hose lay down to the road and having folks clear a path ahead of them was an excellent strategy in the dark. With hindsight, given the EMT assessment of the injured firefighter the responders felt they could have taken more time to get the injured firefighter off of the fire, and allowed for some additional saw work that would have made carrying the firefighter somewhat easier.

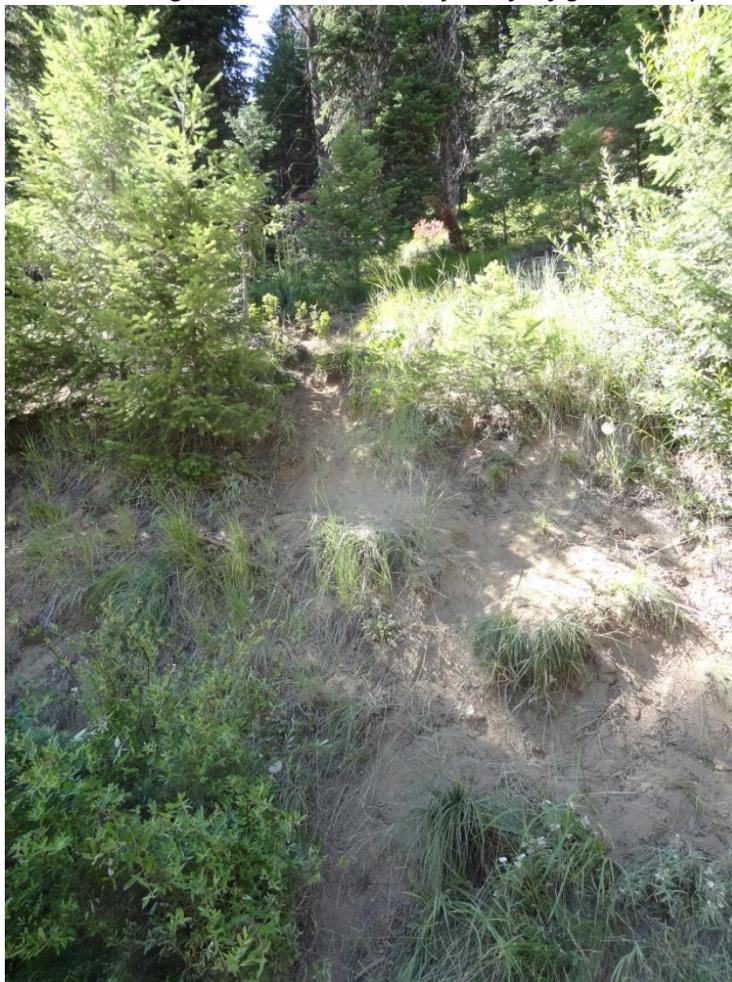
Six firefighters locked arms to carry the injured individual by side-stepping downhill approximately 800 feet, lighting the way with headlamps. An additional firefighter made sure the injured firefighter’s neck remained immobilized by holding the C-Spine in place. The final 20 feet was a cut-bank which required the injured firefighter to be daisy-chained down the hill to ensure good footing and safety of the patient (**Photo 7**).

Photo 7 – A view looking at the cut bank the injured firefighter was passed down.

- It is recommended that firefighters with potential spine injuries are transported with a backboard or similar piece of equipment. Units should consider how they can address this need based on their firefighting operations and access to this type of equipment.

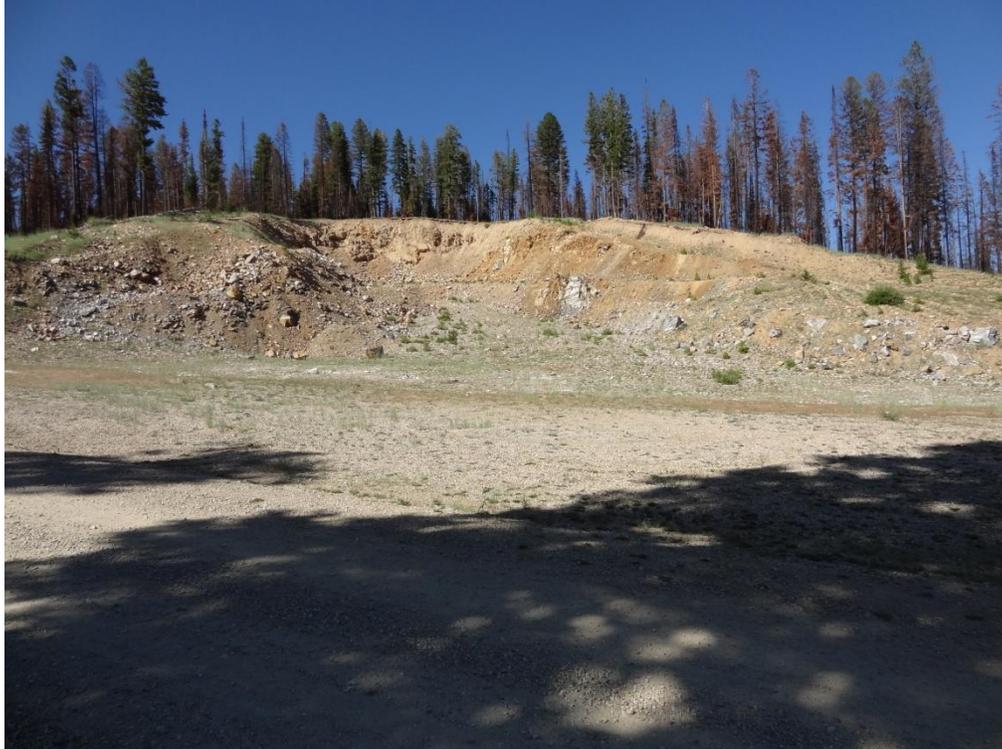
The change from a ground transport response to a medevac transport was communicated to the resources on the ground, and they provided the lat and long of a previously identified helispot (**Photo 8**) to the Elk City Ambulance. The Elk City Ambulance passed that information along to the responding medevac transport who replied that they were 15-20 minutes out.

Photo 8 – A view of the helispot where the medevac ship landed.

- Be prepared to direct a medevac ship in in the dark. Using a light source (head lamp) to identify the exact location of the helispot to the medevac pilot worked very well.
