# GREEN SHEET

## **Firefighter Burn Injury**

**July 8, 2017**

**17-CA-BEU-003551**

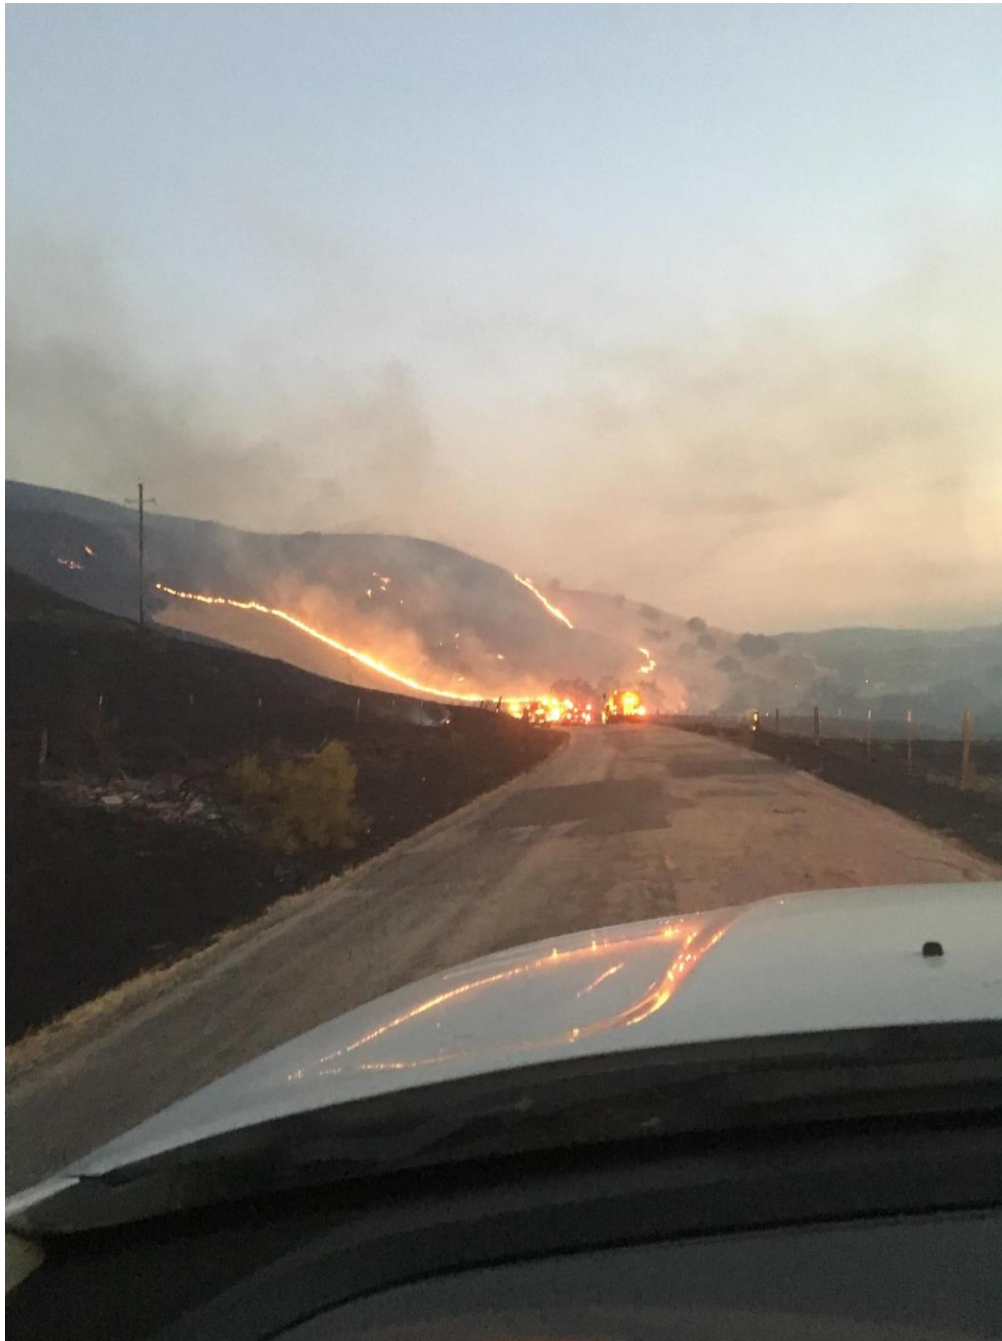
Southwest view from Vineyard Canyon Road. The incident occurred in the field on the right side of this picture.
