PINE INCIDENT
CA-ANF-2407
LAC-04142168

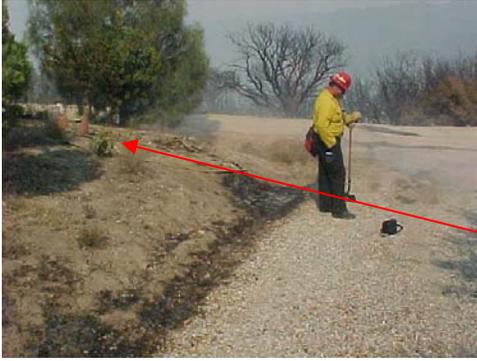
HYDRANT

Hydrant where CNF Eng 27 was filling. Planned egress was road in forefront of picture.

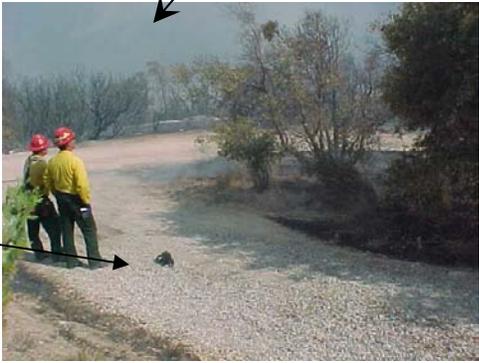
General Direction Fire Came From

Location where CNF Eng 27 was located. Engine was facing fire, the rear facing the residence approximately 150 feet uphill.

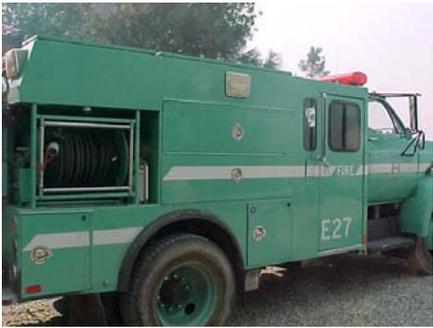
CNF Eng 27, showing no damage
