Subject: Plug Hat Fire, Damage to a Government Vehicle

# **Plug Hat Fire / Damage to Government Vehicle**

**Date: June 6, 2010**

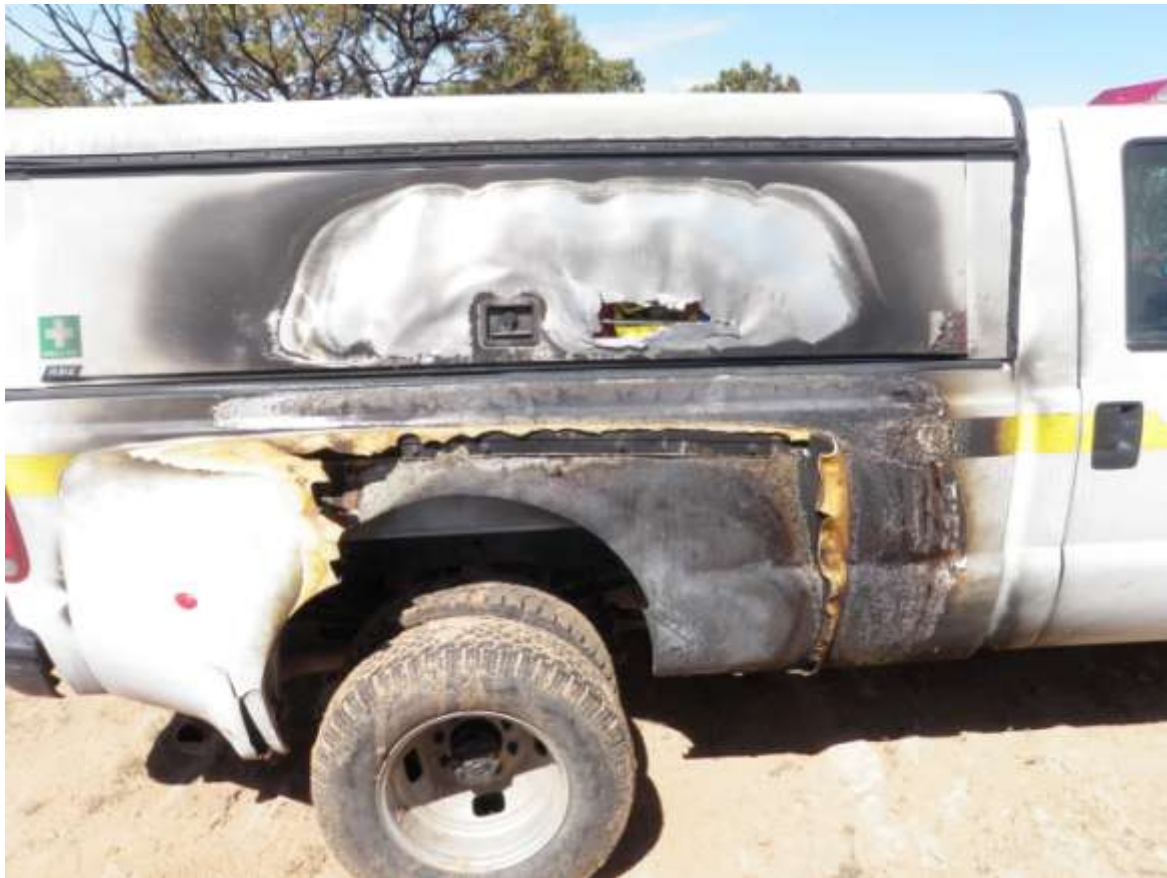
The Squad vehicle was inspected, first looking at the fire pattern, then inspecting both the damaged tire still on the axle and the one that had been replaced and was now in the spare tire rack. From the burn pattern and drip marks position of the tires when burned was established. The underside of the axle was inspected to determine that the fire originated from between the two tires and spread upward to the truck bed and shell. The only item which appeared to be damaged in the storage box of the shell was one Nomex shirt where the fire had burned through the outside door.

Squad Vehicle Damage (spare tire shown)

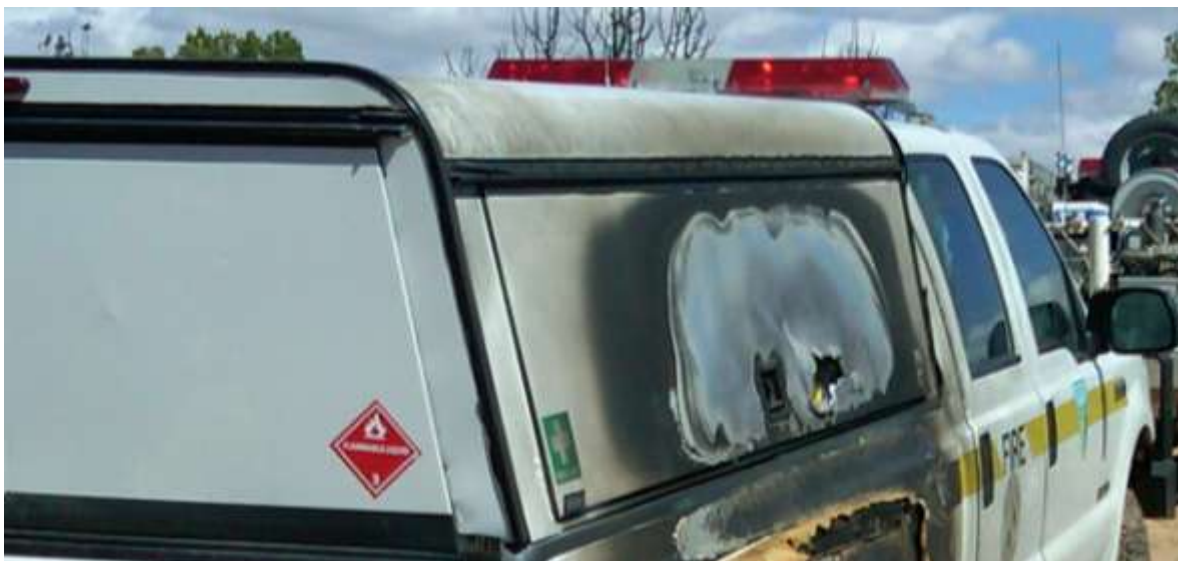
**Finding #1:** The Squad vehicle was transporting flammable liquids in the bed of the truck. Per PMS 442, Interagency Transportation Guide for Gasoline, Mixed Gas, Drip Torch Fuel, and Diesel, the vehicle was displaying the correct placard. The ICT4t did not see the placard as he was extinguishing the fire, he did not realize that flammable liquids were present in very close proximity of an active vehicle fire.

Flammable Liquids Placard

Ensure all firefighters receive initial or refresher training on the most common types of DOT labeling used on Interagency fire apparatus.

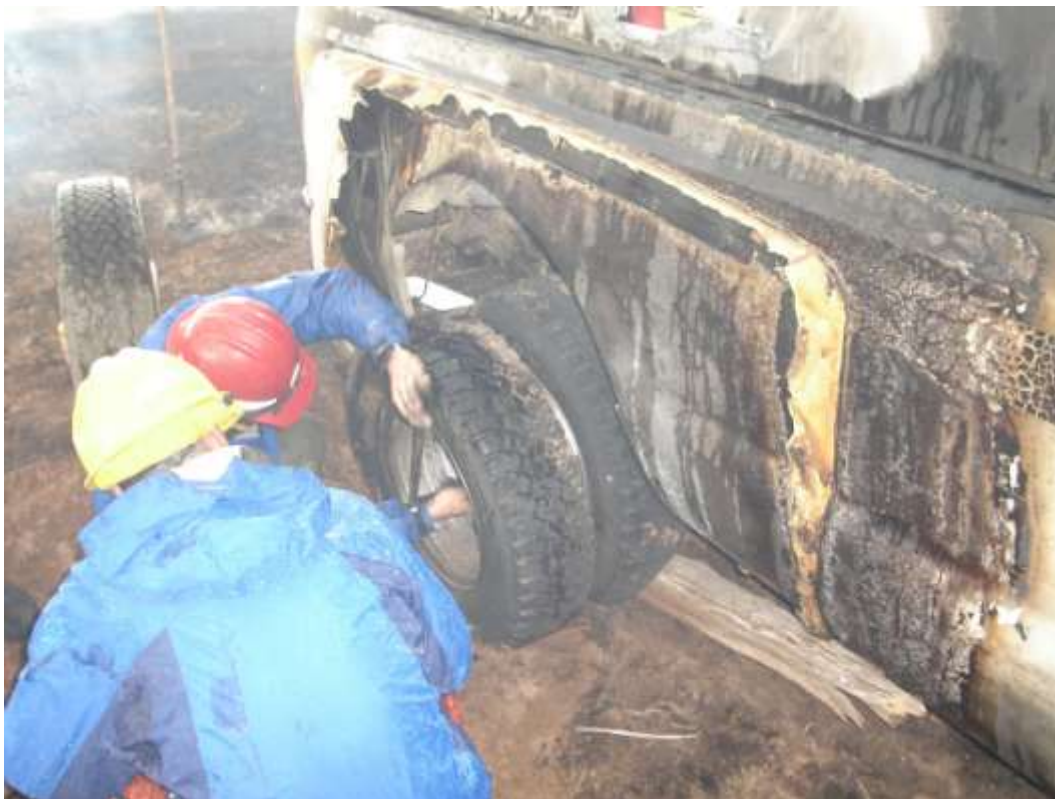
**Finding #2:** Employees appear to be unaware of the administrative processes for Accident Investigations. This resulted in loss of site preservation, disturbing the accident scene, and not allowing for conclusive findings of the ignition source.

Squad Members changing the outside tire.

**Recommendation:** With the increased emphasis on High Reliability Organization (HRO) training, the need for firefighters to better understand the accident investigation process increases as does the clear understanding of what those triggers are.

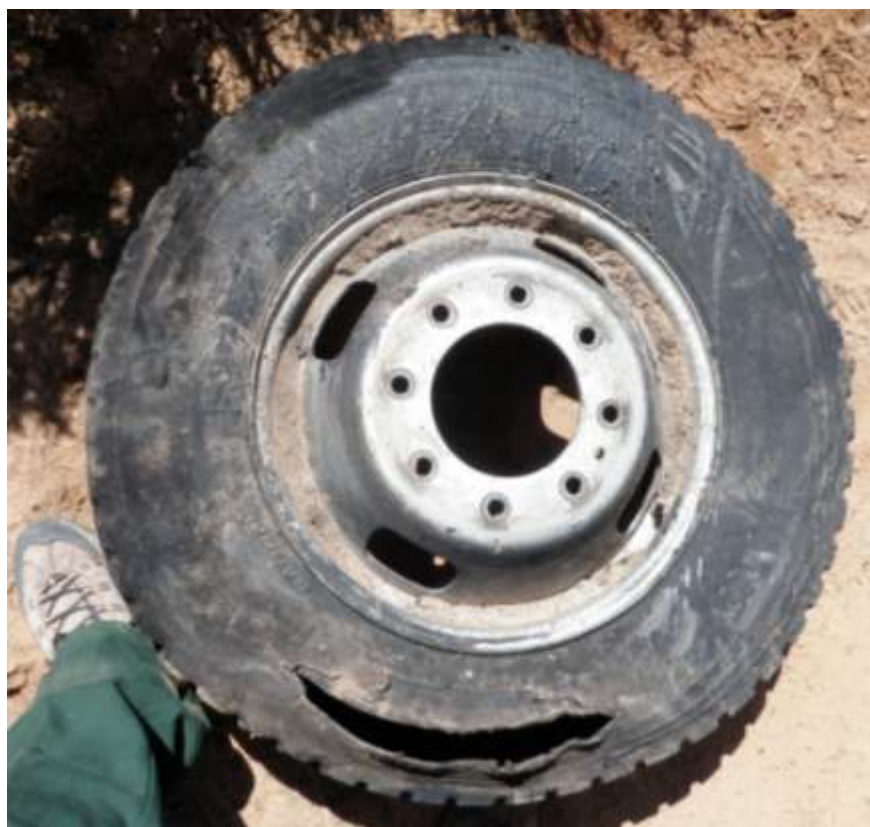
The original location where the truck was parked was inspected next. Following the tire tracks back showed the truck had drove over some sage brush that was approx. the correct width to lodge between the two tires. What caused the fire had to be picked up between the tires and then have enough fuel & time to generate the heat to ignite the tires and burn the truck. Since the vehicle had been moved and the ground where the vehicle fire had originated was disturbed, the team was unable to determine exactly what was picked up but most likely sage brush.

The location of the fire origin would have been extremely difficult to see unless someone got down on their hands and knees and specifically looked between the two tires. Also in the time it probably took to get their equipment and leave they probably would not have had any indications that the tires were beginning to burn.

Damages to Outside Dual Tire
