**CDF Fire Bulldozer Rollover
Moderate Injuries to Operator
Substantial Equipment Damage**

August 28, 2006

**Plymouth Incident
Incident Number 06-CAAEU015367**

Accident Investigation Incident Number CACNR000044

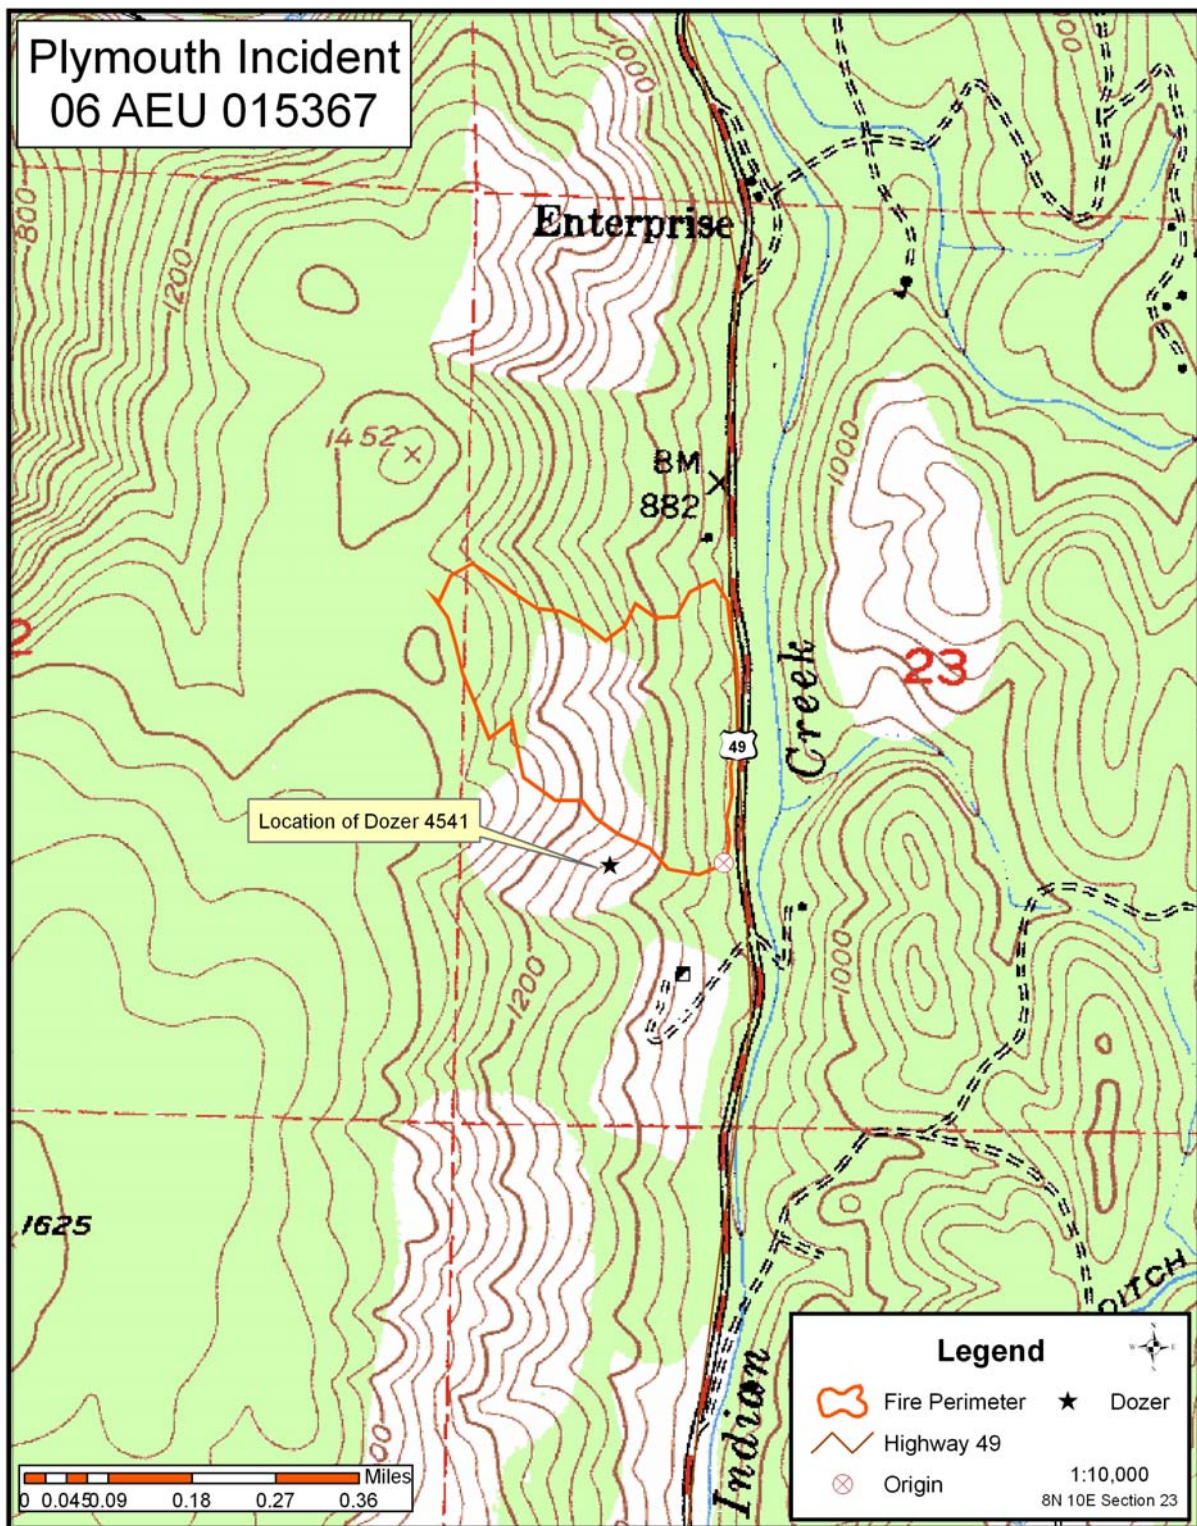
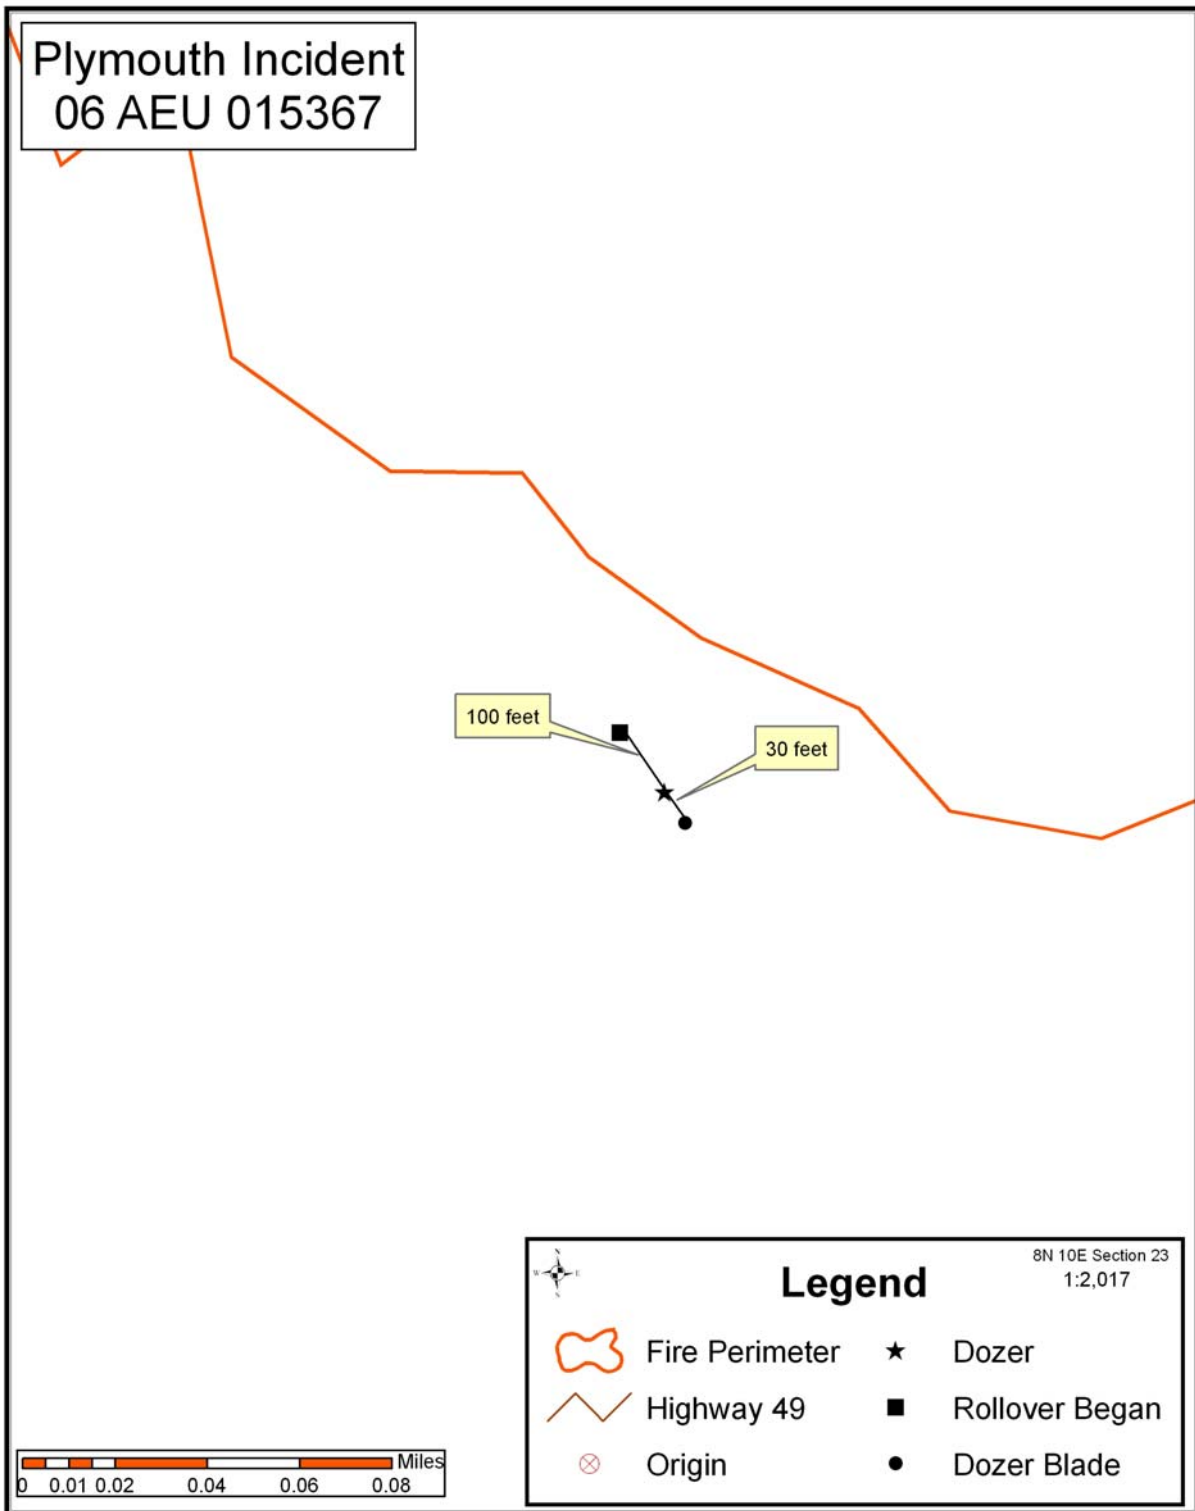
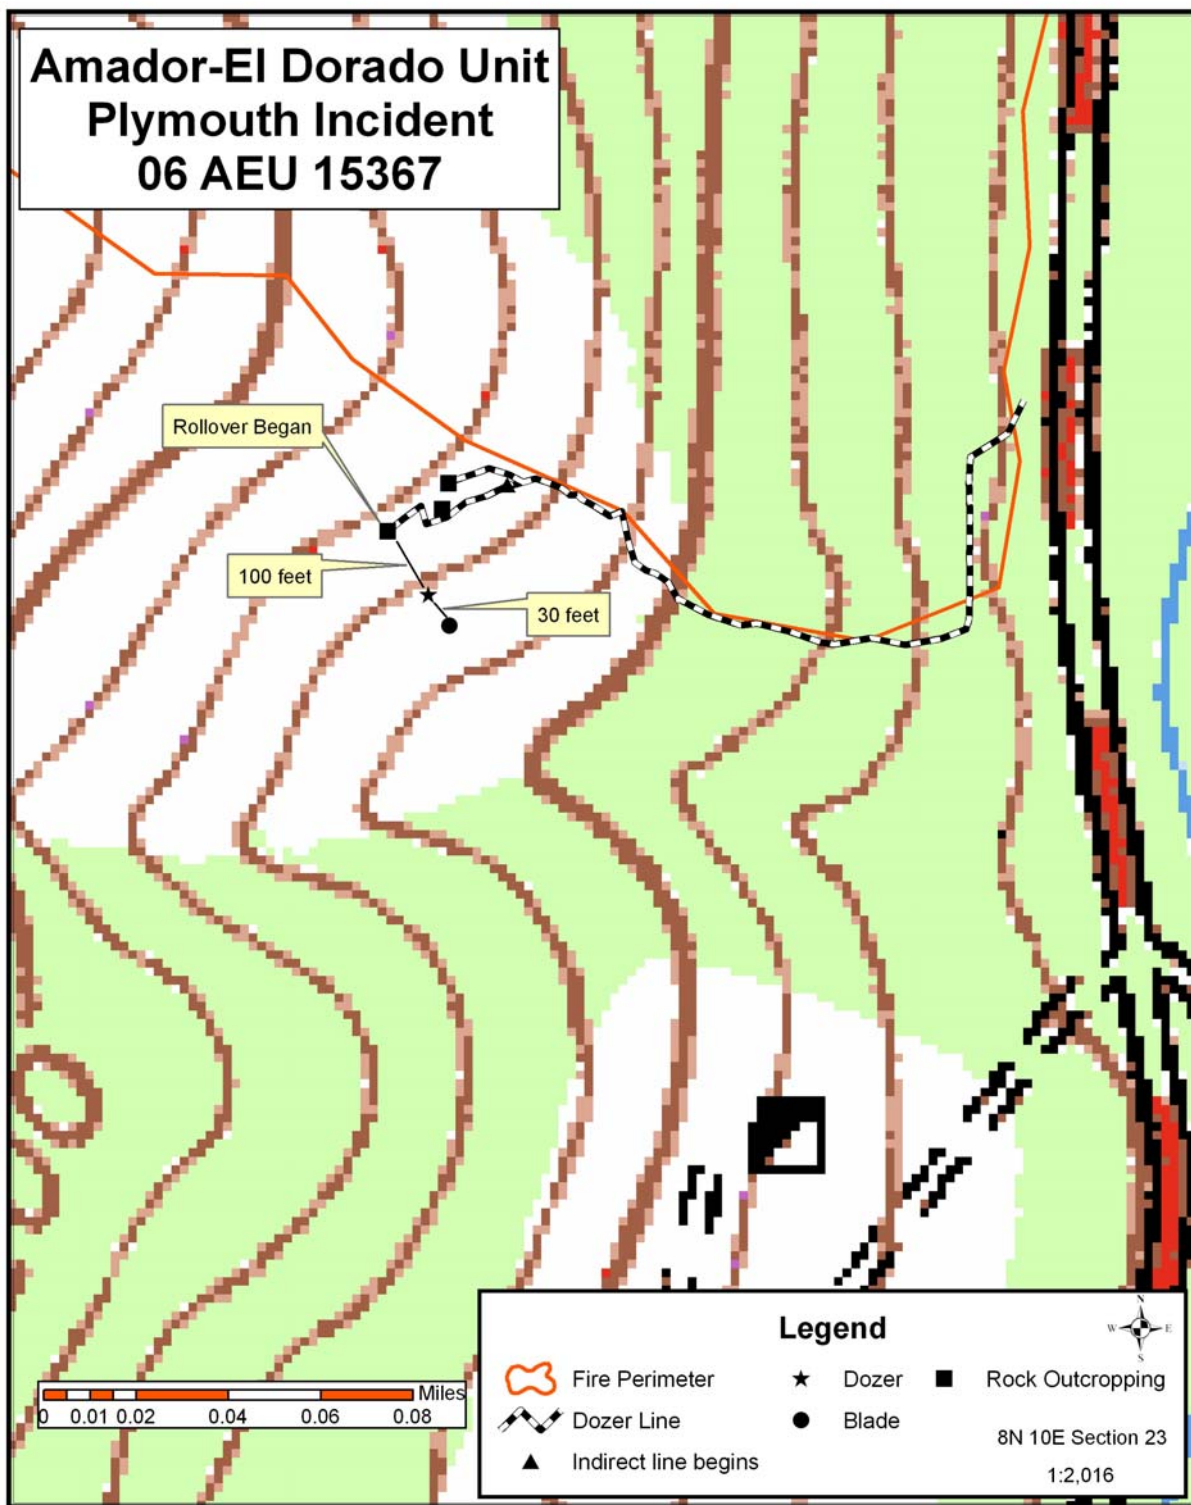
Dozer 4541 received substantial damage to the safety rollover protection system (ROPS), environmental cab, blade, window screens, hydraulic system, cab interior, swing frame, equalizer support system, and assorted sheet metal. It is unknown whether the machine suffered engine or transmission damage as a result of the rollover. The machine is considered a total loss.

As a result of the violent rolling action during descent, the ROPS has been compromised. The safety features of the ROPS system are designed to protect occupants during a slow, gentle, rolling motion. The machine, during descent, rolled up to four complete turns in a

violent manner. The ROPS systems, highly effective in slower instances, are not designed to withstand inertia forces as seen in this incident.
