# Bulldozer Damage Lessons Learned Review

Idaho Falls District BLM  
August 11, 2016

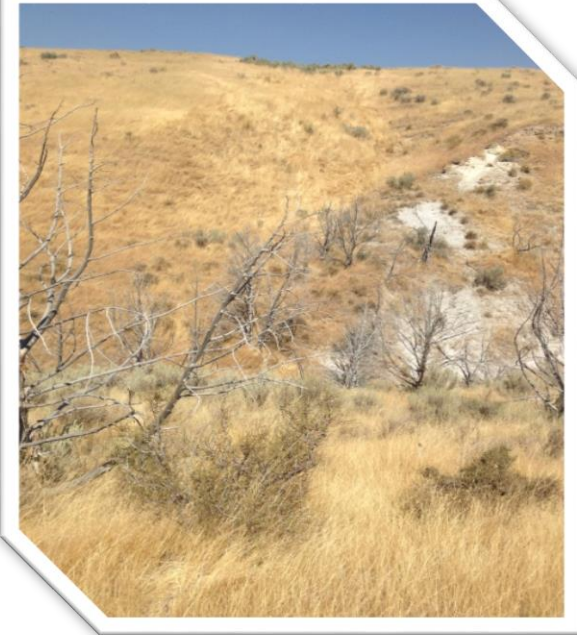
View of the fuel and topography adjacent to where Dozer #1 constructed direct fireline.

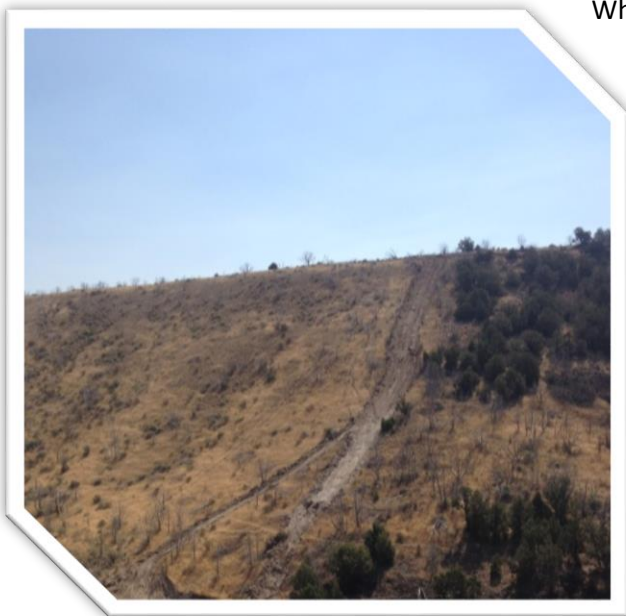
Dozer line leading into the drainage where Dozer #1 got stuck.

When Dozer #1 was about ten feet from the bottom of the drainage the operator felt the dozer “nose down.” Having little to no visibility through the dust and smoke, but feeling the motion of the dozer, the operator engaged the brake. As the dozer continued to slide downslope, the operator pushed the blade down to help him stop—but the dozer was already committed to what would later be found as a nearly vertical cutout from erosion in the bottom of the drainage.

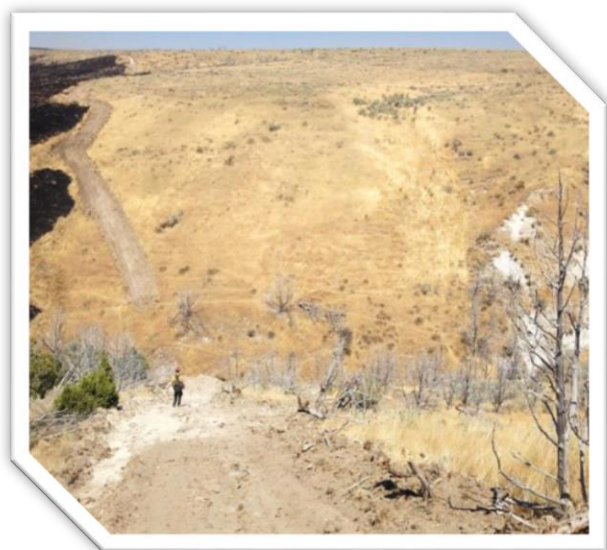
Dozer line leading into the drainage where Dozer #1 got stuck.

- Left the HEQB to scout for the dozers all night,

- Shut down one dozer and have that operator scout to at least create a single line by morning,
- Assign an entire engine crew to stick with the dozer operators to scout line and fire out any indirect chunks of line if needed, or
- Shut down dozer operations until daylight.

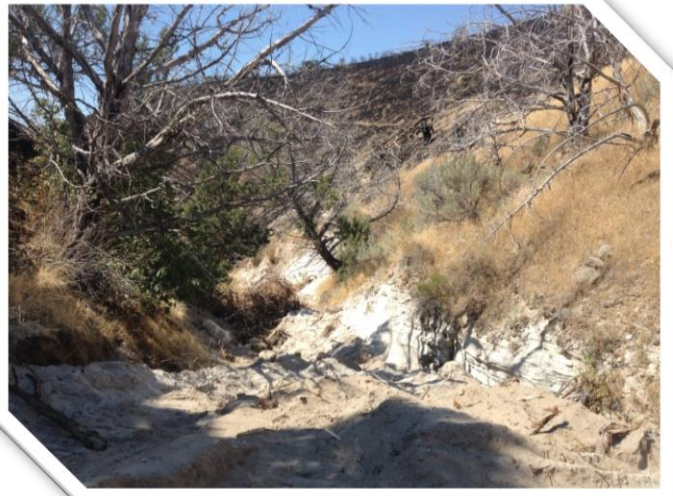
The operators decided the safest method would be to level out the slope behind Dozer #1, allowing the dozer to sit flat and mitigating any potential for tipping. After leveling the slope, Dozer #2 tried to pull Dozer #1 out with a strap, but the strap broke. The operators then tried pushing Dozer #1 with Dozer #2. In the process, Dozer #1’s left blade angle ram broke because the blade was stuck in the ground and had been buried by debris from the leveling work. The blade tilt ram was also broken and the trunnion ball pivot was separated from the blade. Additionally, Dozer #2’s blade was damaged from pushing on Dozer #1.

This is the pad that was leveled in the recovery efforts, not the drop-off that the dozer went over.

Dozer operators tend to be very driven individuals with a desire to succeed, especially when it comes to putting dozer line around a fire. When the dozer got stuck, they put their experienced minds together to figure out a way to free the dozer and complete the line as requested. However, their efforts to get the dozer unstuck ended up causing unforeseen adverse consequences. All of the damage to both dozers and the resource damage to the drainage bottom was done in the recovery phase of the operation. The lesson here is that as long as the equipment and personnel are in a safe spot, wait until daylight, then order the right recovery equipment and get recovery ideas collected when the adrenalin from the incident has worn off.

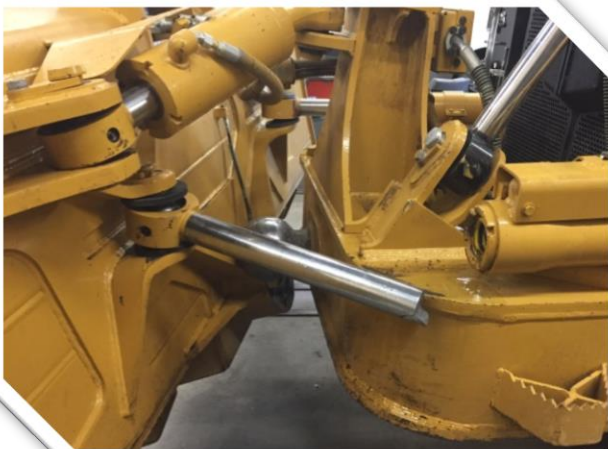
Dozer #1's left blade angle ram as well as its tilt ram were both broken.

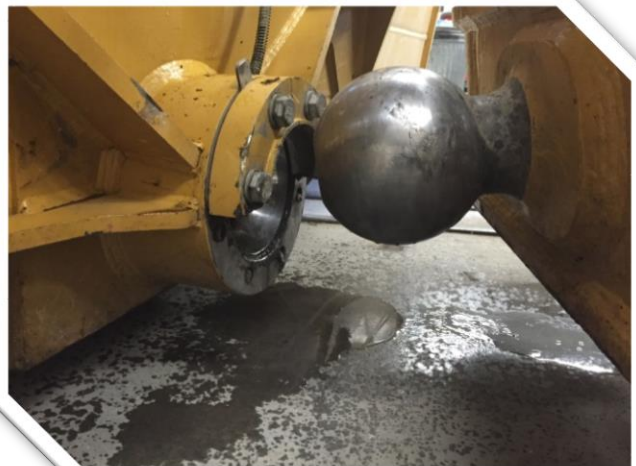
Dozer #1's trunnion ball pivot was separated from the blade.
