Rapid Lesson Sharing

Event Type: Engine Bed Mounting Bracket Failure

Date: March 7, 2016

Location: Ozark-St. Francis National Forests, Arkansas

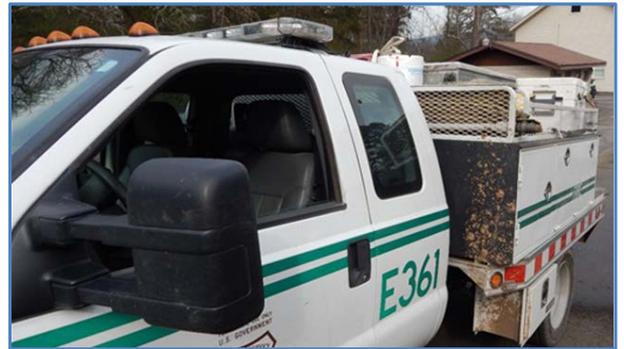
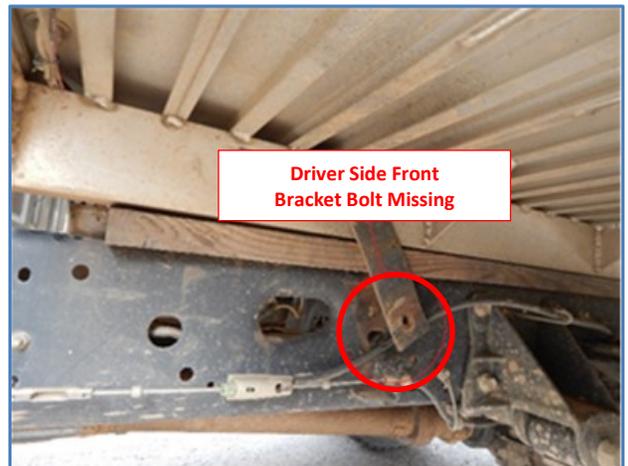
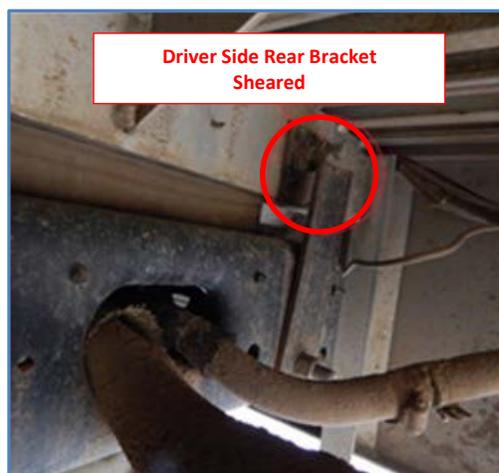
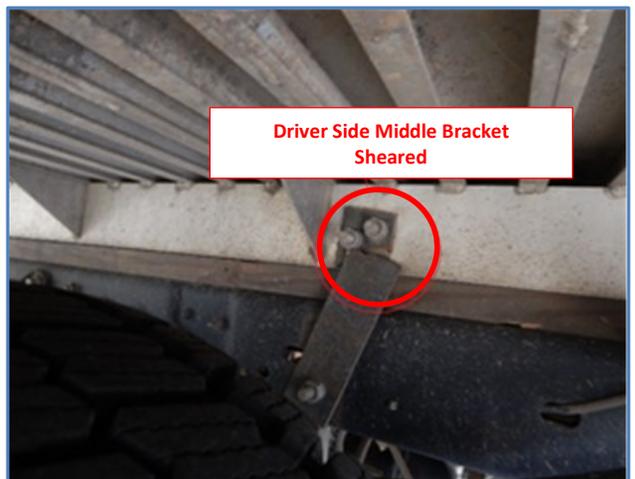
He discovered that the bed had been mounted to the frame with six pieces of steel strap—all of which were compromised. Two of the straps had sheared completely, two had missing bolts, and two were severely bent. (See photos on this page.)

The steel straps used to mount the bed to the frame on this Type 6 Engine with a Model 52 pump package (pictured at top) were not substantial enough to withstand the load of the pump package. This resulted in hazardous consequences. The 1/4” steel plate used to mount the aluminum bed to the frame does not appear to have the strength to handle the forces involved. It is not believed that one single event caused the failure, but rather the effect of stress over time.

not been stopped by the chock block mounted on the passenger side cab of the truck (see photo on right).

- ✓ Inspect similar Type 6 configurations for similar bed mounting systems and replace/upgrade bed mounts whether damage is evident or not.
- ✓ At a minimum, ensure that bed mounts are inspected during monthly PM checks.

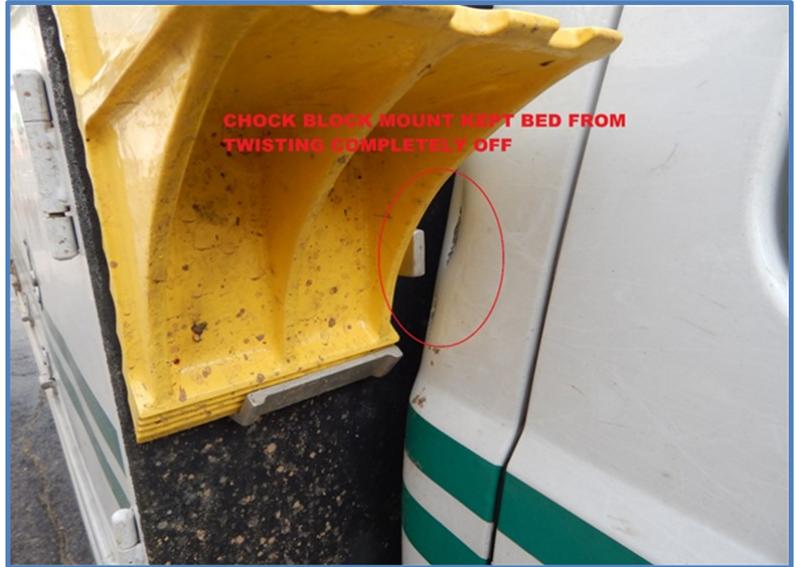
The entire bed and pump package had moved over six inches on the front.

Furthermore, it became apparent that the bed would have continued to rotate even farther off the frame had it

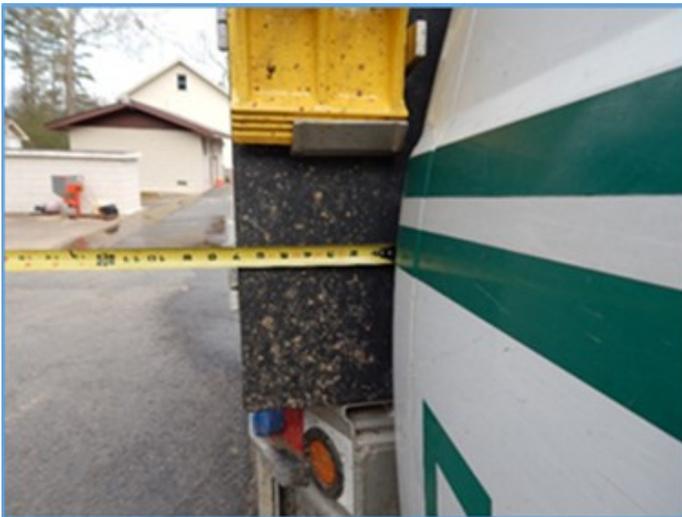
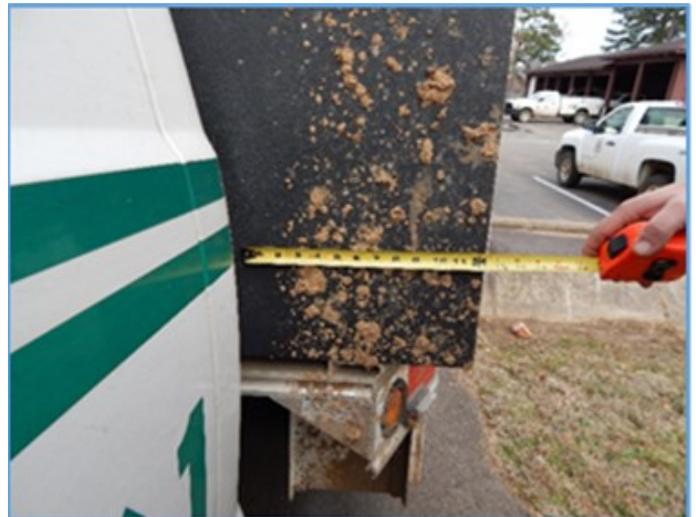
The entire bed and pump package have rotated off the frame.
