Rapid Lesson Sharing

Event Type: Type 6 Engine Wheel Torque Malfunction

Date: Nov. 15, 2016

Location: Oklahoma, Traveling on Interstate 40
Just West of the Arkansas State Line

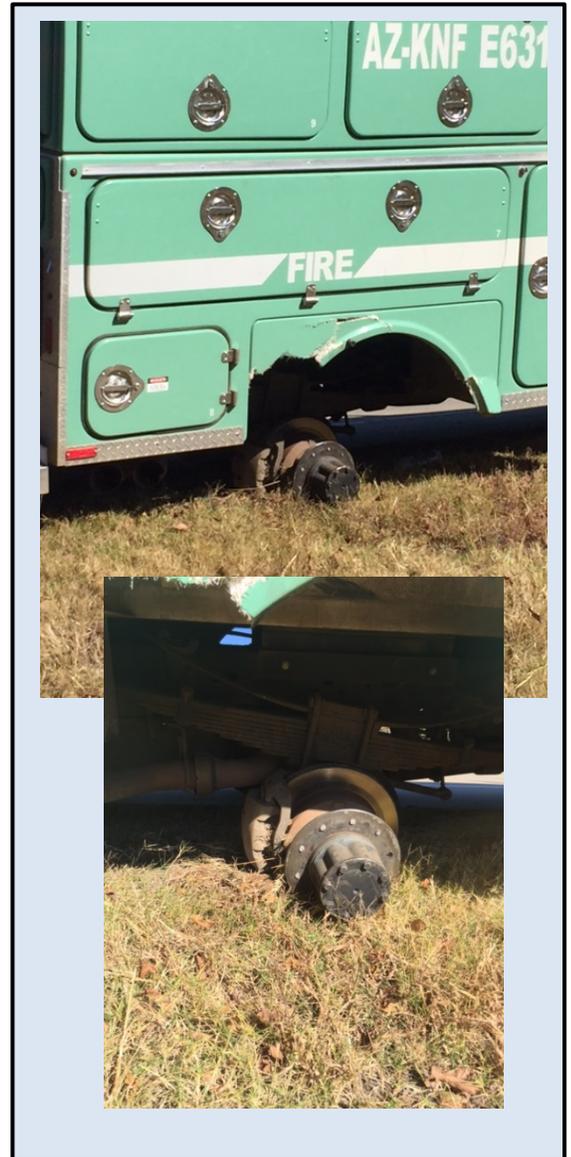
Kaibab National Forest Engine 631 was traveling to the Party Rock Fire in North Carolina when the Operator felt a change in driving characteristics in the engine handling—and a wheel from the passenger-side rear duals passed them.

Shortly after this event, the second wheel came off and ended up in traffic behind the Engine.

- ❖ One destroyed tire,
- ❖ Two unreparable rims,
- ❖ A damaged rear rotor,
- ❖ A damaged rear hub, and
- ❖ A damaged fender skirt.

This Engine had just come from a local vendor for service. New tires had been installed all the way around. The Engine was picked up and made ready for the two-and-half day trip to North Carolina.

This Unit will now be purchasing torque wrenches for all of these type of vehicles.

✓ Units should purchase proper torque wrenches for vehicles that have special procedures.
