# Rapid Lesson Sharing

**Event Type:** Wing Tip Strike

**Date:** Nov. 30, 2016

**Location:** Tri-Cities Regional Airport  
Blountsville, Tennessee

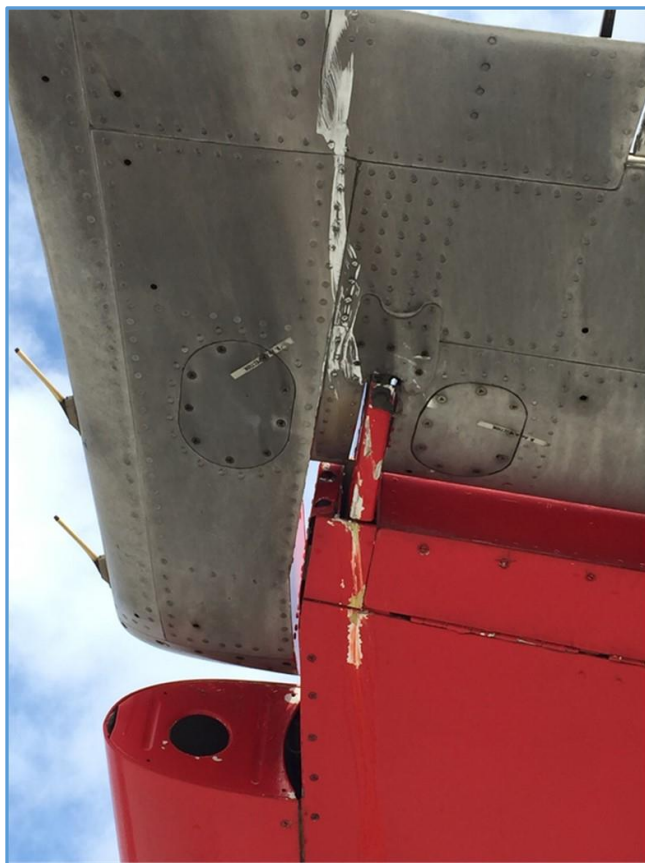
Photo shows some of the damage that occurred to the underside port wing of Tanker 41.

At the Tri-Cities Regional Airport in Blountsville, Tennessee on the evening of Nov. 23, 2016, a corporate Gulfstream Jet (Gulf Stream 4) taxied between another private business jet (Lear Jet) and Tanker 41 (T41), resulting in the underside of the Gulfstream jet's left wing tip winglet striking the entire width of the underside port wing tip of Tanker 41—causing damage to the air tanker's left wing aileron, wing tip, camera shroud, and leading edge hot wing.

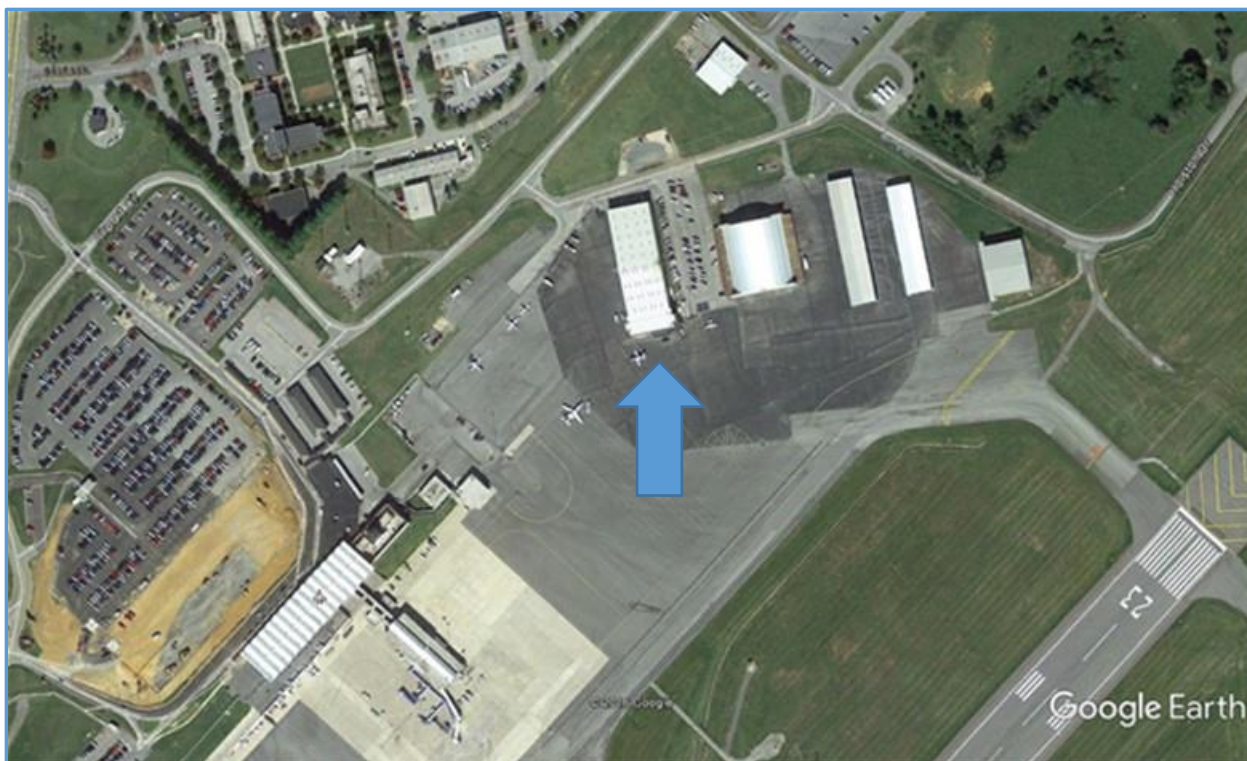
This image is orientated north. The FBO is the rectangular building, upper center, running almost north/south (indicated with blue arrow), with parking lot to right of it. To the west, running northwest/southeast, is where multiple aircraft were parked.

The FBO had a ground guide, with lighted wands, directing the Gulfstream jet into a parking spot south of the FBO, rather than to the southwest where T41 and other aircraft, including the two CL 415s, were positioned in a line from the southwest extending to the northwest.

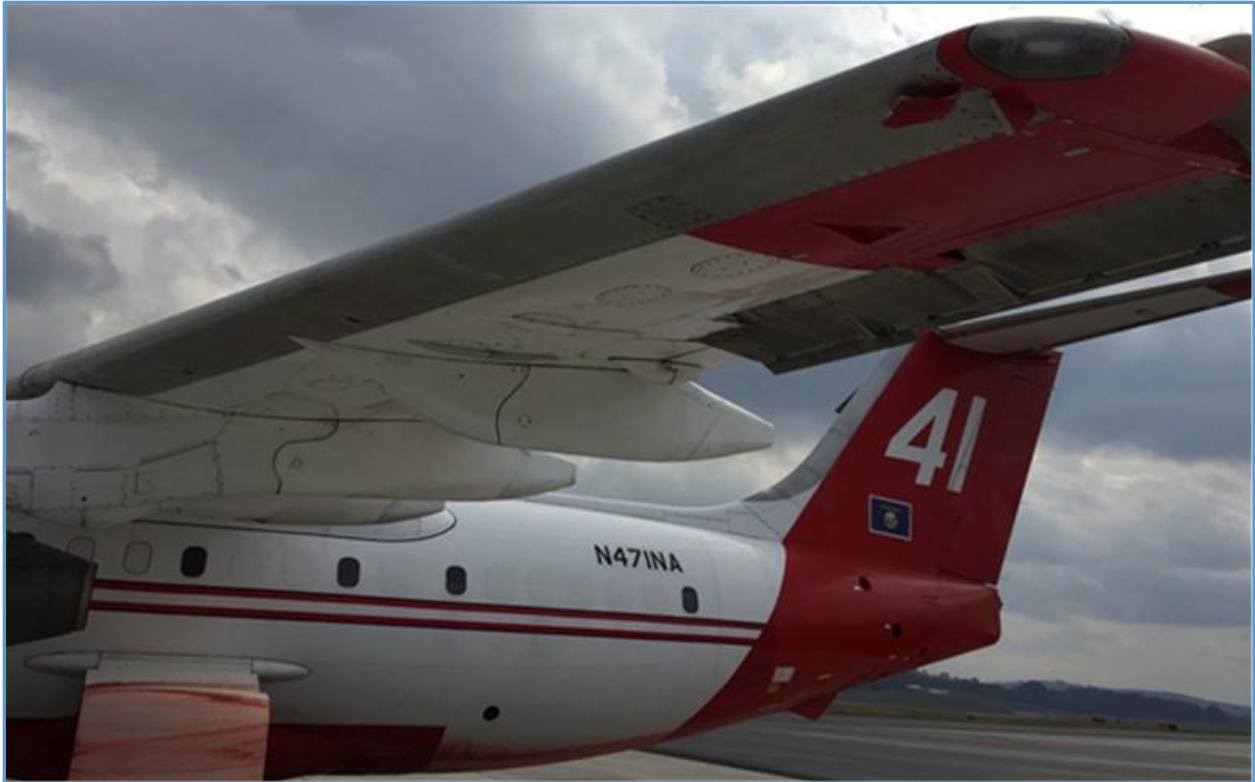
- ❖ The Gulfstream jet's wing span is 77 feet, 10 inches.
- ❖ The distance between T41 and the Lear Jet was 83 feet.
- ❖ Sunset was at 1716. The strike incident occurred at approximately 1730.
- ❖ The Gulfstream pilot was a seasoned corporate pilot with a considerable amount of flight experience.

- ❖ The Gulfstream pilot operated consistently out of this airport.
- ❖ The Gulfstream pilot did not follow the parking tender's directions.
