# Fire Entrapment Investigation

Idaho City Complex

Rabbit Creek Fire

# Idaho City Complex Rabbit Creek Fire Fire Entrapment Investigation Report

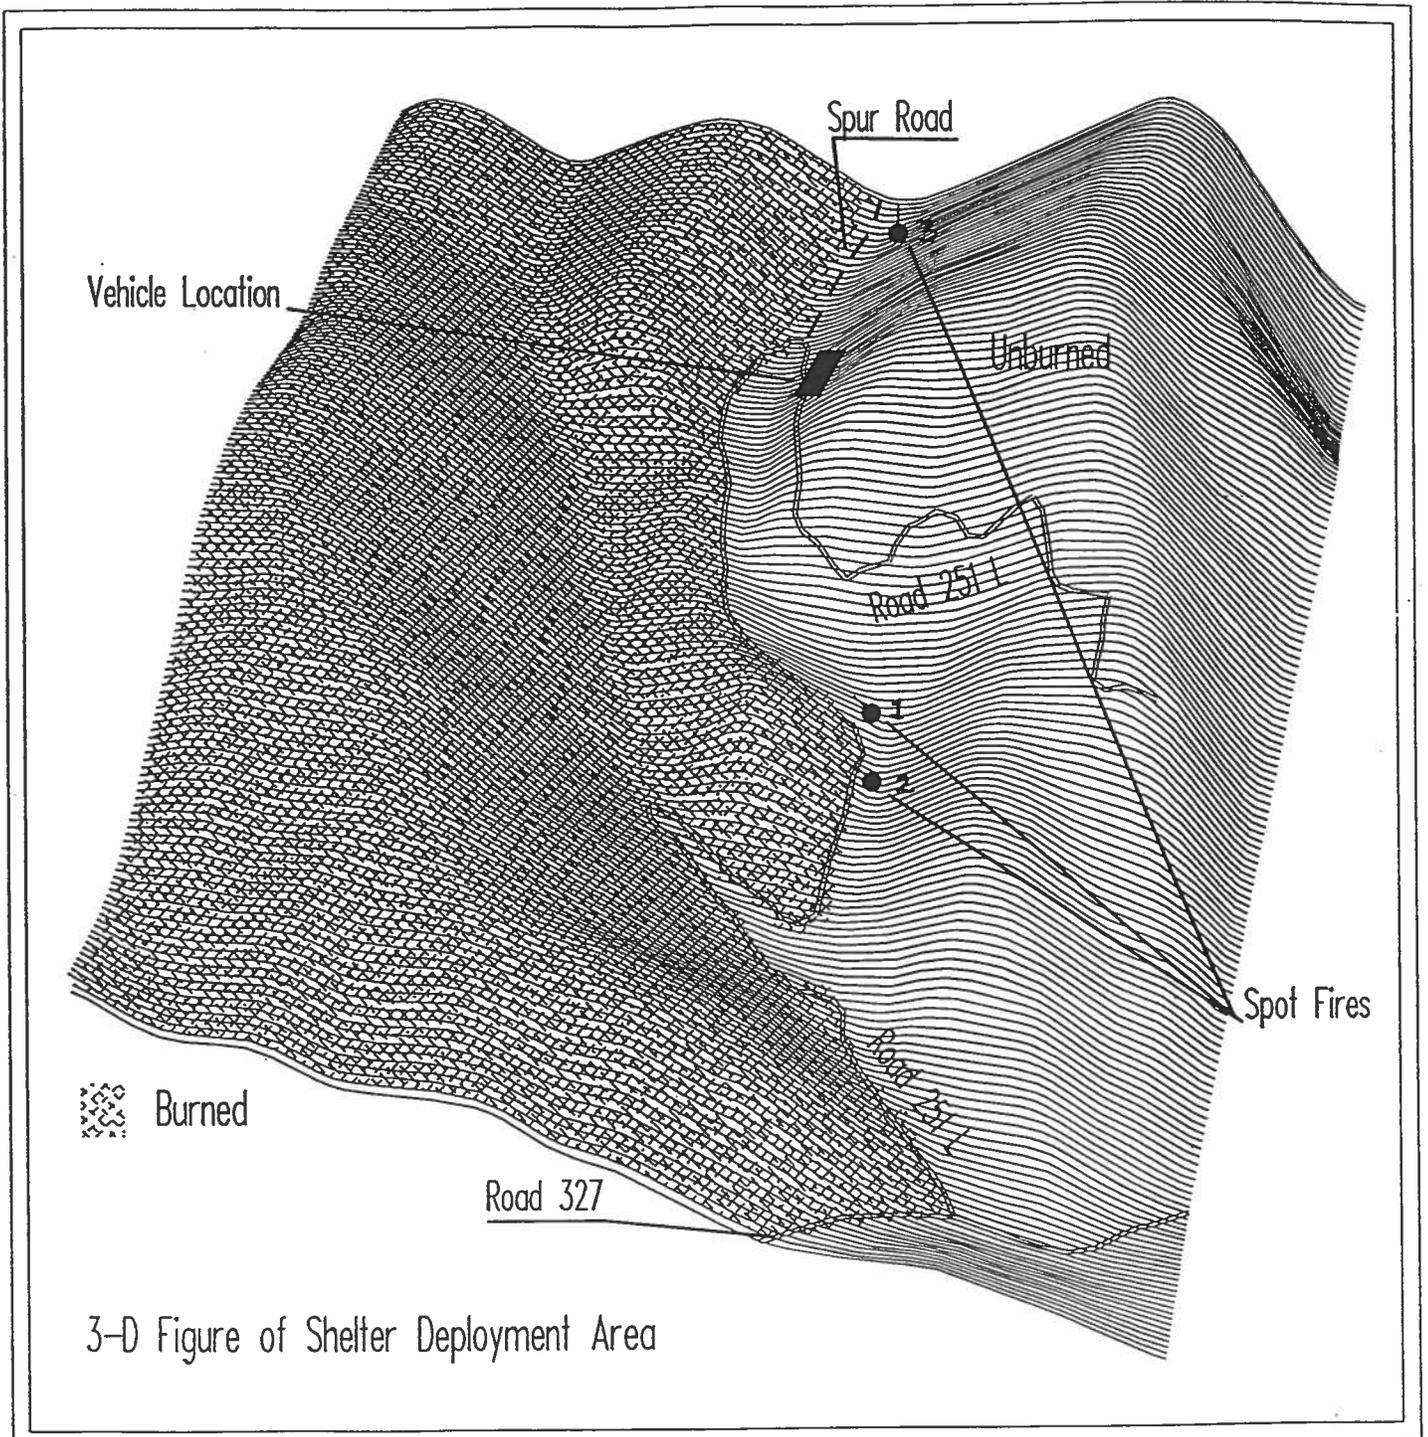
3-D Figure of Shelter Deployment Area

- The deployment area was situated in the middle of a draw or chute.
- The slope on the south end of the fire run area averaged 47% with the slopes on the north end of the fire run was side 20%.

- Incident was situated in a "thermal belt" which contained the highest temperatures and lowest relative humidity compared to areas above and below the site.
- The deployment site occurred on the upper one third of the ridge in the middle of a draw or a chute.
- Slopes below the deployment site ranged from 20% on the north side to 47% on the south side.
