Sunflower Fire

Hazard Tree Felling Accident

Facilitated Learning Analysis

Tonto National Forest
June 2012

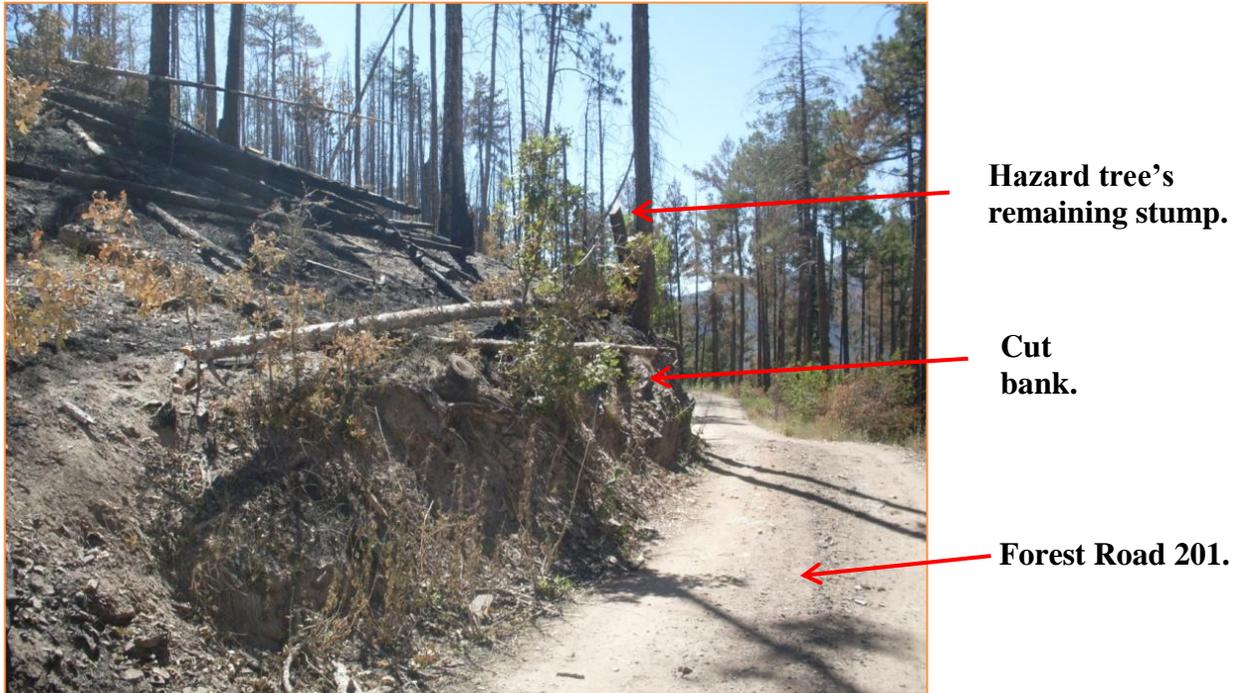
The work this day is concentrated on the uphill side of FR 201. This section of the road has a fairly significant cut bank uphill and a steep slope downhill (see Figure 4 above).

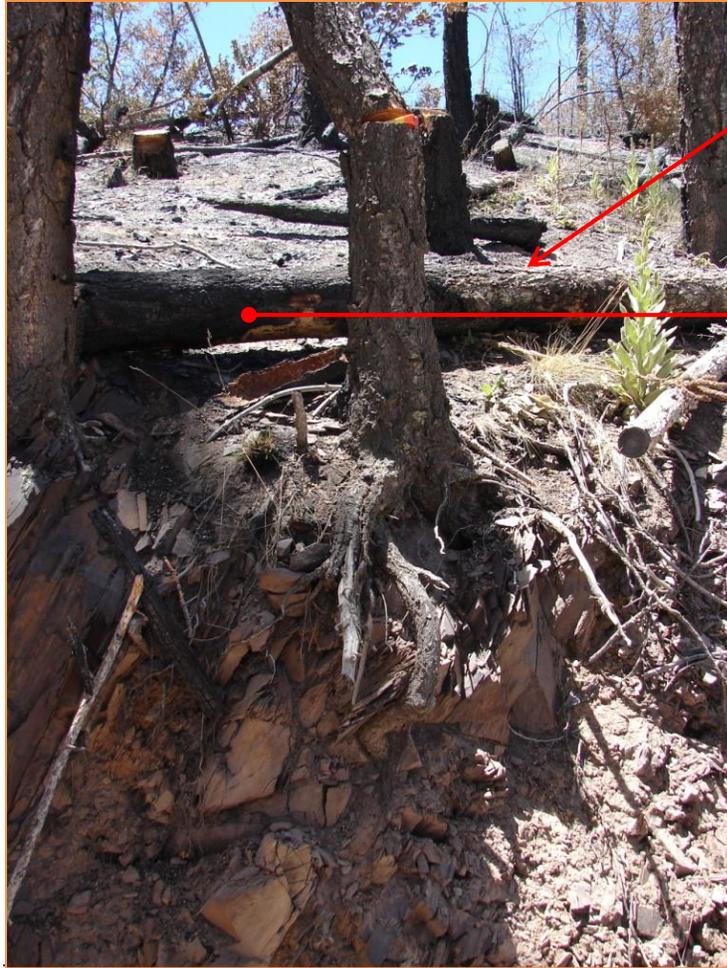
Log utilized to secure footing.

Perspective of the height of cut bank. This line marks approximately six feet above road.

Due to the cut bank, the safest side to cut this tree is on its right side (as viewed from the road). He makes all three of his cuts from the same side. His position on the cut bank also hinders his ability to use the “gun sights” on the saw. In setting up his cuts, C-Sawyer opts to leave in place a 10-inch diameter downed log to secure his footing while cutting above the road’s cut bank. He purposely straddles this log as an anchor for his right foot (see Figure 5 on previous page).

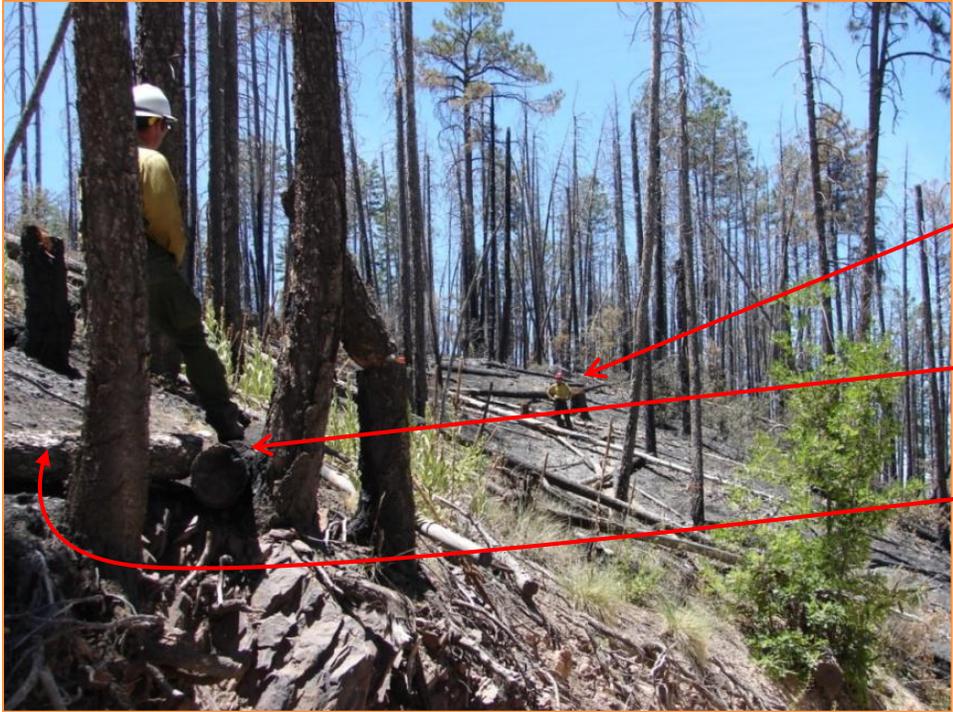
Figure 6

**B-Sawyer's
lookout position
during drop cut.**

Log used to secure footing.

**Butt end of hazard tree
that struck C-Sawyer.**

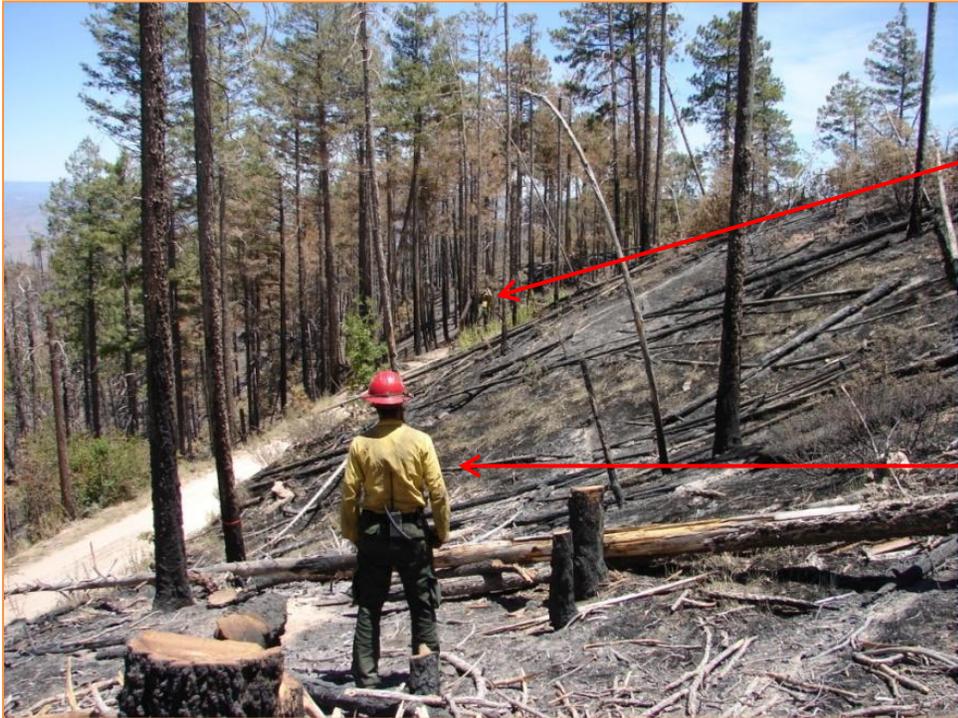
Figure 7

**Position of
C-Sawyer
making release
cut of
hung tree.**

**Position of
B-Sawyer
watching
release of hung
tree.**

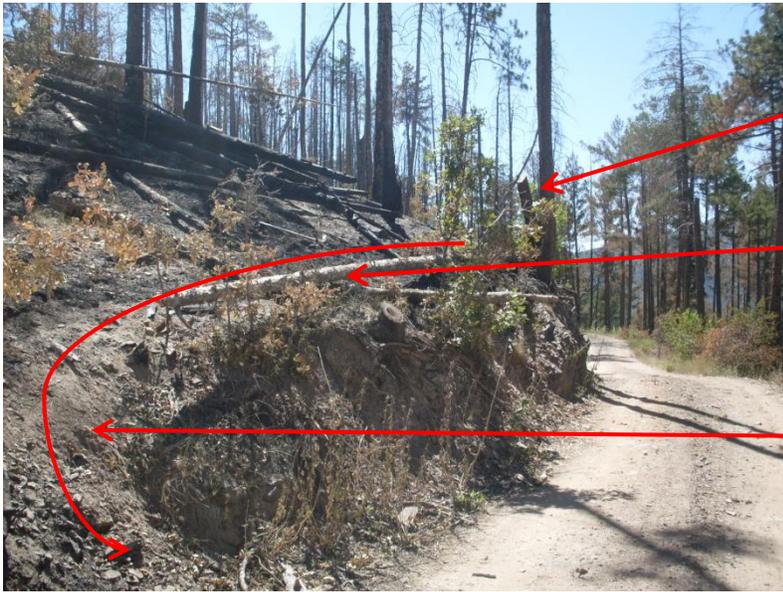
Figure 8

Hazard tree's remaining stump.

Hung tree after striking C-Sawyer.

C-Sawyer's escape route for release cut of hung tree.

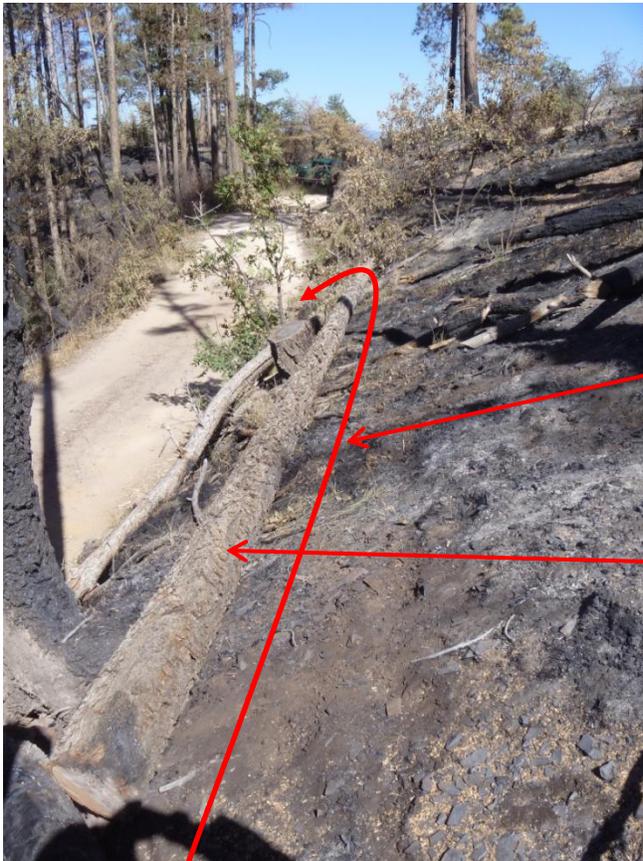
Figure 9

C-Sawyer's escape route for release cut of hung tree.

Hung tree after striking C-Sawyer.

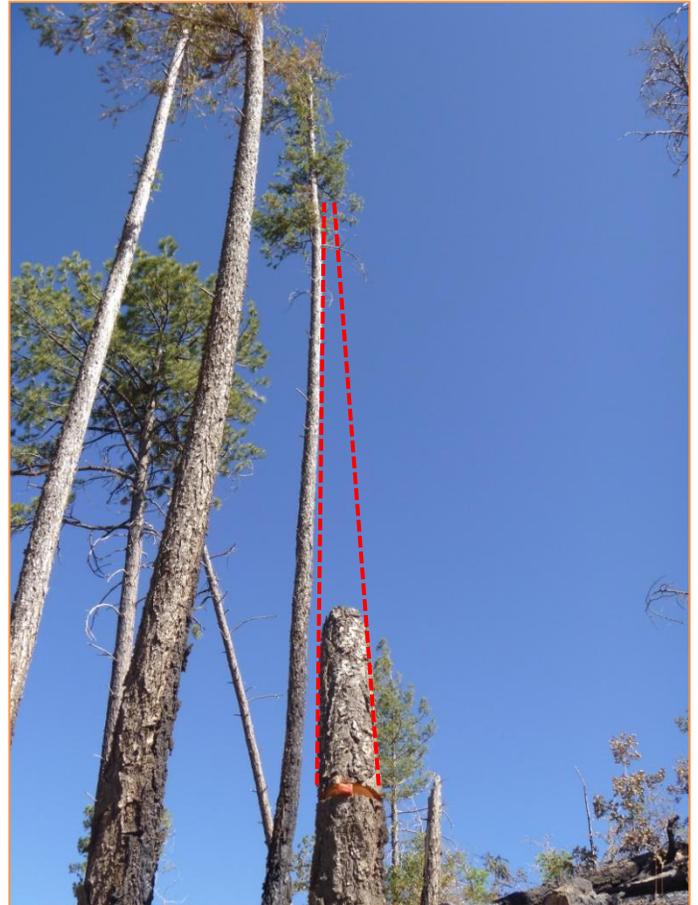
Red dotted lines show the probable position of the hazard snag where it hung up on adjacent tree’s limbs.

- Upon first assessment, the limb causing hang-up appeared to be a dead limb with no needles. Upon further assessment during site visit, it was determined this limb may have been green and therefore unable to snap away. Based on the angle of the lean (as recreated by red lines overlaid in Figure 10 (page 16), the hazard tree may have been supported by bole of green tree in addition to suspected limb. Support of the green bole may have contributed to the hazard tree righting itself (see Figure 10).

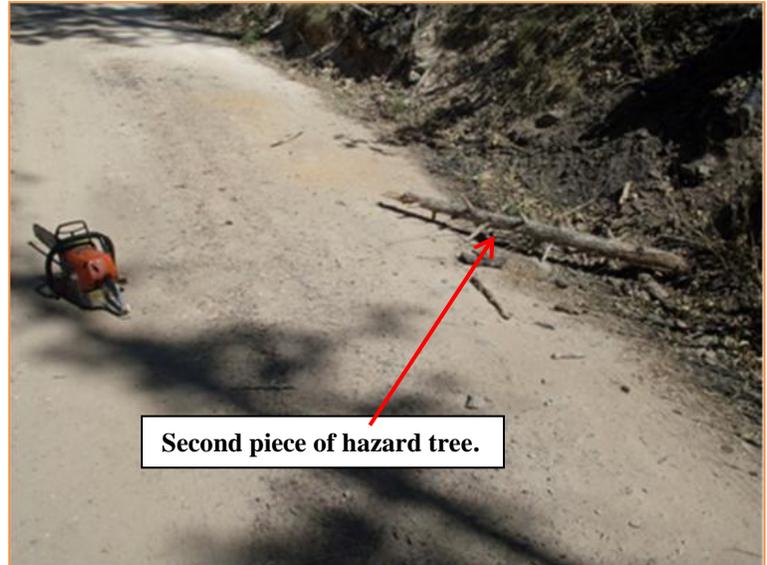
Figure 11

The energy associated with the felling tree striking C-Sawyer's right arm is also suspected to contribute to knocking the saw out of his right hand and either casting it off the cut bank or rolling off the cut bank down onto the road in an upright position.

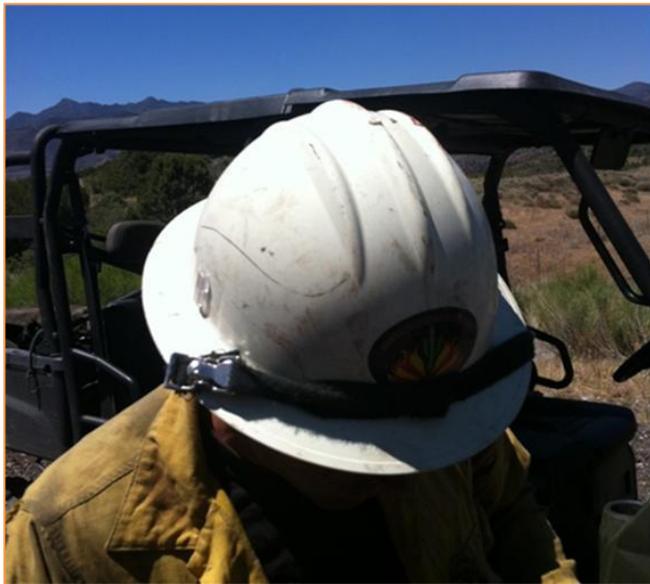
Figure 12

Scratch on right side of C-Sawyer's hard hat indicates his—and tree's—forward momentum at time of strike.
