PACIFIC SOUTHWEST REGION

August 7th, 2015

Rapid Lessons Sharing TAIL ROTOR STRIKE

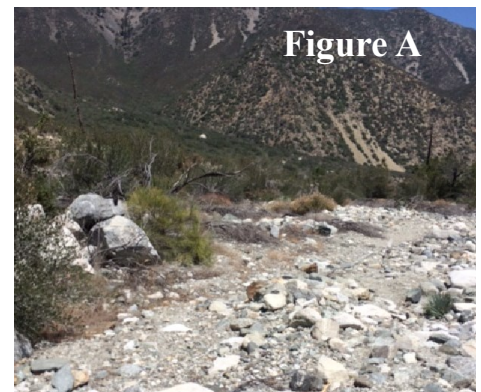
Figure A

After a recon of the area, the pilot and the Helitack crew noted several suitable areas to land and selected one located at the center of the Middle Fork within the dry alluvial river bed adjacent to the fire. Although it was characterized by rocks, shrubs, and an occasional tree snag, it was suitable based on his selected (**6Ss, 2Ws**) considerations. After deploying the crew, the helicopter then conducted water drops to support the fire which was located only about 75 yards up the adjacent hillside.

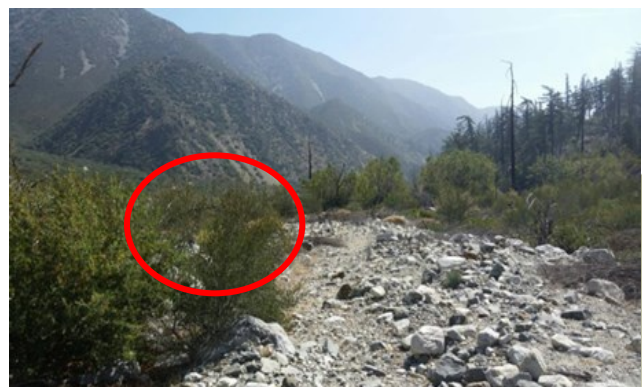
Figure B.

Rotor Strike Event: The pilot is very meticulous about the operation of the helicopter and is careful with the equipment. The technique to lift the snorkel off the ground, without dragging and damaging it on the rocks, involves lifting the snorkel hose off the ground while maneuvering slightly backwards. While similar (although reversed) to the flight profile when landing, the exaggerated tail low attitude while moving backwards involves somewhat more exposure to potential damage to the rotor, especially since visibility to the rear of the helicopter is negligible. While performing this maneuver, the helicopter struck a shrub (about 5'tall) with the tail rotor.

LZ where tail rotor strike occurred, circle identifies "strike" shrub (helicopter was in front of the shrub shown, facing down valley)

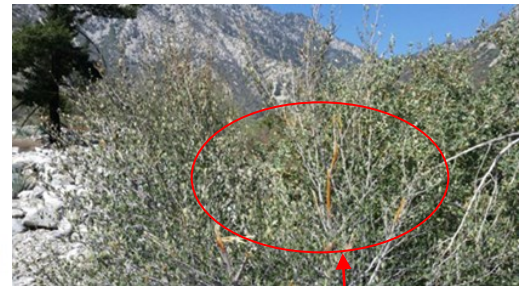
Lifting the skids, while keeping snorkel stationary on the ground

Backward maneuver to carefully lift snorkel

In moving backwards, the helicopter struck a shrub (about 5' tall) with the tail rotor .

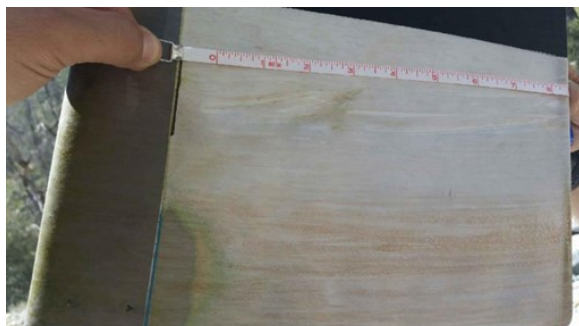
Figure C

The pilot did not feel or hear the strike, but the helicopter manager and crew on the adjacent hill heard an abnormal "whack, whack" like a rotor blade had struck "something". The crew radioed the pilot to ask if he was OK, and he indicated that he was. At that time, the pilot had no knowledge of the rotor strike and proceeded to land at a more suitable spot. After the crew arrived at the helicopter, they examined both rotor systems (main and tail) and found signatures indicating a tail rotor strike (see figure B). The crew then searched for the strike object, and found a shrub with recent damage approximately 100 yds. upstream from where the pilot had first attempted to land.

Tail rotor strikes can damage other parts or adjacent components as well as tail rotor blades, tail rotor drive shaft, 90 and 42 degree gear box mounts, and tail fin and tail boom mounts.

Pilot and Mechanic assessed damage, and although it appeared minor, they elected to stay on site to complete repairs.
