Rapid Lesson Sharing

Event Type: Dozer Fire

Date: September 7, 2018

Location: Tepee Fire, Oregon

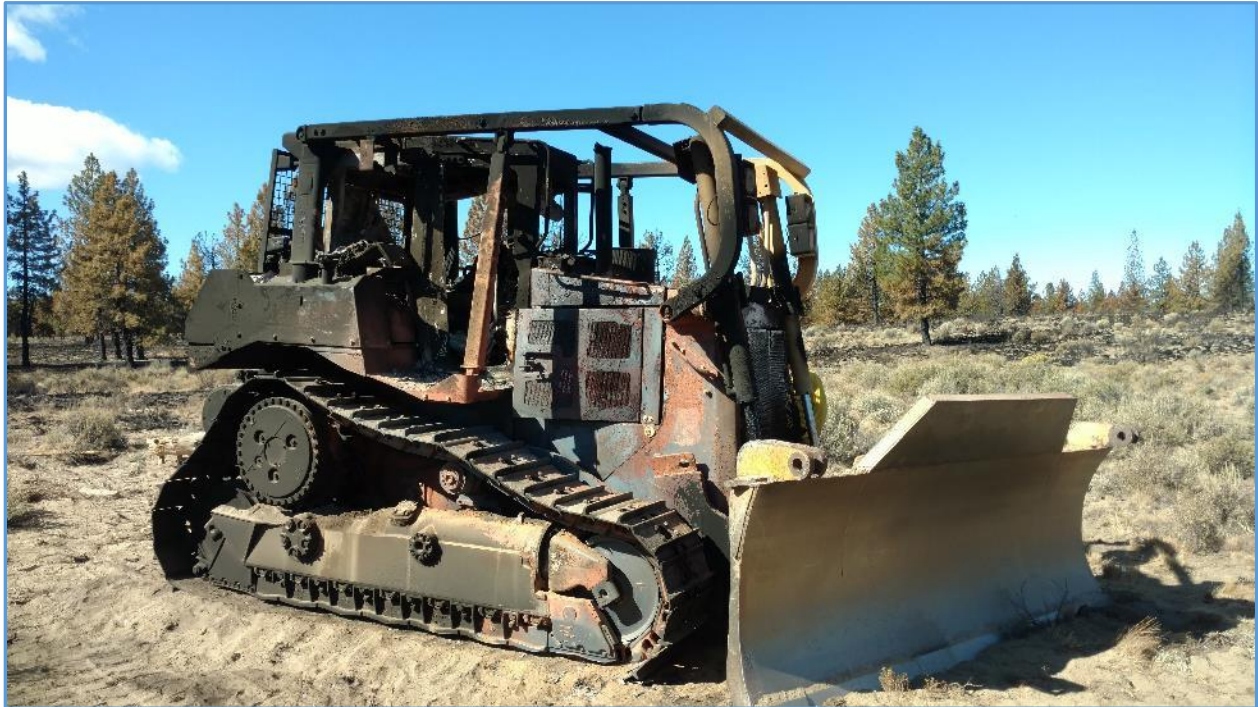
Burned Dozer 230.

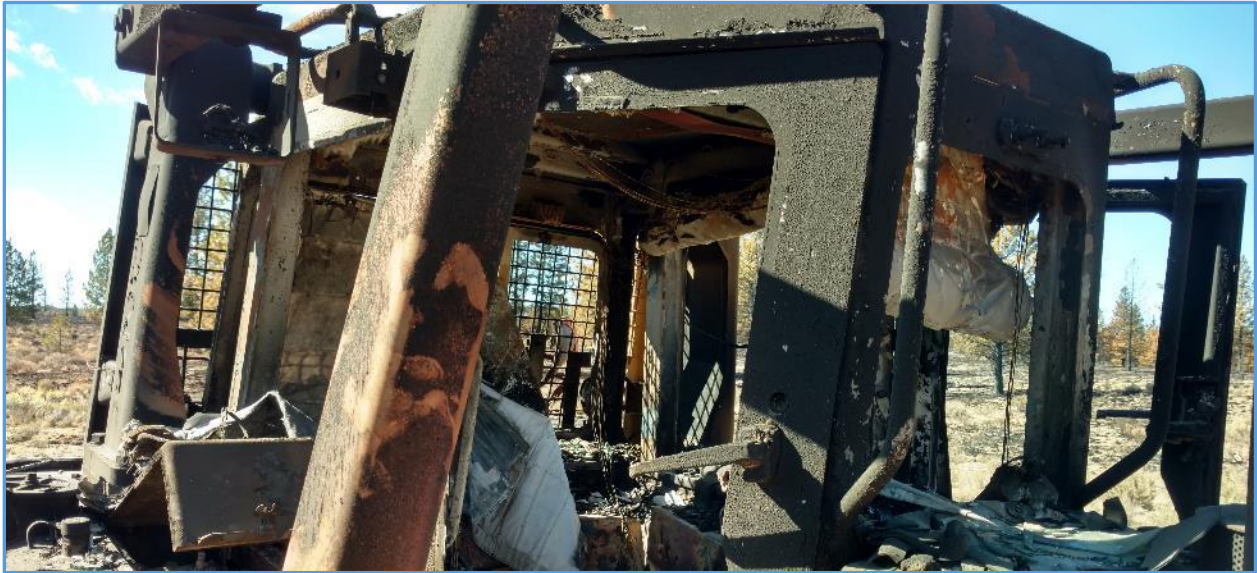
While working on his own from the southern anchor point, Dozer 230 noted strange odors inside his environmental cab. He continued with direct line construction before noticing the smell once again, but this time much stronger. He looked out the rear window and noticed smoke coming out from between the tank guard and the fuel tank.

The cab was rapidly filling with smoke. The fire extinguisher had little noticeable effect.

The operator, along with a member of Engine 332, returned to the dozer, which now had thick black smoke rolling from the cab and motor compartment.

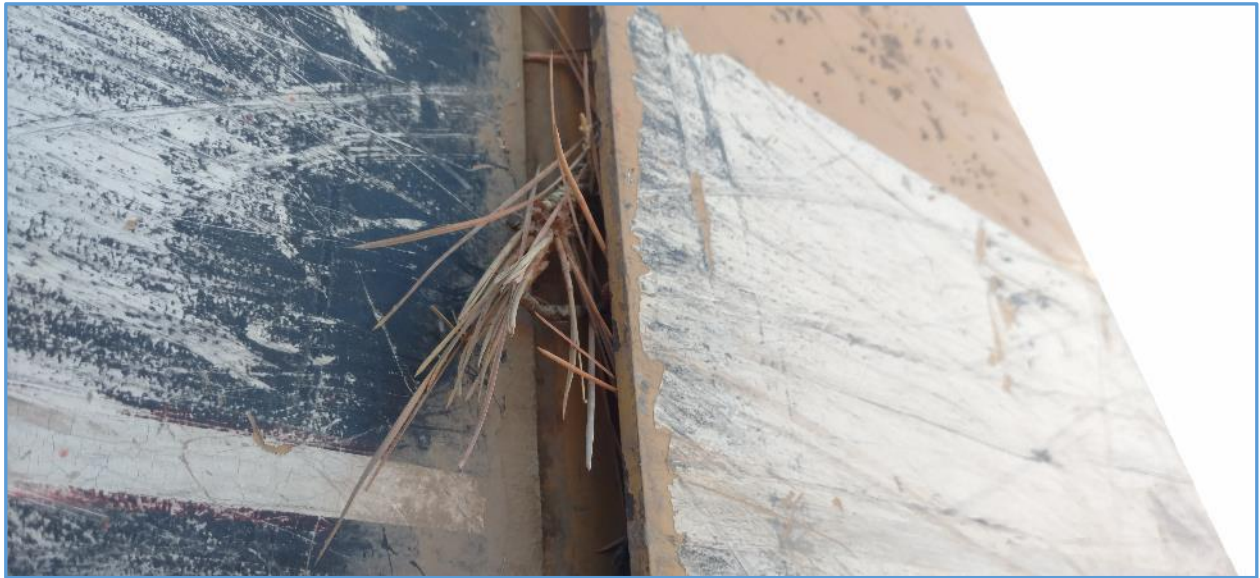
Woody debris were noticed several times both on and smashed into different compartments of Dozer 230. (See photo on next page.) One small fire was started by needles and branches on the rear of the dozer. These materials may have been what started the cab fire. Personnel on the fire noted the probability of ignition as being very high.

Woody debris that had been smashed into the side of Dozer 230 during operations on the Tepee Fire.

- ❖ A regular maintenance schedule that includes the clearing of debris from all compartments in and around the equipment.
 - ✓ An early season and mid-season review of areas, emphasizing the oil pan and tank guards.
