Event Type: Thunderstorm Influence on IA

Date: July 14, 2016

Location: Tok River Fire, Alaska

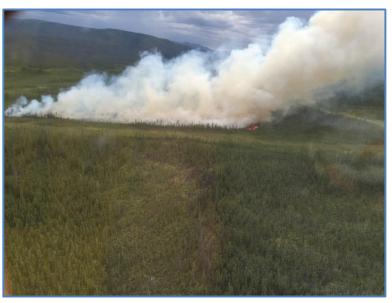
The Tok River Fire as the helicopter arrived on scene.
