**Technology &  
Development  
Program**

# **Toolbox Complex Fire Shelter Deployment Accident Investigation**

*Factual Report and  
Management Evaluation Report,  
September 6, 2002*

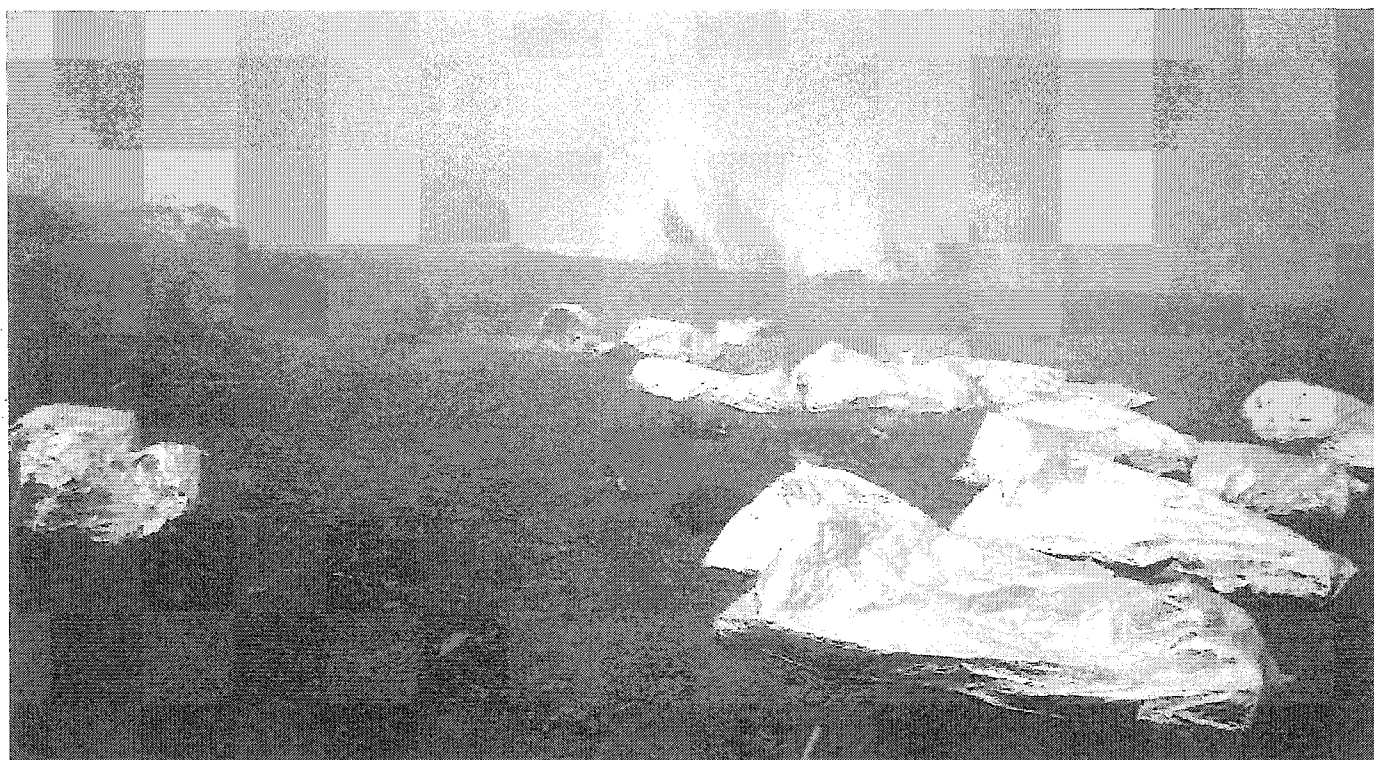
Photo (looking east) taken during fire shelter deployment (photo by Ferguson 53 crew boss).

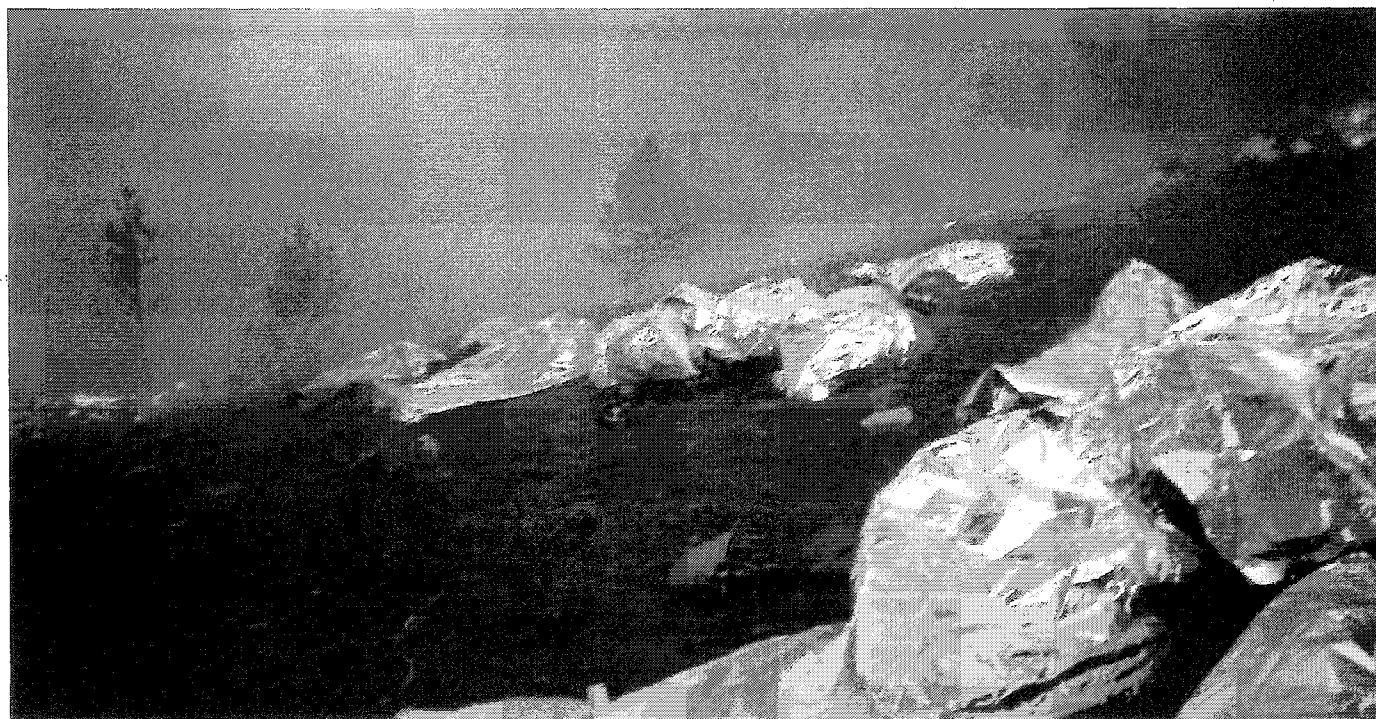
Photo (looking north) taken during fire shelter deployment (photo by Ferguson 53 crew boss).

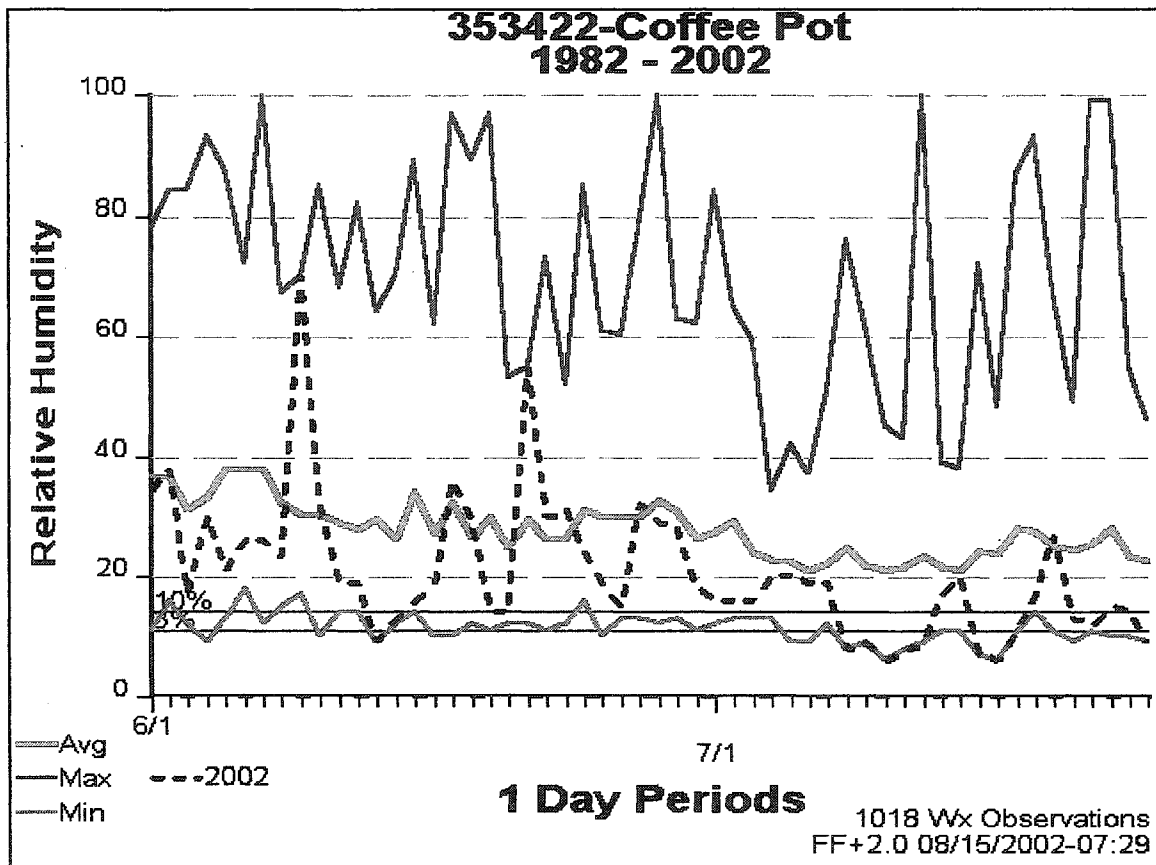
Chart 1

Fire weather conditions on the Toolbox Complex Fire had become more severe by the July 24 shift compared to the previous 5 days. The air mass over the fire area had become significantly more dry as evidenced by the following relative humidity traces from area remote automatic weather stations (RAWS). Chart 1, below, shows a trace of the relative humidity for the Coffee Pot RAWS from June 1 through July 24, compared to historical values since 1982. Note that the recorded value on July 24, is at the 97th percentile low value since 1982.

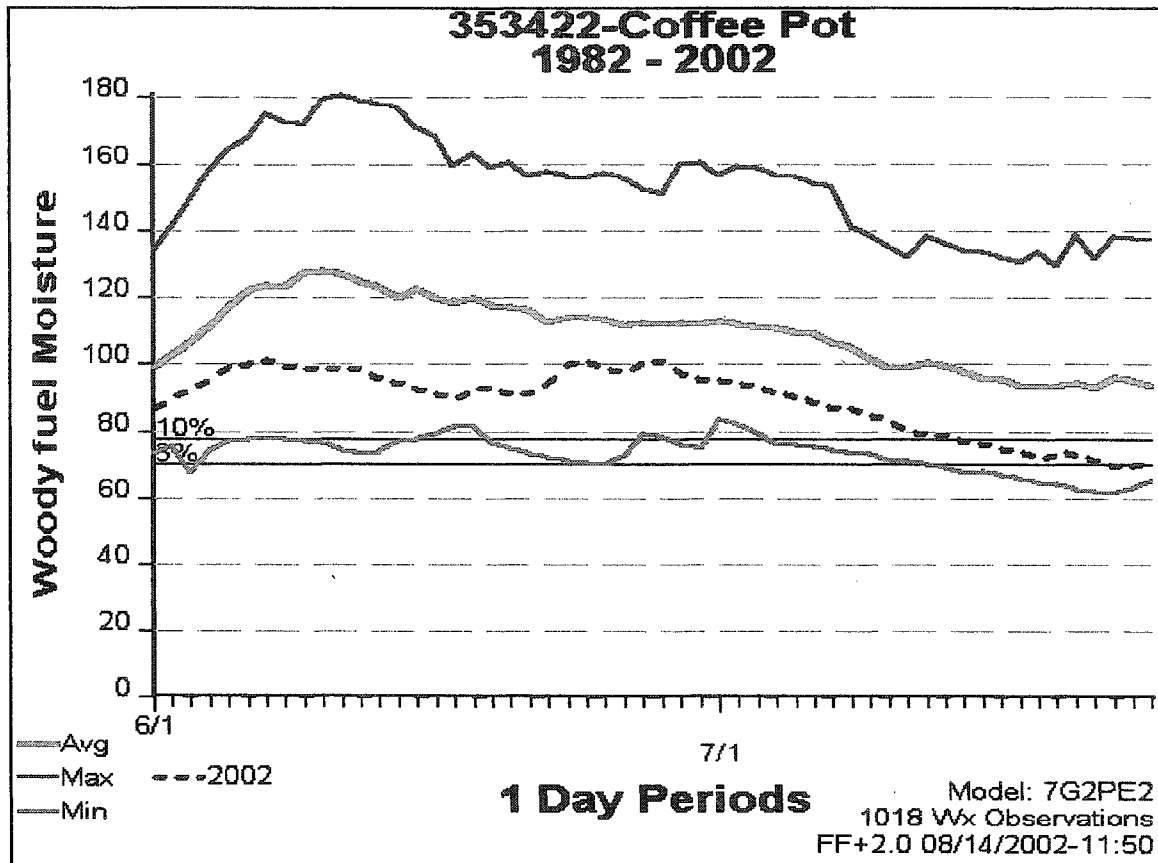
Obviously, the fuels in the Toolbox Complex Fire were at volatile moisture content levels. Chart 2 displays the 2002 trace for woody fuel moisture content for the Coffee Pot RAWS. The live woody fuel moisture value for July 24 is at the 97th percentile low value since 1982. This displayed woody fuel moisture value was confirmed by fire behavior observed in Division T, which included crown fire in mountain mahogany stands.

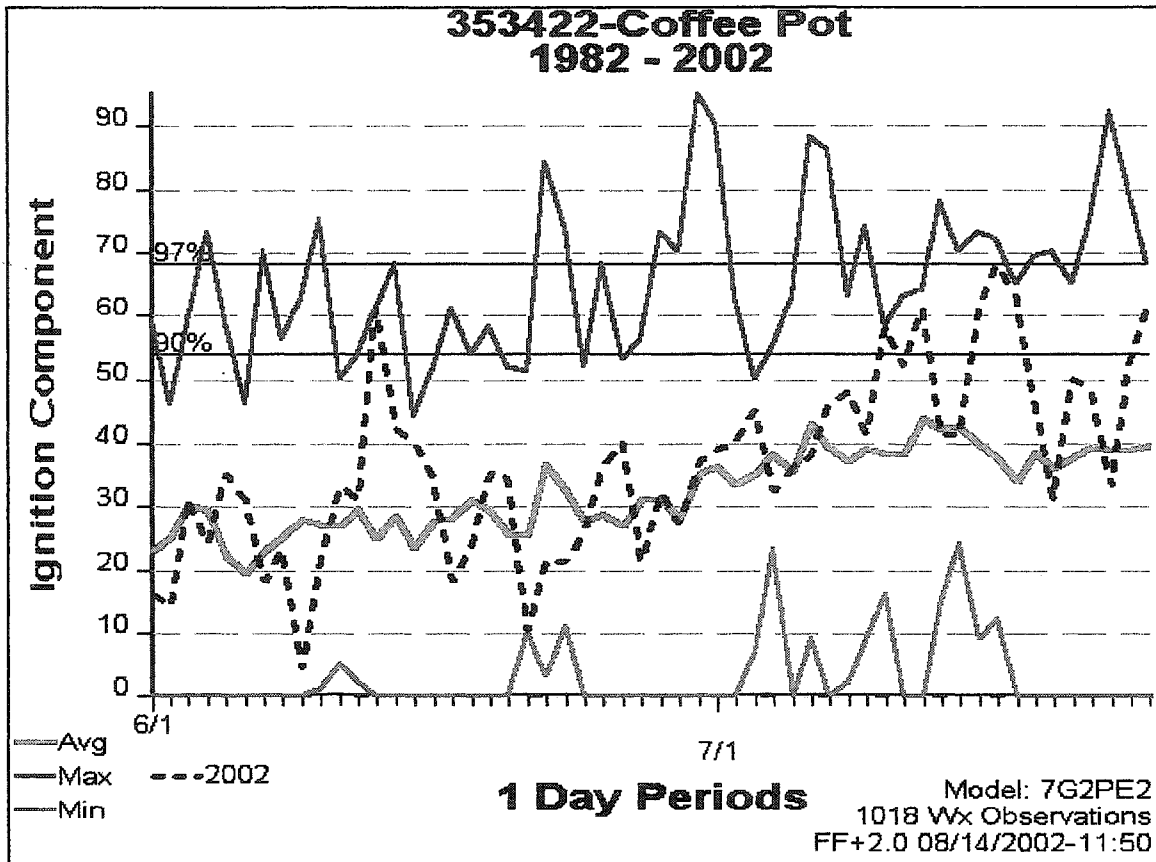
Chart 3

Spotting potential was recognized by the fire behavior analyst and noted in his forecast for the shift. This potential is confirmed by the ignition component trace in chart 3 for the Coffee Pot RAWS. Ignition Component displays the probability of a firebrand causing an ignition requiring a suppression action.

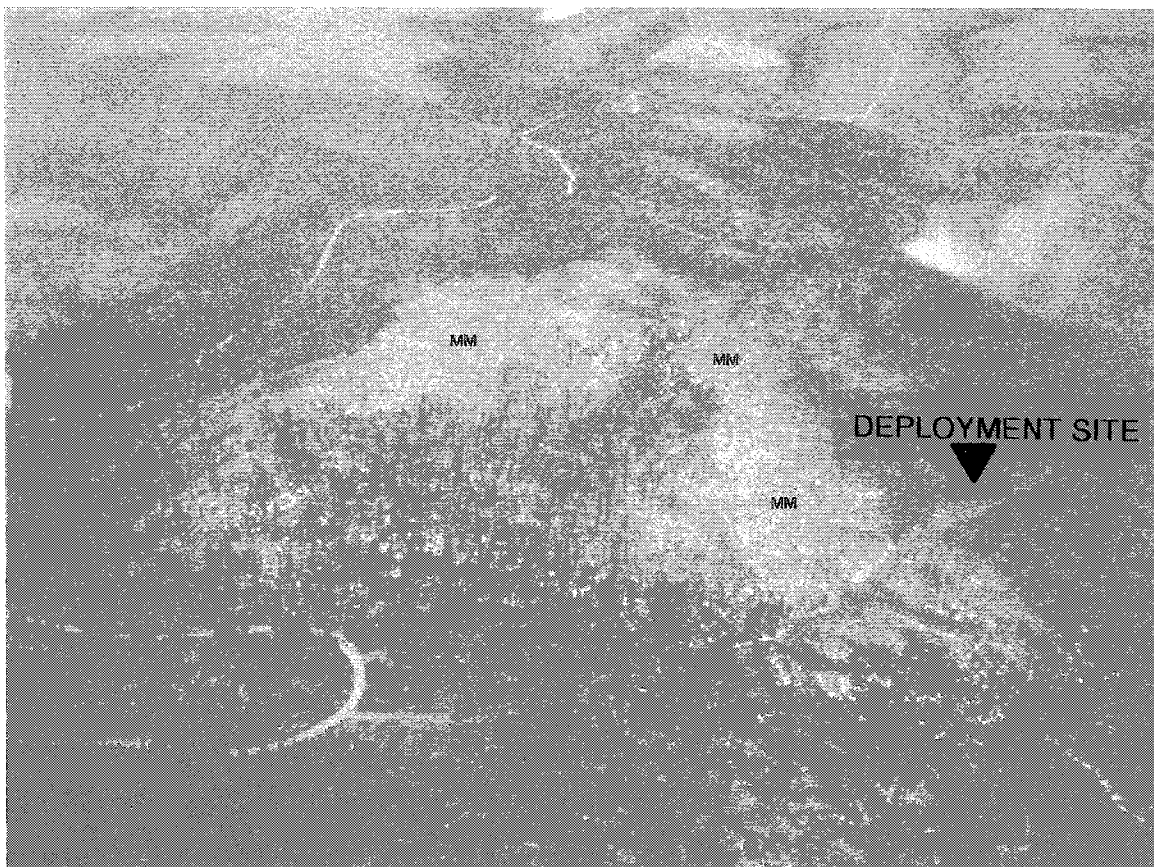
Photo B-1 Large areas of white ash in mountain mahogany stands.

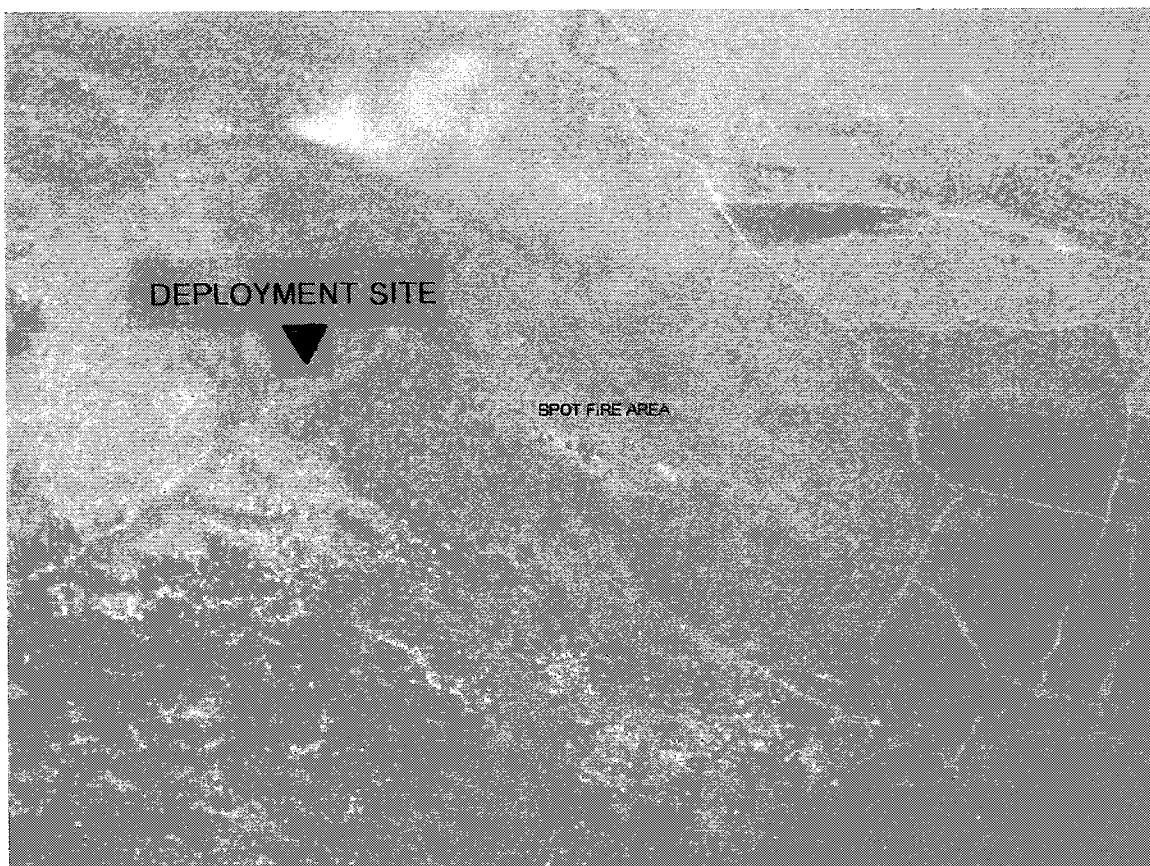
Photo B-2

As the fire behavior began to pickup in the afternoon, torching and crowning behavior was evident in Division T. The shifting of the winds and influence of eddy rolls along the topographic break dropped firebrands into the unburned fuel inside the lower dozer line and beyond it. Spot fire activity was observed by the Ferguson 53 crew adjacent to their safety zone. Spot fires were observed by the incident commander, deputy incident commander and plans section chief on the face of the slope below the Division T lower safety zone. See photo B-2.

As noted by the Ferguson 53 crew boss, the first spot fire near the lower safety zone appeared near the southeast side of the safety zone. This spot grew rapidly in light grass and generated its own spotting when scattered juniper trees began to torch. Spot fires formed on the west side of the short ridge above the safety zone. This slope burned rapidly in the fine grass fuels. By this time there had to be prolific spotting from the mahogany stand as leaves were lofted by crown fire behavior. (It was about this phase in the fire spread that the mid-slope spot fires were observed by the incident commander, deputy incident commander and plans section chief on the road. The same group observed the column of the fire "roll over" the slope prior to the mid-slope spots being observed, see Photo B-2.)
