Rapid Lesson Sharing

Event Type: Dozer Rollover

Date: July 2, 2016

Location: Trailhead Fire, Eldorado National Forest;
Pacific Southwest Region

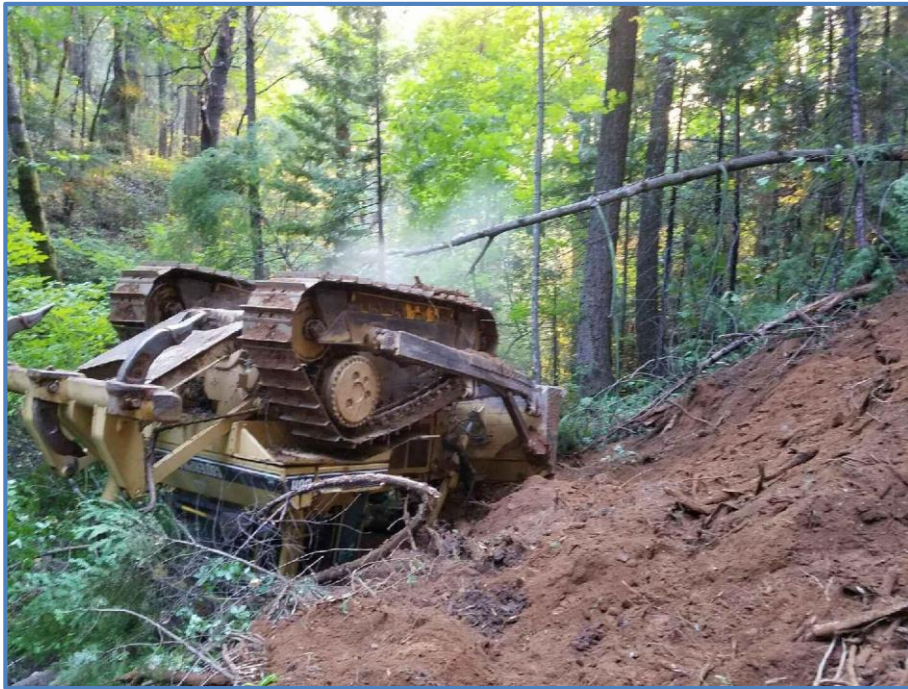
While trying to push another tree over, the dozer became unbalanced and started to slip off the pad. The operator shut off the motor and the dozer did a slow roll off the pad and onto its side. The driver was able to extricate himself and—with the help of the Structure Group Supervisor—climb back up the slope. At this point, the dozer slipped again and ended up rolling onto its top in the creek bottom.
